FEDERAL EMERGENCY MANAGEMENT AGENCY

Above the Flood: **ELEVATING YOUR FLOODPRONE HOUSE**

MITIGATION DIRECTORATE

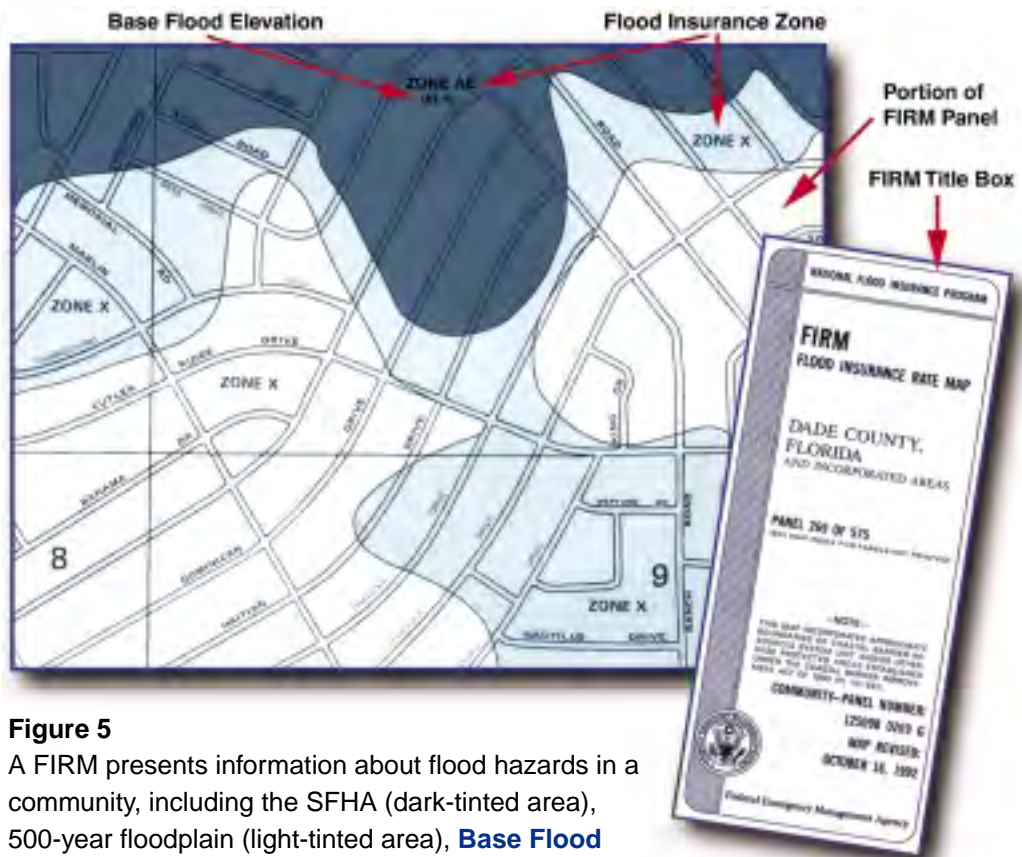
Figure 5
A FIRM presents information about flood hazards in a community, including the SFHA (dark-tinted area), 500-year floodplain (light-tinted area), **Base Flood Elevations**, (BFEs) (number in parentheses), and flood insurance zones (AE and X in this example).

Note that the SFHA in the example in Figure 5 is designated Zone AE. This zone is only one of several applied to SFHAs under the NFIP, including V, VE, VI-V30, A, AE, A1-A30, AO, and AH. These zones indicate differences in the types and severity of flood hazards in SFHAs. For the purposes of this publication, it is sufficient to focus on the basic differences between the two main types of SFHA zones—V zones and A zones. The distinction is important because regulatory requirements associated with V zones and A zones differ significantly. As explained later in this chapter, these requirements affect the types of building elevation techniques that may be used under the NFIP.

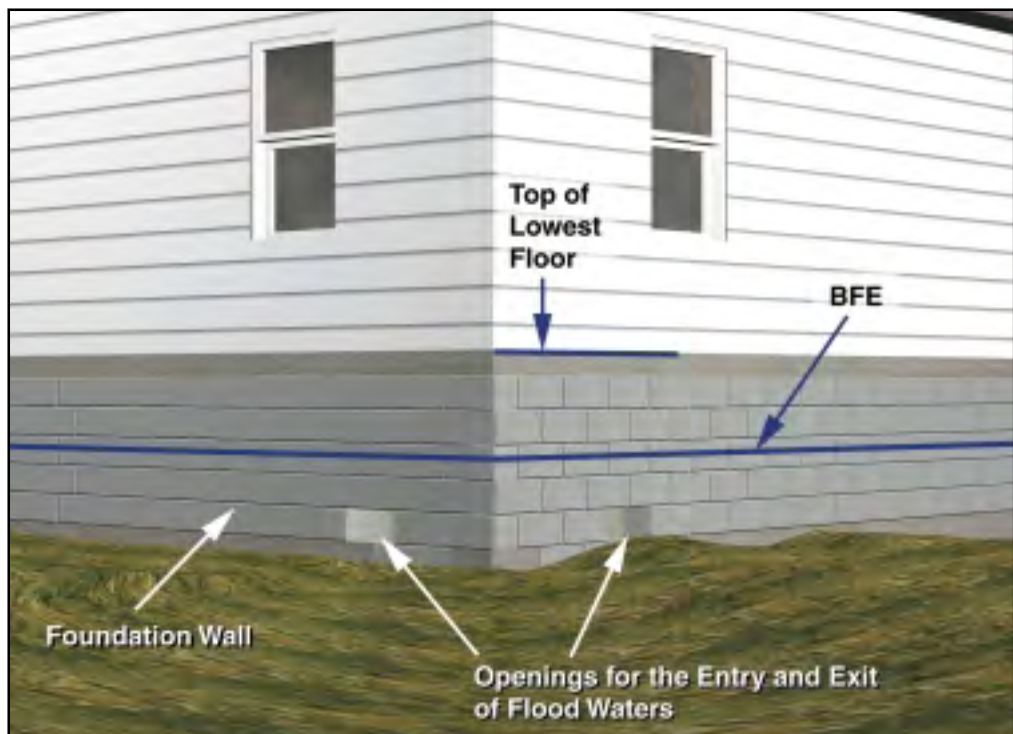
Figure 6

In a new, substantially improved, or substantially damaged building in an A zone, the elevation of the lowest floor must be at or above the BFE.

In A zones, where flood hazards are less severe, buildings may be elevated either on an open foundation or on continuous foundation walls below the BFE (Figure 6). Regardless of the type of foundation used, A-zone buildings must be elevated so that the **lowest floor** is at or above the BFE, as shown in Figure 6. If continuous walls are used below the BFE, they must be equipped with openings that allow flood waters to flow into and out of the area enclosed by the walls (Figure 6). Allowing the entry and exit of flood waters ensures that water pressures will be the same on both sides of the walls and reduces the likelihood that water pressure will cause the walls to fail.

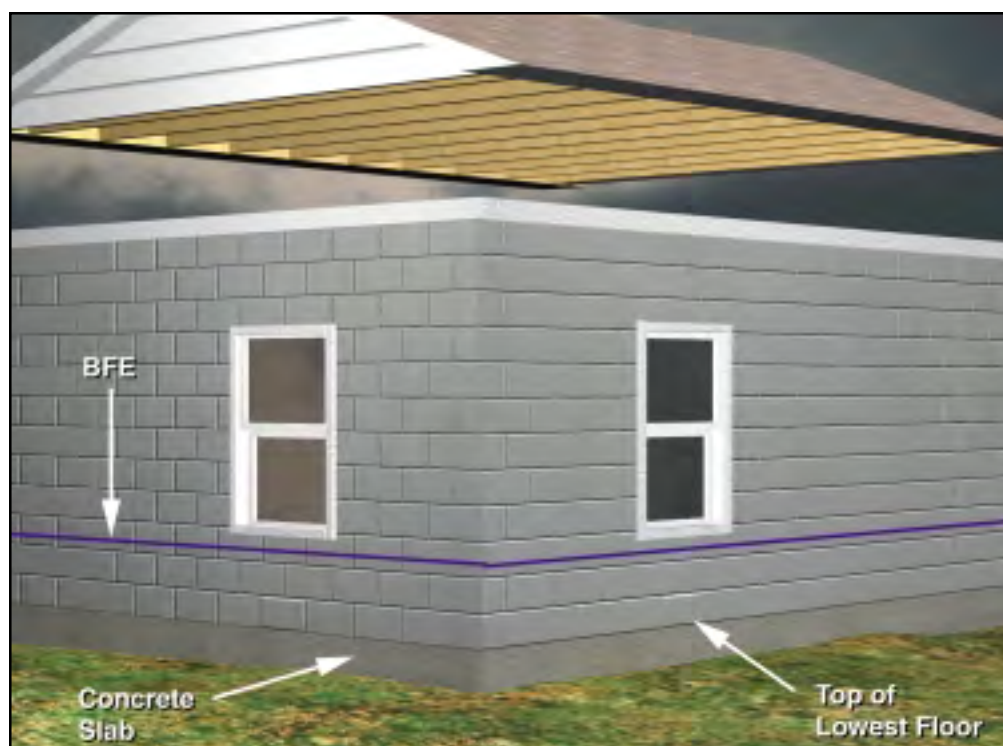
Figure 10
The first step in Technique 1 is removing the roof.

Technique 1 is appropriate for houses with concrete or masonry walls, but not for houses with other types of walls, such as those framed with wood studs, which would be more vulnerable to flood damage. This technique is usually appropriate when the depth of the base flood at the house is no more than 4 or 5 feet above grade. The elevation process begins with the temporary removal of the roof and roof framing, in a single piece if possible (Figure 10). This is commonly done with a crane. The roof is then stored on site so that it can be reinstalled later. The next step is to remove the windows and doors.

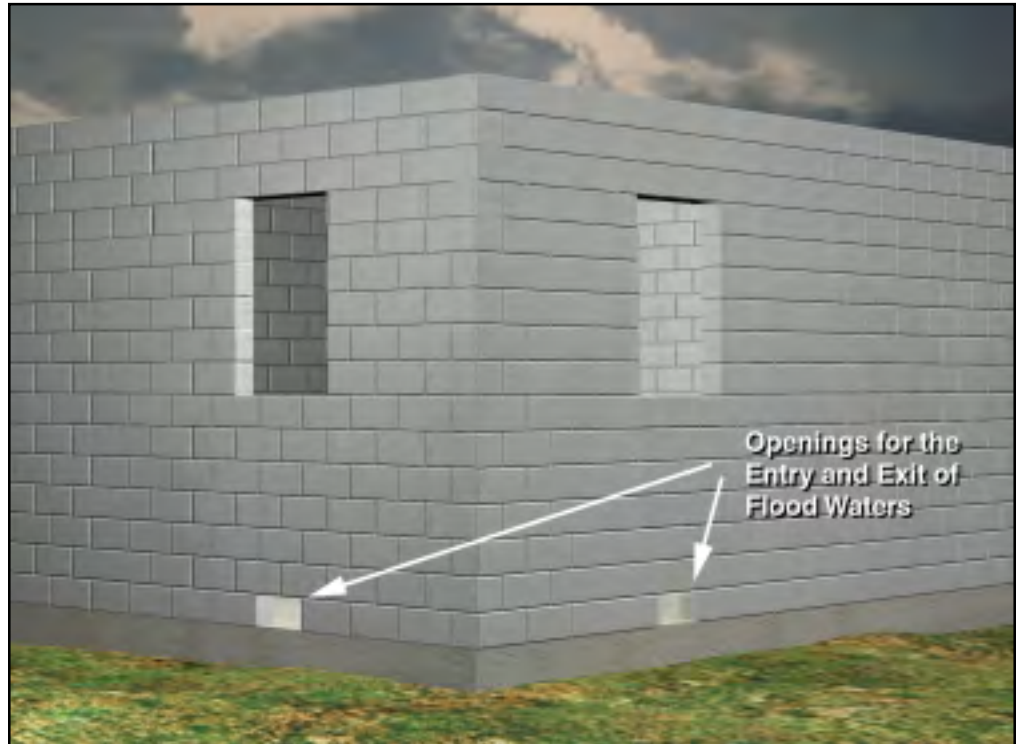
Figure 12
Openings are created in the walls near the ground.

Blocks are removed from the walls of the house at selected locations within 1 foot of the ground (Figure 12). The resulting openings will allow flood waters to flow into and out of the lower area of the house so that the water pressures on both sides of the walls will remain the same. The roof and windows are then replaced, and a new wood-frame floor is constructed above the flood level (Figure 13).

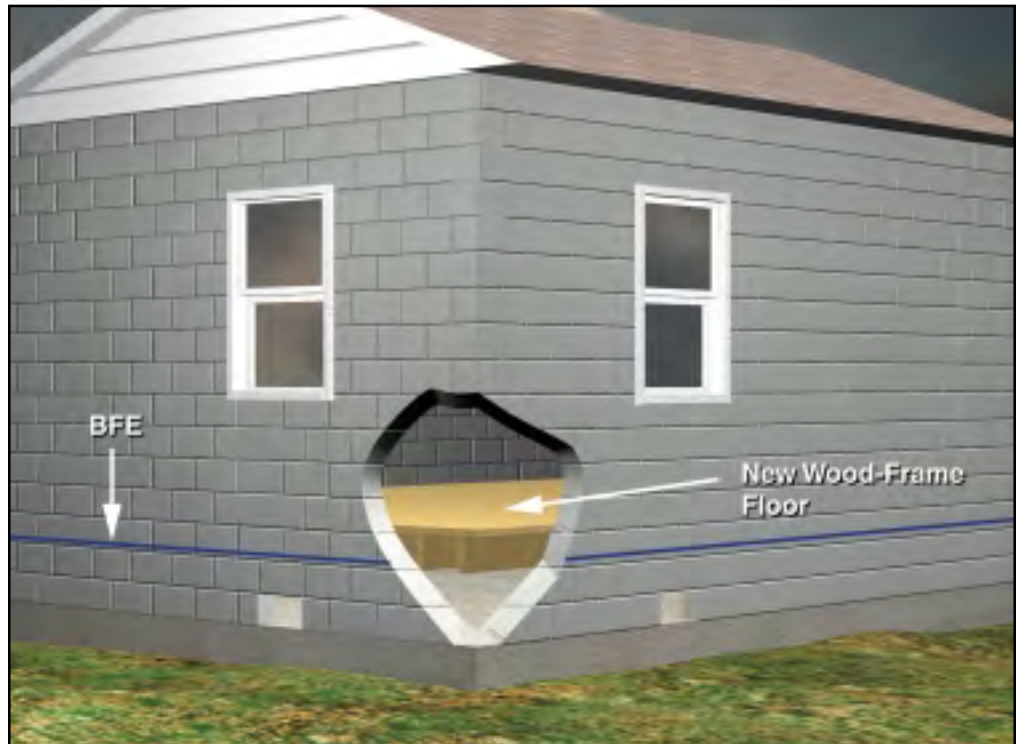
Figure 13
A new wood-frame lowest floor is constructed above the flood level, and the roof, windows, and doors are reinstalled.

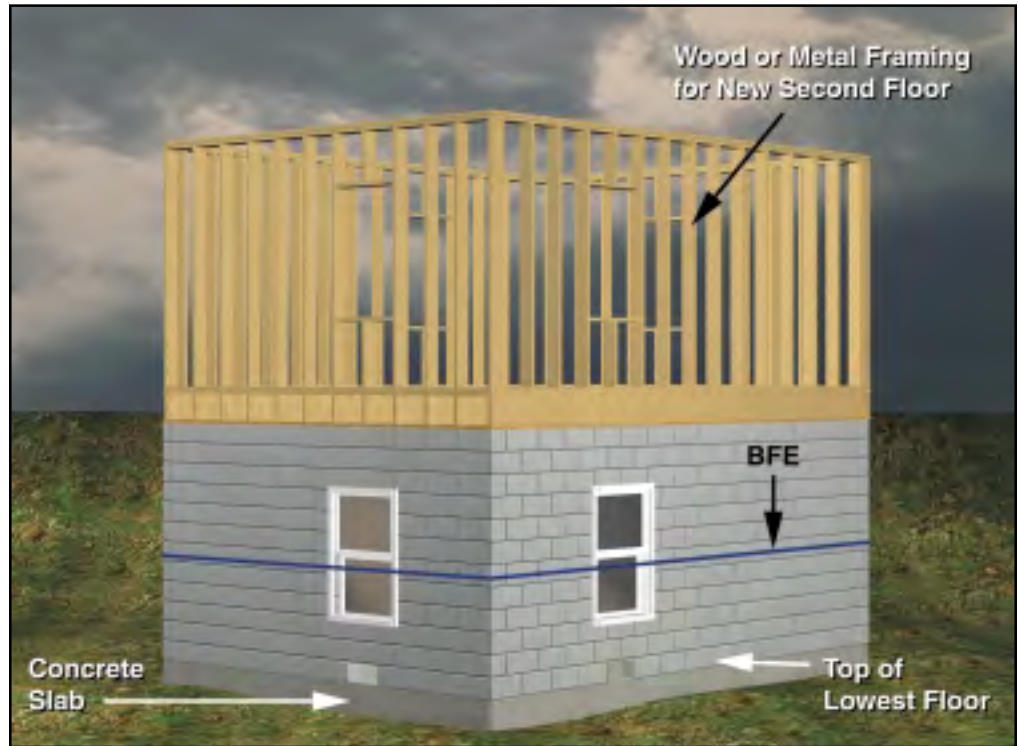
Figure 15
The new second-story floor and walls are built on top of the existing lower story.

As in Technique 1, the repairs begin with the temporary removal of the roof and roof framing (Figure 10). After the roof is removed, construction of the new second story begins. First, a new wood-frame floor is built on top of the existing lower-story walls. The second-story walls are framed with metal or wood studs and set in place on the floor (Figure 15).

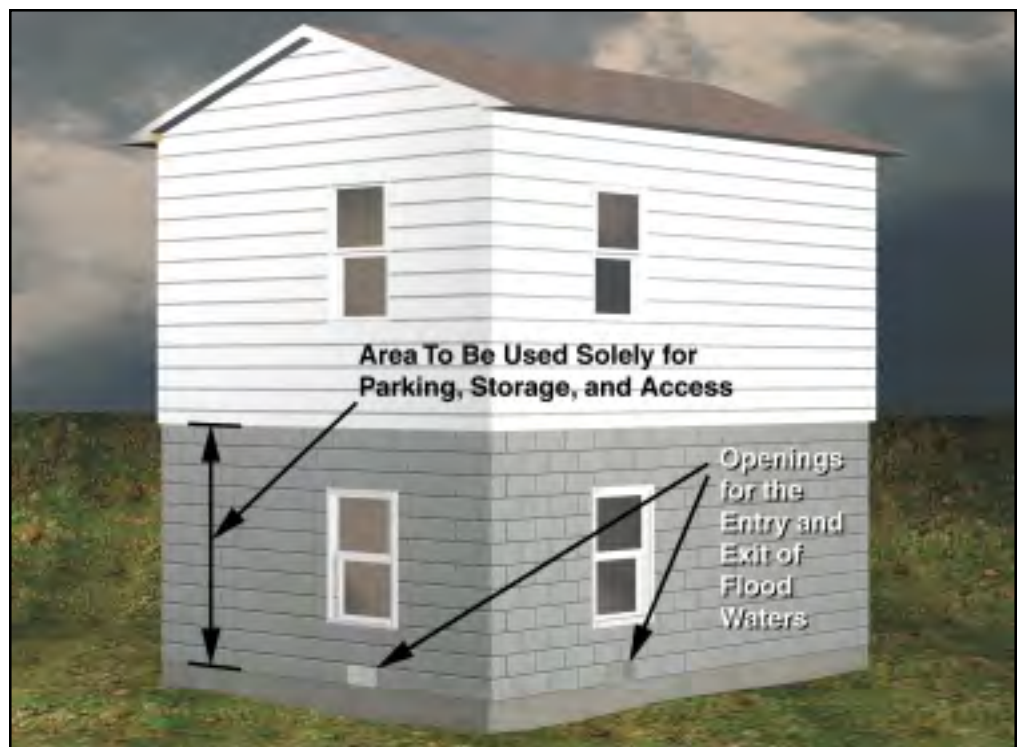
Figure 16
The new second-story walls are covered with siding or stucco.

Some homeowners prefer that the second story be constructed of masonry, but wood- or metal-framing is more common, primarily because it is lighter and less expensive. The roof is replaced, and blocks are removed from the walls to allow flood waters to enter and exit. Exterior sheathing is then added to the framed walls of the second story, the new windows are installed, and siding or stucco is applied to the sheathing (Figure 16).

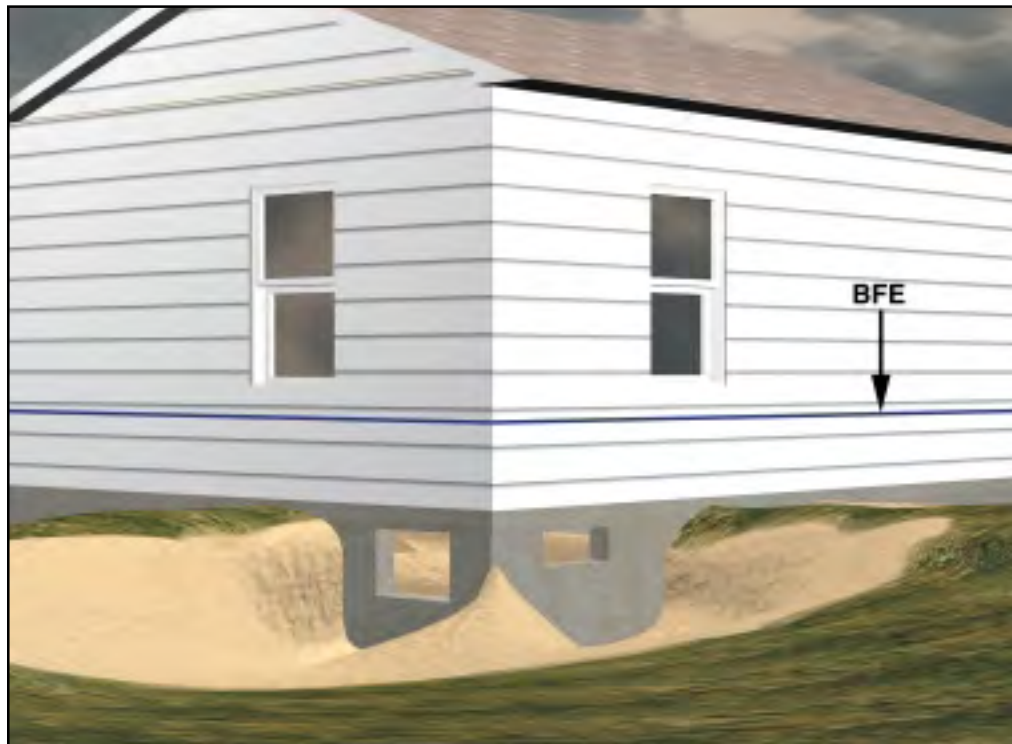
Figure 17
Trenches and tunnels under the slab provide access for the jacks and I-beams that will lift the house.

First, trenches are dug to expose the foundation walls immediately below the slab. Holes are then cut in the foundation walls at intervals around the house, and tunnels are dug under the slab (Figure 17). Jacks are placed in the trenches and large I-beams are inserted through the tunnels and allowed to rest on the jacks. Smaller I-beams are then inserted through the tunnels at right angles to the larger beams and positioned on top of them. The smaller beams support the slab when the house is raised (Figure 18).

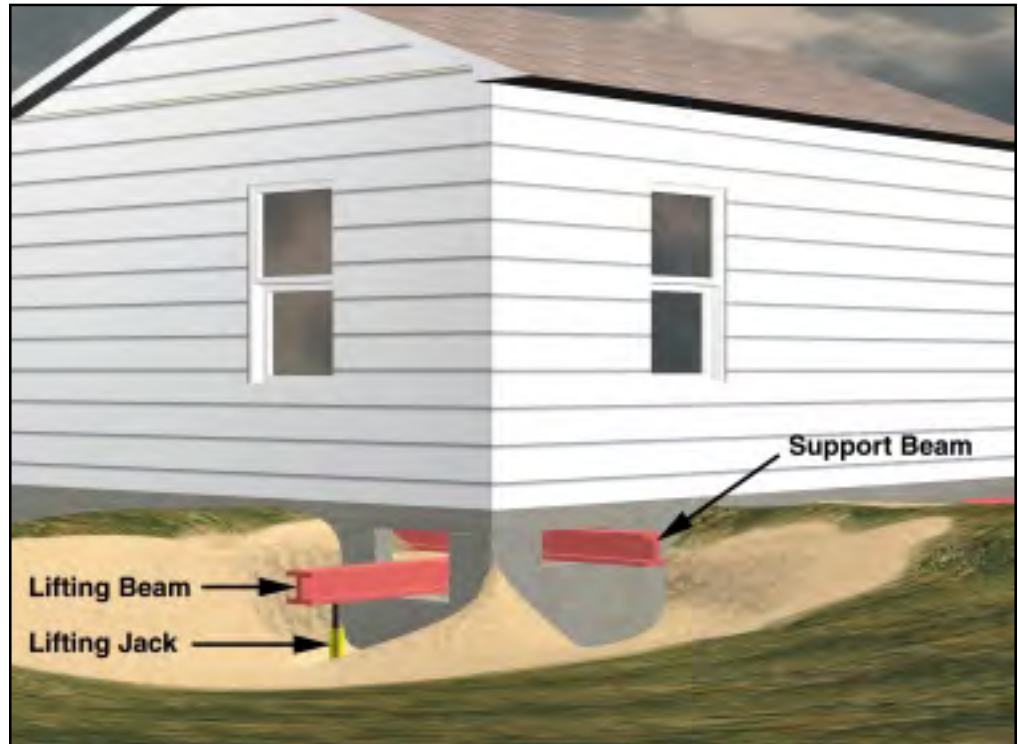
Figure 18
With I-beams and jacks in place, the house is ready to be lifted.

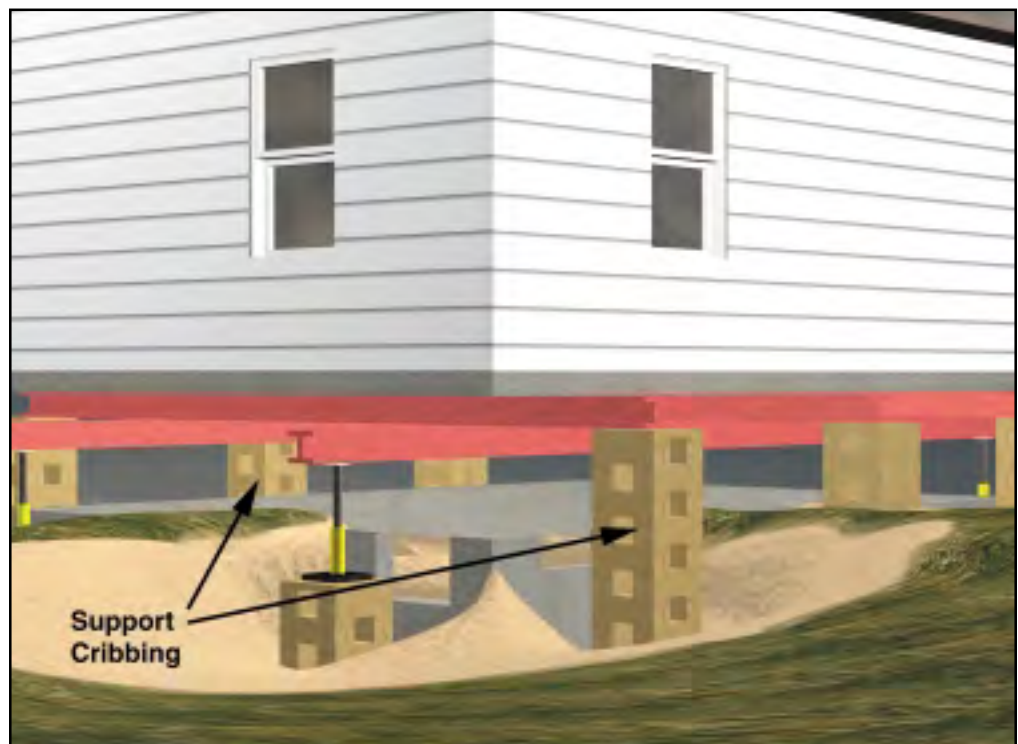
Figure 19
The house is temporarily supported on cribbing.

The house is then jacked up. When the jacks have extended as far as possible, the house must be supported temporarily while the jacks are raised. Both the house and the jacks are usually supported on “cribbing”—temporary piles of crisscrossed timbers (Figure 19). The jacks are then used to raise the house higher.

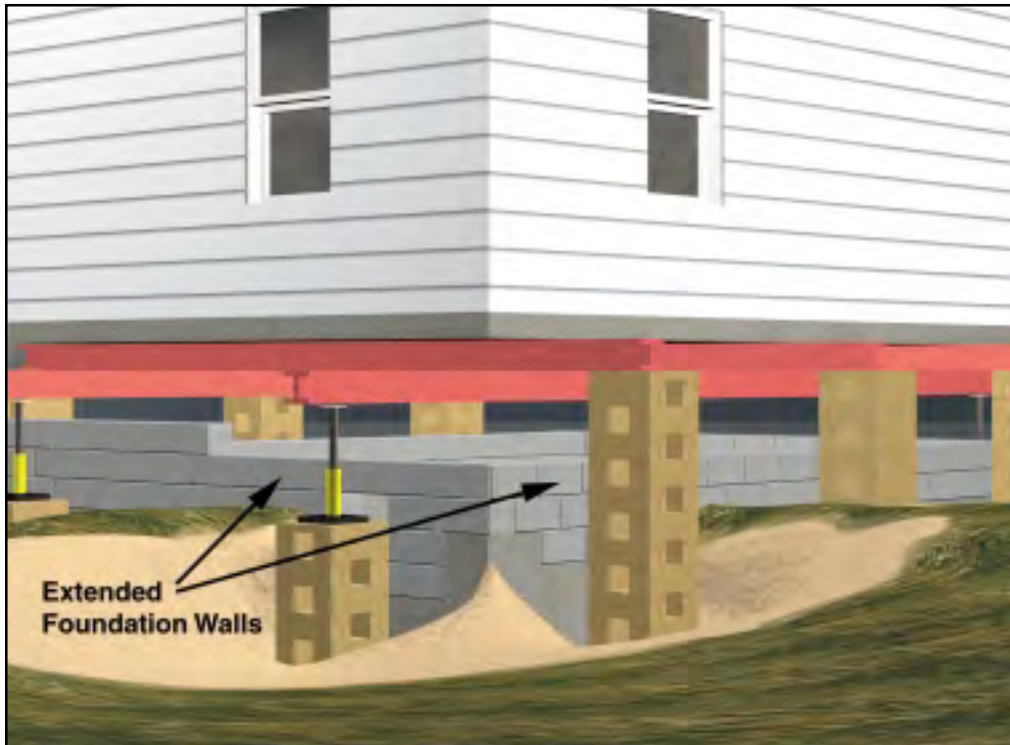
Figure 20
New, extended foundation walls are constructed with concrete blocks.

This process is repeated until the house is raised to the desired height. The foundation walls are then extended upward with additional rows of concrete block (Figure 20). As in the previous techniques, openings are made in the walls within 1 foot of the ground so that flood waters will be able to flow into and out of the area below the elevated floor. The jacks and beams are removed, and the openings left around the beams are filled with blocks (Figure 21).

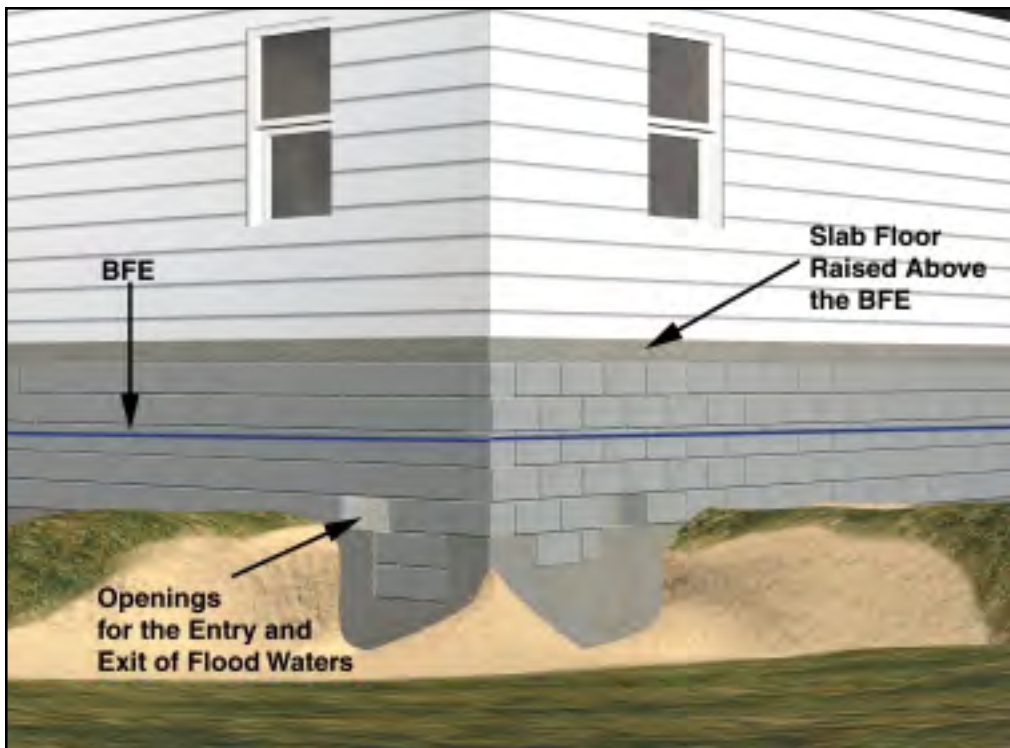
Figure 21
Elevated house and slab on new, extended foundation walls.

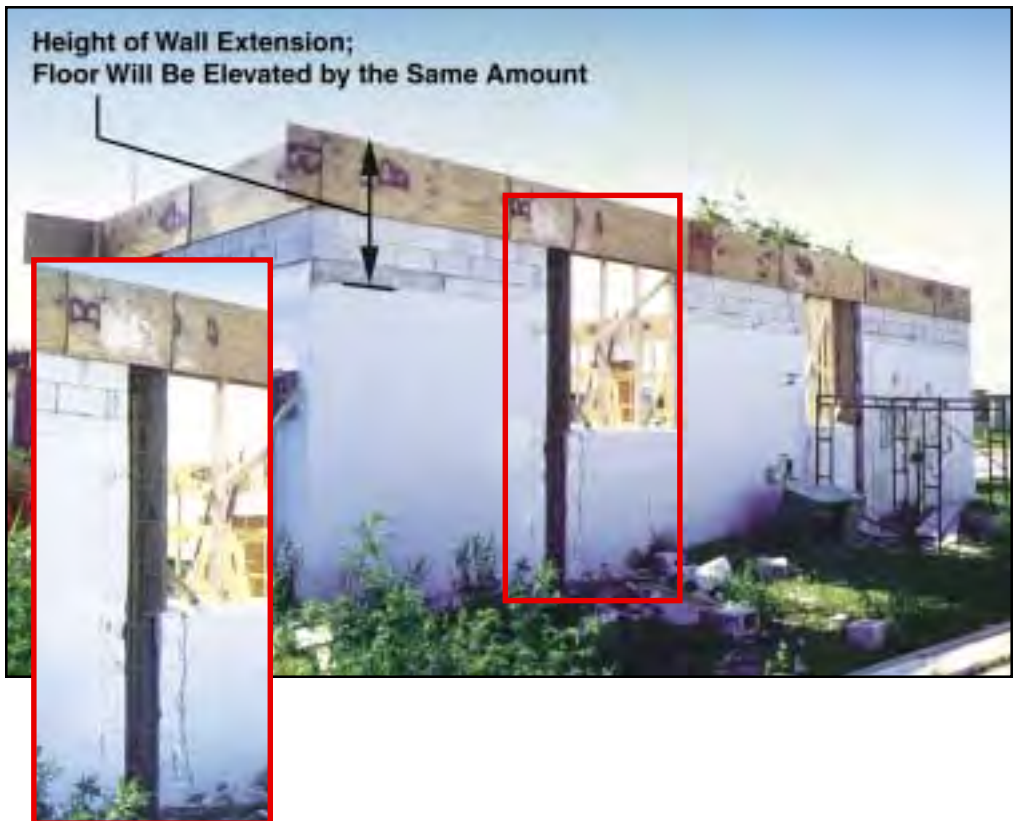
Another view of the extended walls. The vertical cuts in the walls next to the windows are for concrete tiedown columns that will be cast in place to further strengthen the extended walls against wind loads. The owner of this house was able to meet the elevation requirement by raising the floor only a few feet, as indicated by the amount that the walls have been extended.

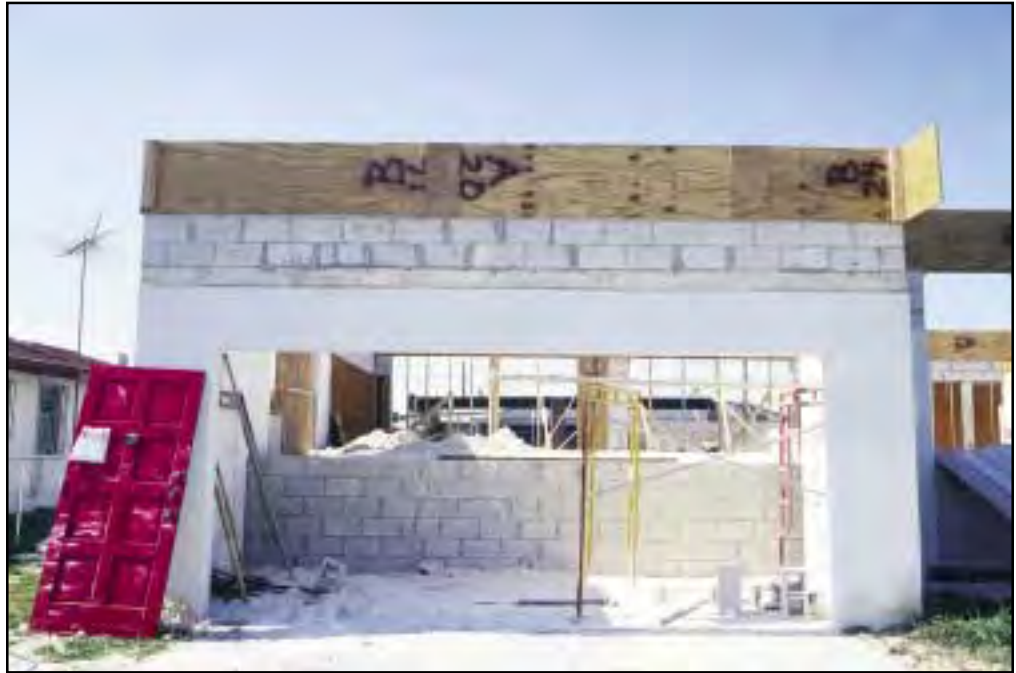
Figure 25

This view through the garage door reveals the different levels of the elevated slab floor, in the background, and the unelevated garage floor.

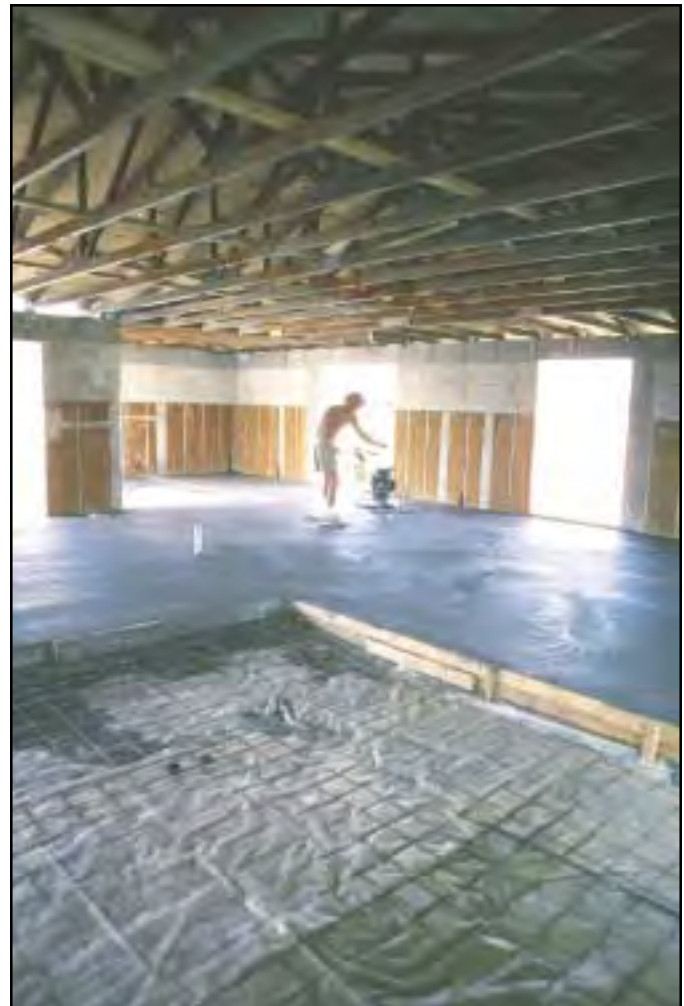
**Figure 26**

The roof has been rebuilt with the salvaged trusses, and most of the new concrete slab has been poured on top of the sand fill. The open area in the foreground, where plastic sheeting and wire reinforcement can be seen on top of the sand fill, is where the remaining part of the slab will be poured.

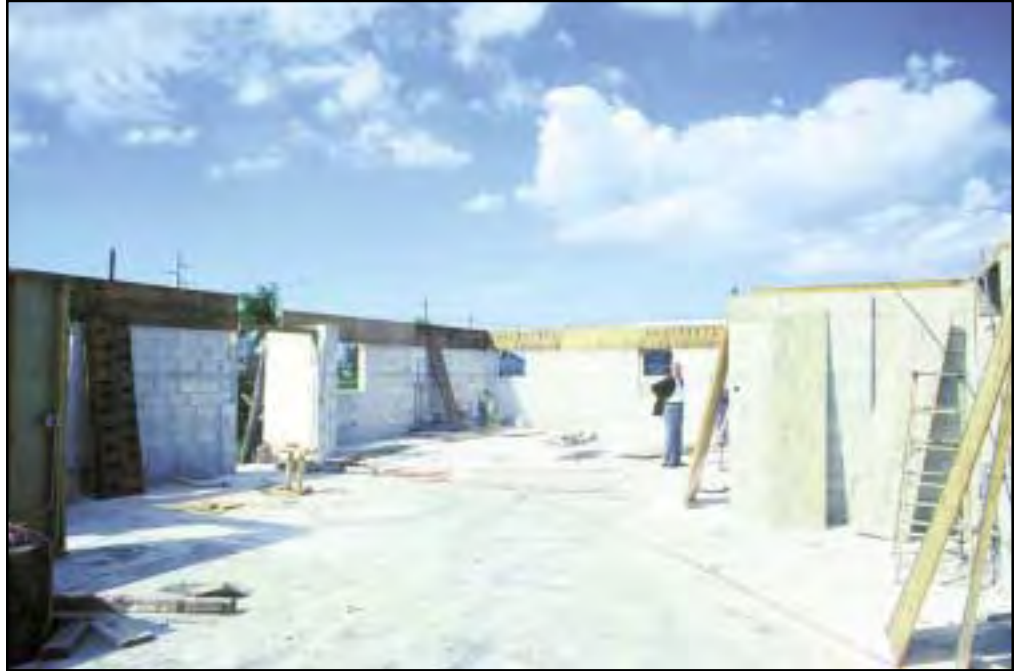
Figure 40

After the roof was removed and the storm-damaged interior gutted, the walls of the house were extended upward and a new bond beam added at the top.

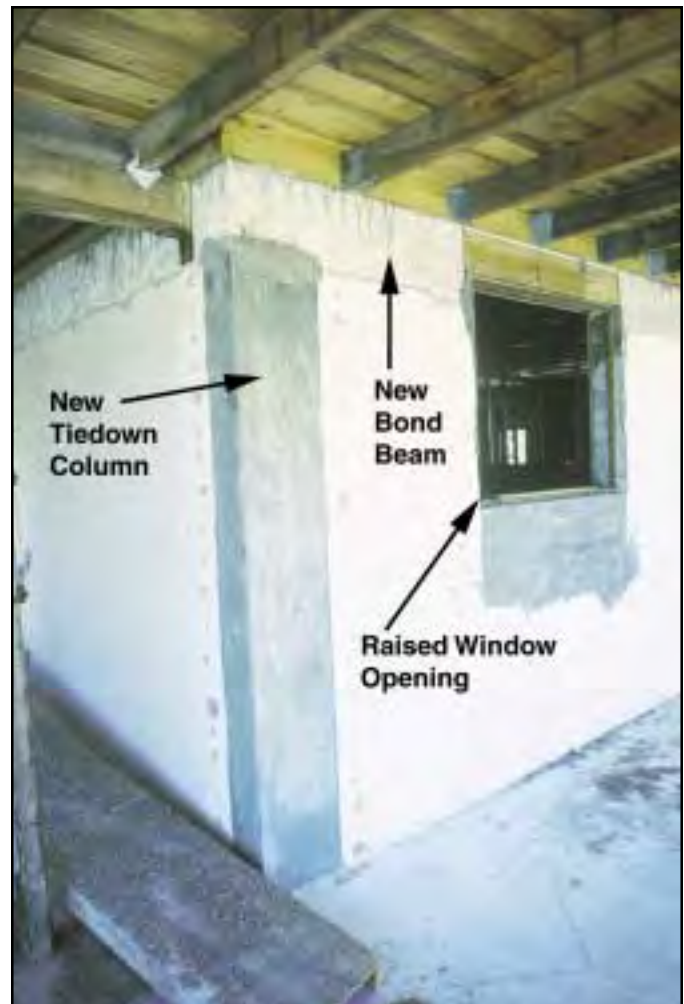
**Figure 41**

Note the new bond beam at the top of the extended wall, the new concrete tiedown column at the corner, and the raised window opening.

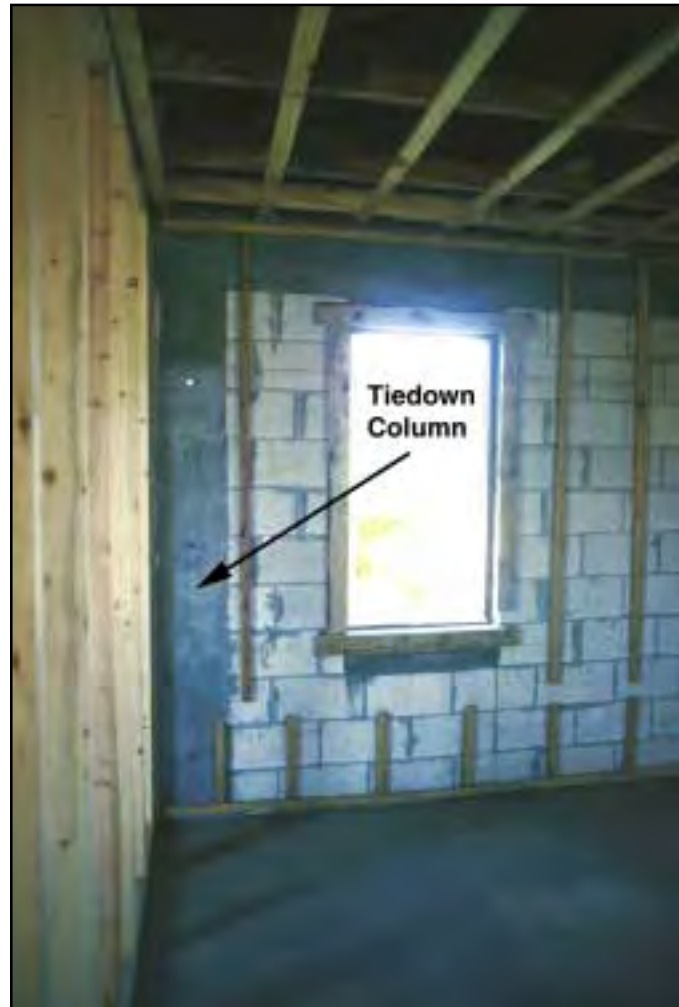
Figure 46
Concrete tiedown columns, such as the one to the left of the window in this photograph, were also used in this house.

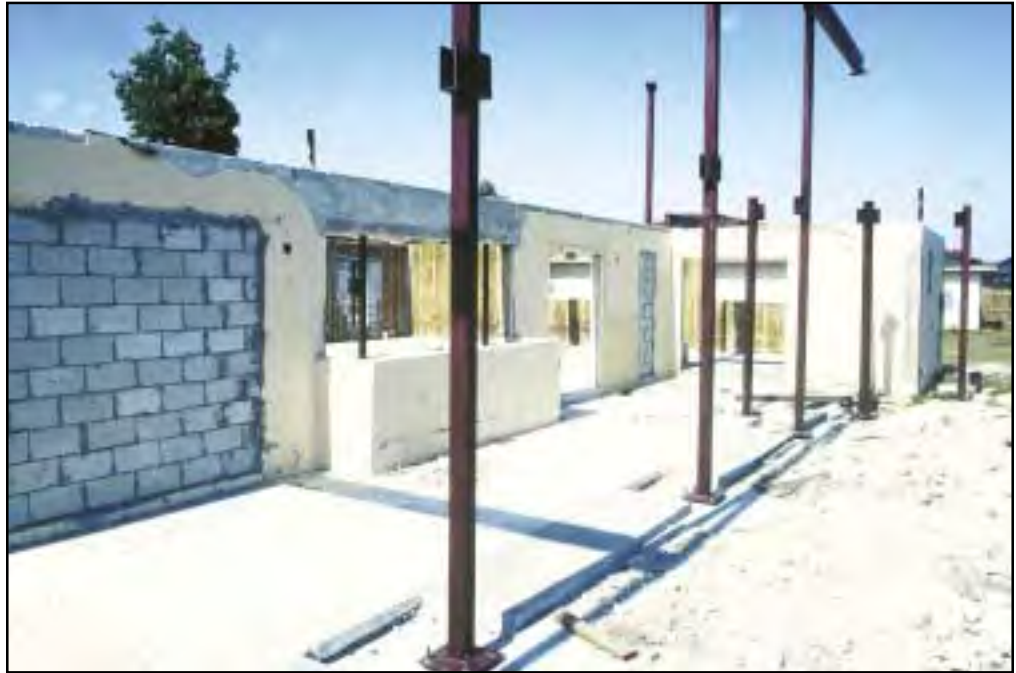
Figure 52

The existing first-story walls have been strengthened by the addition of concrete block. Metal columns and beams have been added to help support the new second story.

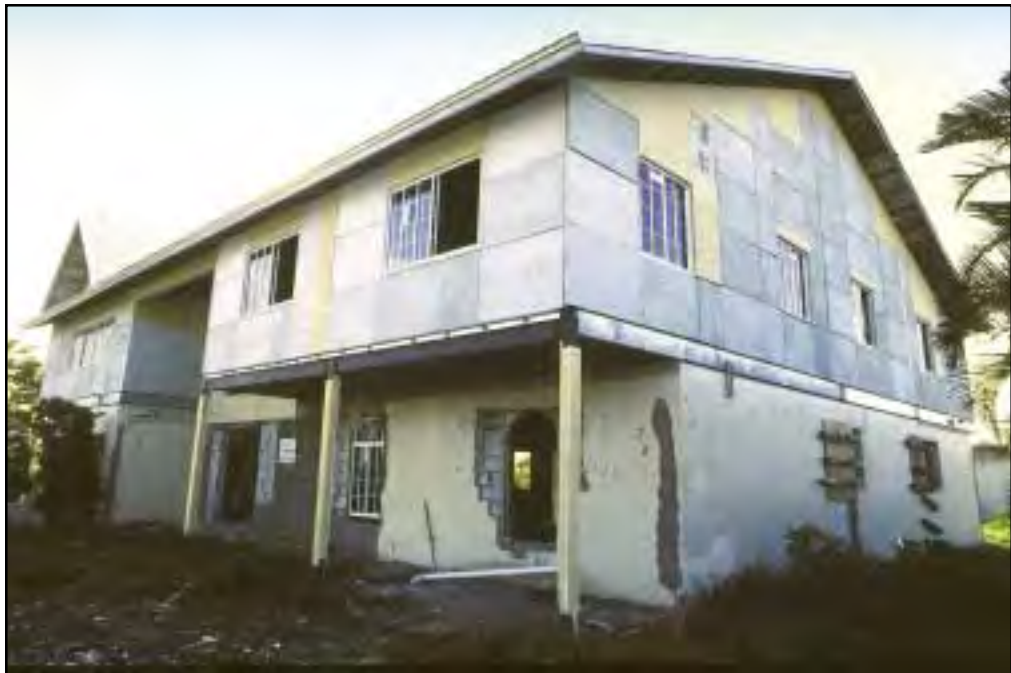
Figure 59

The exterior walls consist of prefabricated concrete panels. Innovative techniques such as those employed in this project are helping homeowners who need practical and economical methods of repairing and protecting their houses.

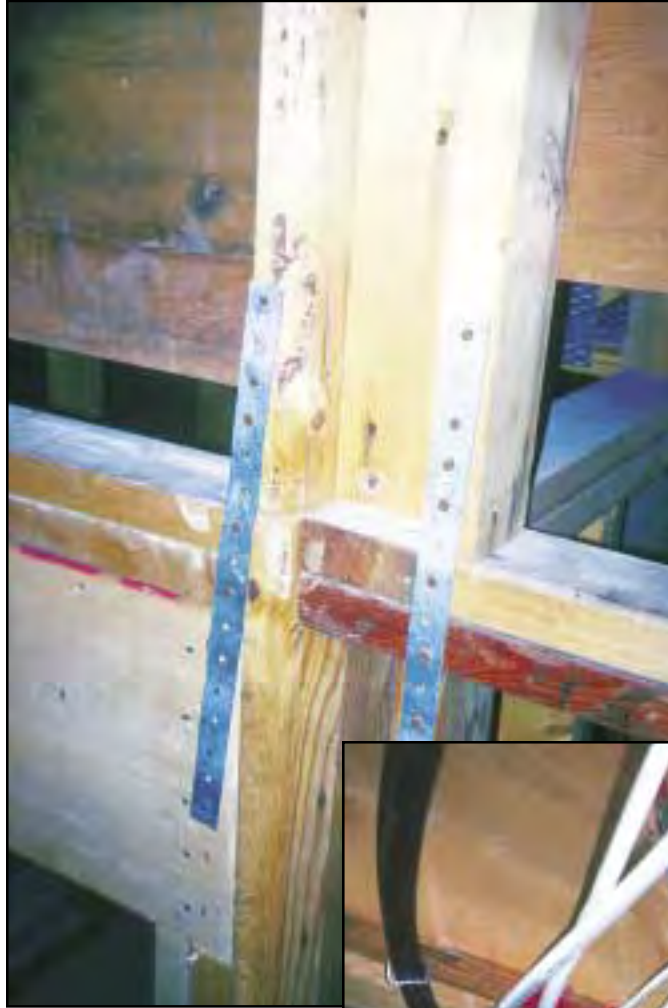
Figure 70

Metal hurricane straps are used to tie the structural members together and create a continuous load path from the roof to the foundation.

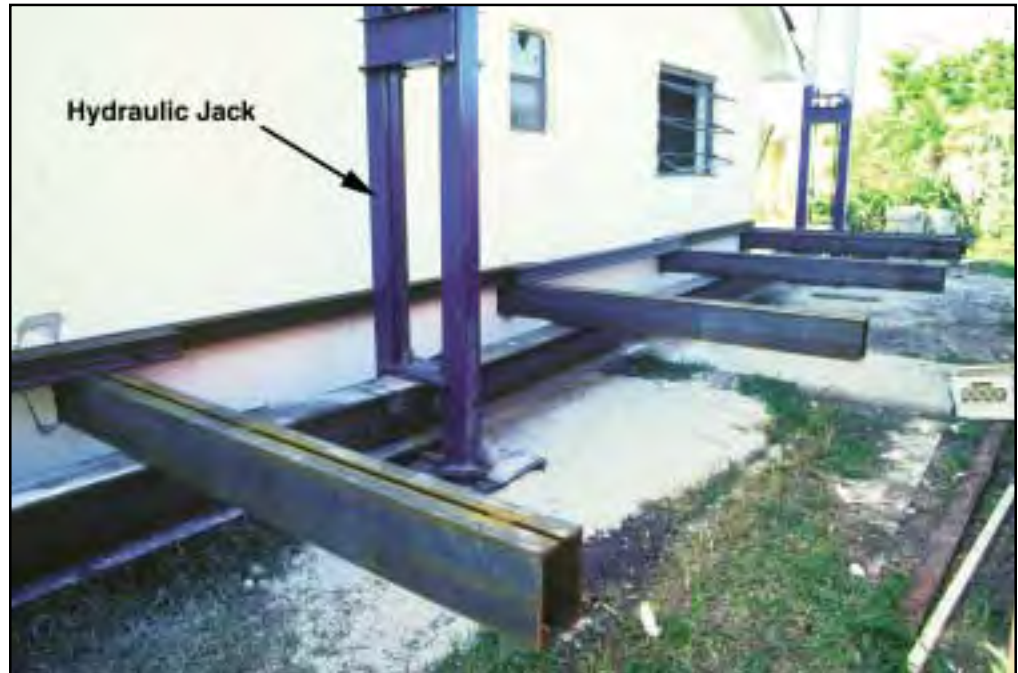
Figure 74

In this variation of Technique 3, steel beams are inserted through the walls of the house rather than under the slab. The beams span the length and width of the house and cross one another inside to create a grid. Outside the house, the beams rest on larger beams that will be raised with hydraulic jacks.

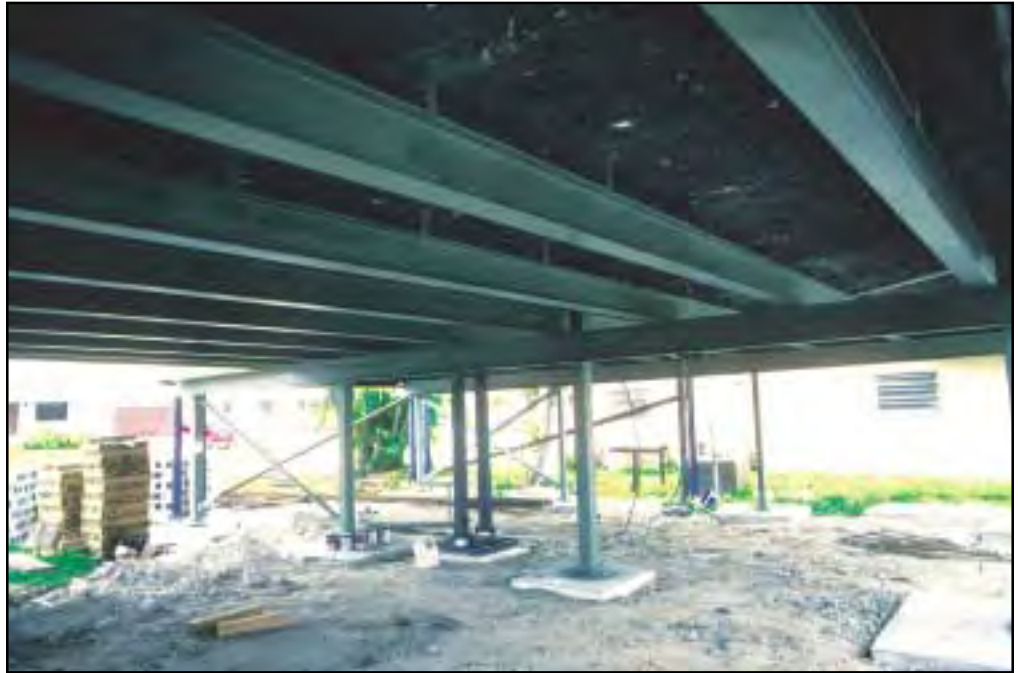
Figure 82

While the jacks and beams supported the house, new steel foundation members were installed below.
