# ***The 25 Most Environmentally Damaging Dirt Roads of Baldwin County, Alabama***

A Report by the Baldwin County  
Environmental Advisory Board

**March 2010**

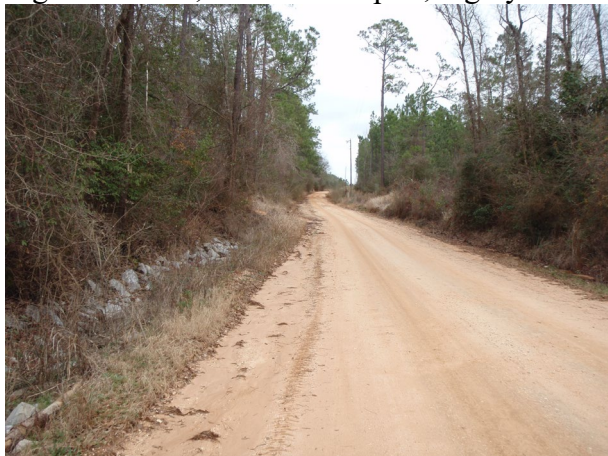
Photo 1: Example of previous ditch line treatment.

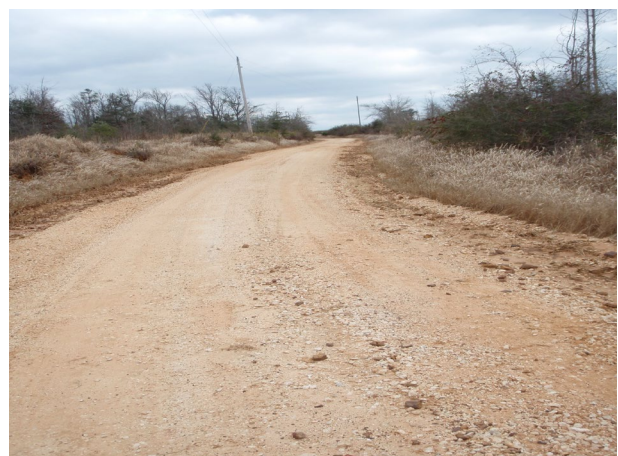
Photo 2: Example of previous road surface treatment.

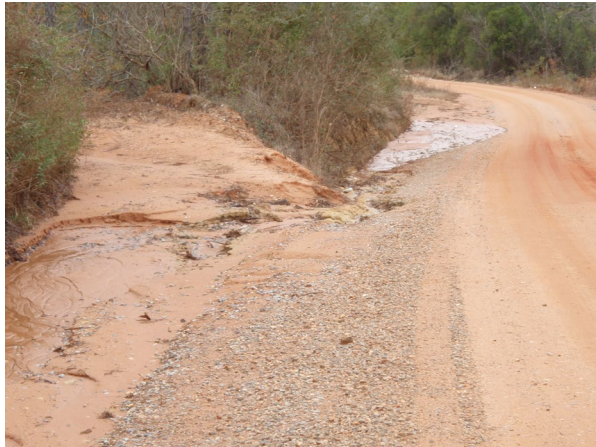
The authors were less encouraged by the frequency of failed “turn-outs”, the number of “turn-outs” discharging directly to streams and wetlands, ineffective cross drains (filled, submerged or complete absence), the vegetative clearing and placement of fill material without the use of temporary BMPs or permanent stabilization practices (although not required by regulation).

Photo 3: Example of failed “turn-out”.

- The County should be more diligent with the application of temporary or permanent best management practices (BMPs) during road repair.
- “Turn outs” should be located in areas that will not discharge directly to a wetland or stream, where possible, and maintenance of “turn-outs” should include the periodic removal of accumulated sediments particularly where they discharge near wetlands or streams.

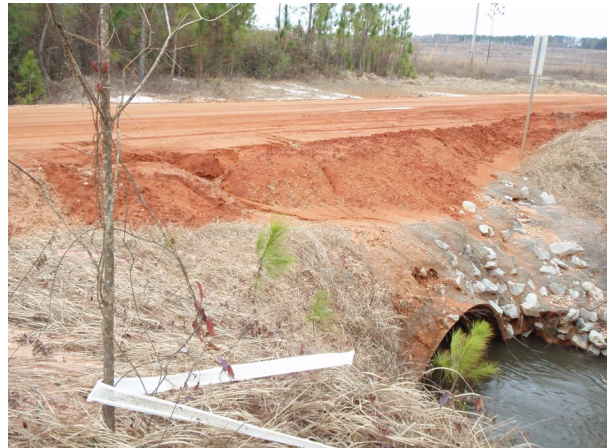
Photo 4: Example of fill placement without BMPs.

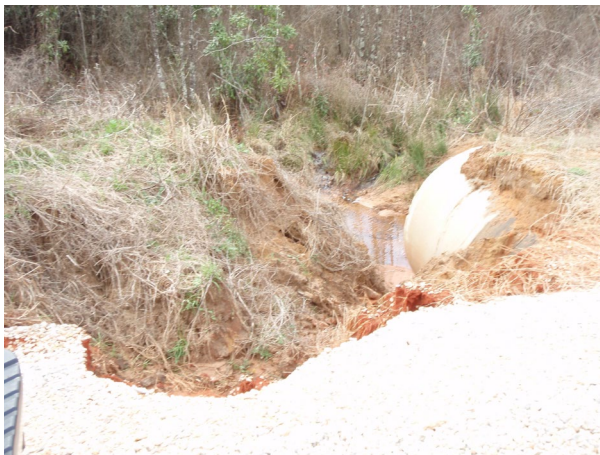
Photo 5: Lack of adequate outlet protection.

Many culverts lacked adequate outlet protection on the down flow side to prevent scour and have contributed to the formation of gullies. Although there were few locations where elevated turbidity

- The County should avoid the use of “staining” fill material in proximity to wetlands and waterways.
- Outlet (and in some cases inlet) protection should be provided at stream crossings to provide roadway and culvert protection and energy dissipation to reduce erosion downstream.

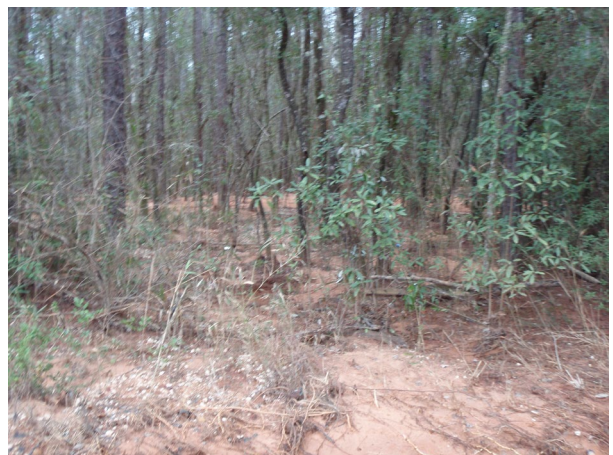
Photo 6: Wetland impacts due to sediment discharge.

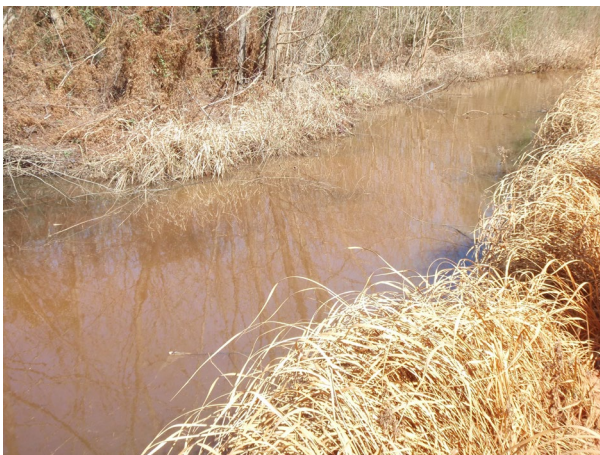
Photo 7: Turbidity impacts.

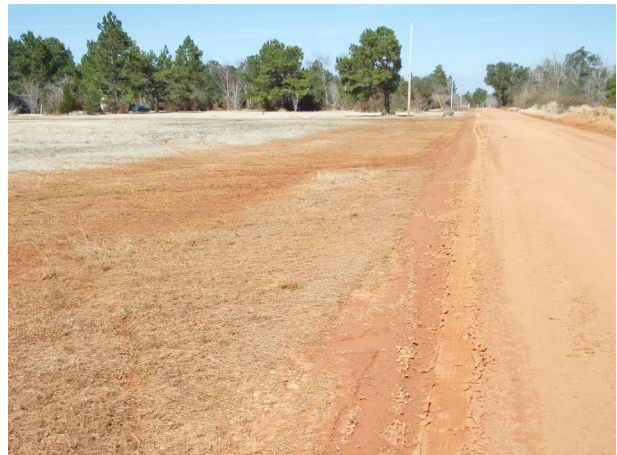
Photo 8: Typical staining associated with turbid runoff.

was actually observed in adjacent waterways, in a number of locations there was a distinct discoloration or “staining” of vegetation in areas receiving runoff from the roadway. This is due to the nature (color) of the material used for road construction or repair and a typical indication that the stormwater runoff is excessively turbid during periods of discharge. The authors also noted a prevalence of non-native invasive species, particularly cogon grass and privet. Where significant growth of cogon grass occurred along the shoulder, sediment delivery was notably retarded, however this should not be considered a preferred erosion and sediment control management practice.

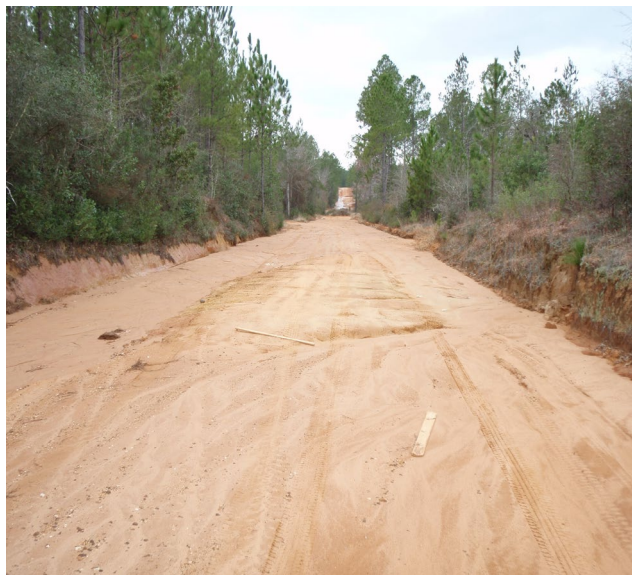
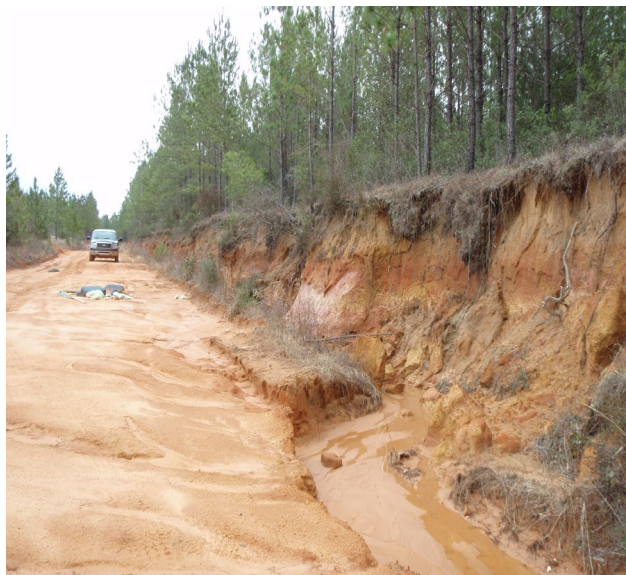
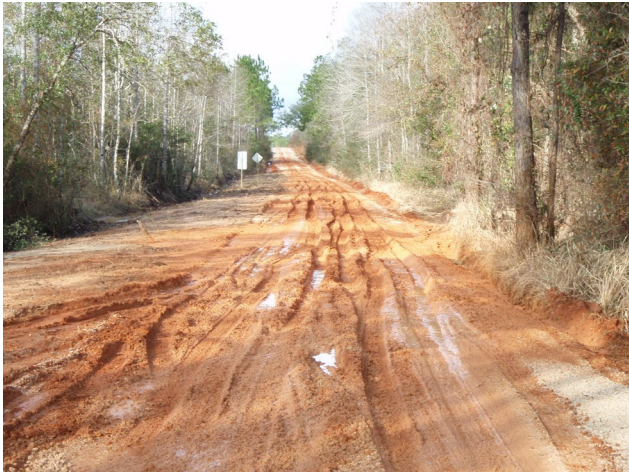
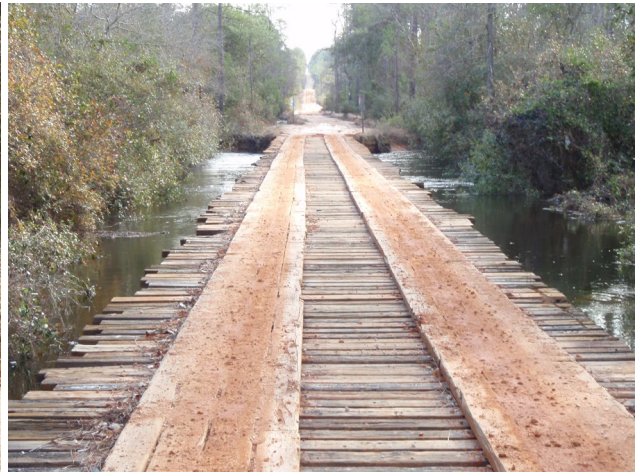
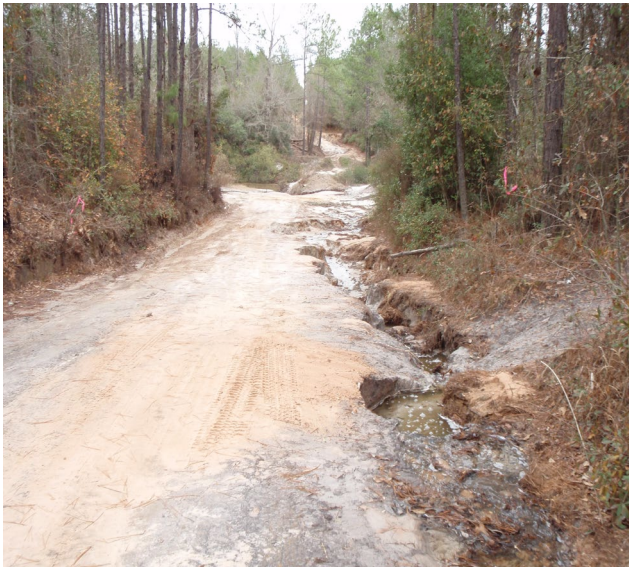
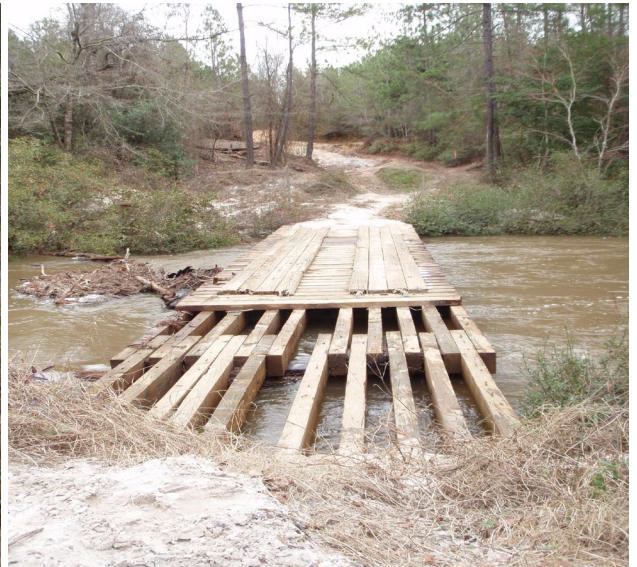
- MP 4.7 and 5.4 - Wetland crossing with sediment plume in wetlands
- MP 5.5 – Hollinger Creek crossing; BRIDGE OUT; severe erosion at approaches
- MP 5.5 to 7.2 – ROAD NOT EVALUATED DUE TO IMPASSIBLE CONDITIONS

- MP 7.4 – Road surface eroded and deeply incised with ditch banks 4 to 6 foot high
- MP 7.7 – Wetland crossing with sediment impacts

Truck Trail 17 near MP 3.2 (06 February 2010).

Truck Trail 17 near MP 5.5 (06 February 2010).

Truck Trail 17 near MP 1.0 (06 February 2010).

Truck Trail 17 Styx River bridge MP 1.4 (06 February 2010).

Truck Trail 17 was the #1 environmentally damaging road in the earlier report, and conditions do not appear to have improved. The impacts from this one road are likely greater than the cumulative impacts from half the list of 25 road segments. Approximately 2 miles essentially appear to have been abandoned, significant gully erosion is occurring both in the roadway ditch lines at several locations. The inaccessible portion is probably as bad or worse. Suggestions would include closure to traffic, installation of long-term stormwater treatment, and restoration/vegetation from the end of pavement at Steelewood to Brady Road and from Brady Road east to approximately MP 7.6. Areas of significant sedimentation should be removed from streams and wetlands to prevent further migration downstream. Culverts need stabilization and energy dissipation at both ends to minimize road erosion and in downstream scour. The remnants of bridges are a potential safety hazard and are acting as a dam for debris within the streams. Slope approaches to the bridges are eroding considerably. Suggestions are abandonment of the roadway from the top of each slope. These areas would benefit from stabilization measures such as seeding and erosion control matting. On the eastern end of the roadway the agricultural areas have kept the road in fairly good condition. Regularly traveled areas that cross wetlands and streams would benefit from a surface treatment.

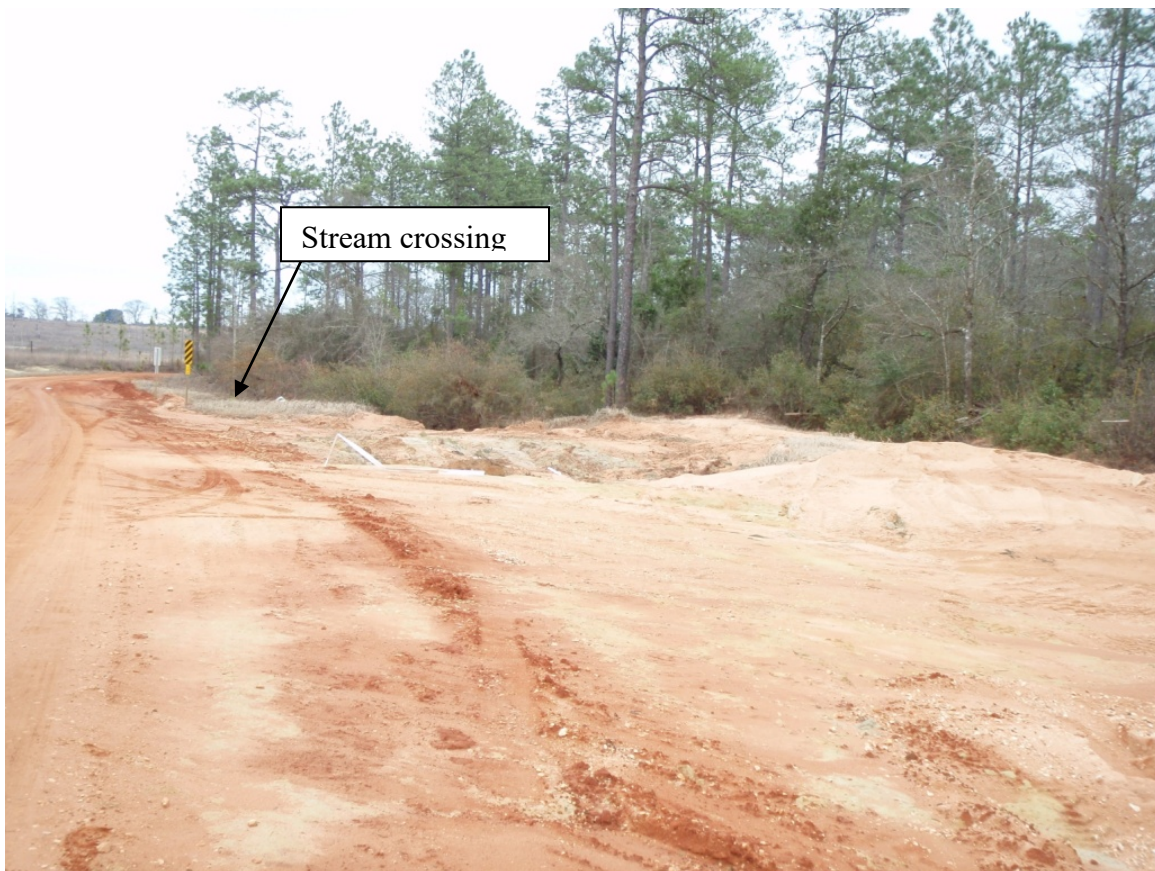
- Mile Post 0.2: The road crosses a stream (convergence of Flat and Reedy Creeks) where stormwater runoff discharges and significant sediment deposits were observed
- Mile Post 0.3: A large sediment pile, believed to be the result of grading activity, is located adjacent to the stream and the river with evidence of severe erosion

River Road facing east near MP 0.3 (6 February 2010).

The road essentially serves as a channel for stormwater runoff from the area, delivering sediment to the stream and river. Water diversions discharge (terminate) directly to, or in close proximity to, the stream or river. This segment was ranked #2 in the earlier survey and conditions have not improved. Either relocation of the road to higher ground or significant engineering (fill, drainage, stabilization) will be required to eliminate the environmental concerns. Temporary measures to reduce impacts could include removal of accumulated sediment, vegetative stabilization of area surrounding the stream crossing and surface treatment of the road surface with rock.

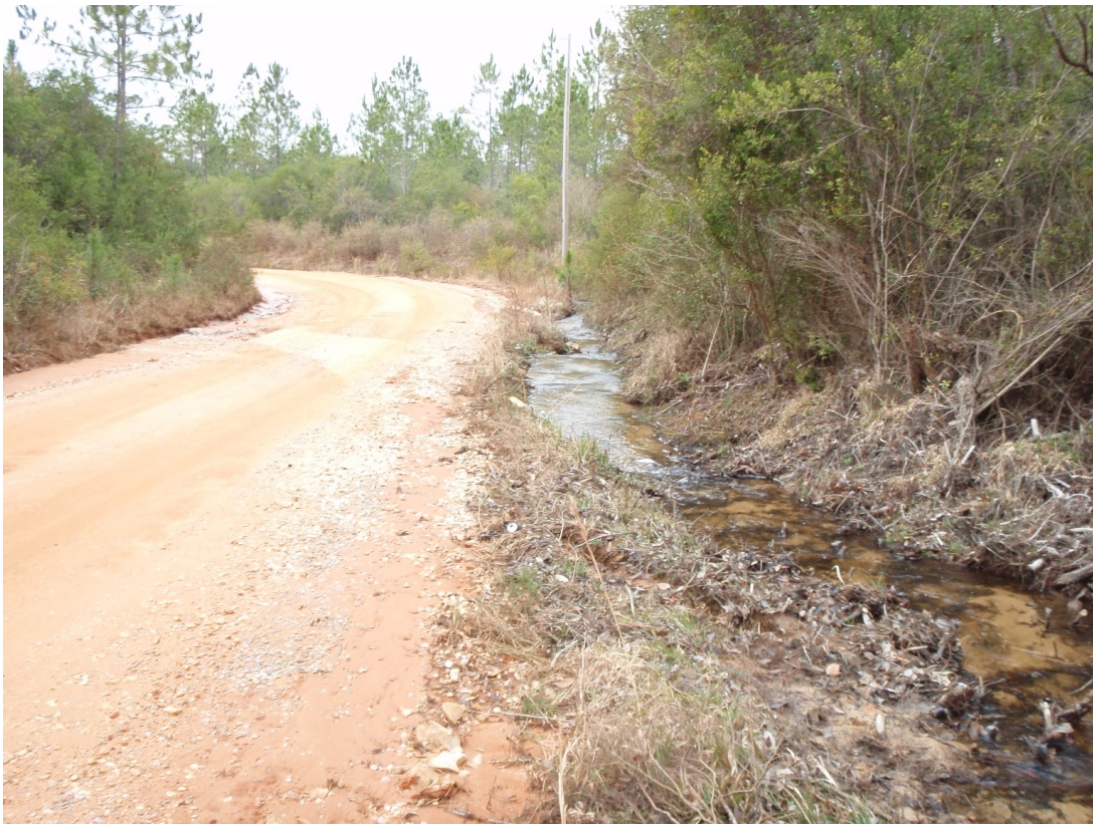
- MP 0.8 – Eight Mile Creek crossing with gravel – Sediment & turbid water in wetlands
- MP 1.2 – Dry Branch crossing with gravel – Minor erosion at culvert
- MP 2.7 – Elam Creek crossing – Sediment in stream from turnouts
- MP 2.9 – Elam Creek crossing – stream flows in north side of ditch for 0.2 miles, submerged cross drain with fish observed in ditch, turnouts have blown out from sediment overload

Linholm Road MP 2.9 (6 February 2010).

Linholm Road was ranked #10 in the earlier survey and the road has received a surface gravel/rock treatment in several areas and at least one ditch line was found lined with rip-rap. Turn-outs generally discharge to upland areas for much of the road; however several were noted as failing (filled with sediment with runoff directed back to roadway. Near MP 2.9 Dry Branch now flows within the ditch line apparently due to an inadequate cross drain and ditch construction. Surface treatment appears to have been effective in areas where it was applied but was in need of “freshening”.

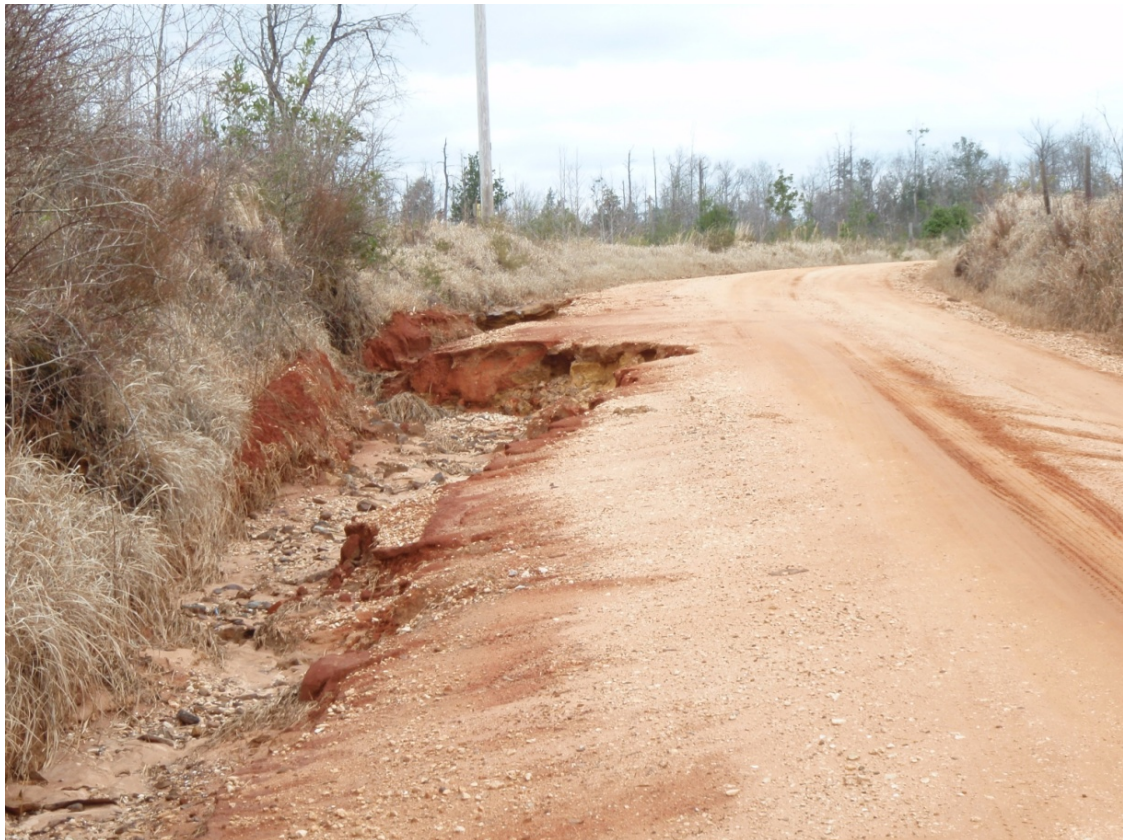
- MP 1.3 to MP 1.7 – gravel treatment
- MP 1.8 – Gully erosion in road draining sediment to wetland bottom
- MP 1.9 – Eight Mile Creek crossing – Wetland filled with large plume of sediment

Griggers Road near MP 1.8 (6 February 2010).

Griggers Road appears in the earlier survey with a ranking of #21. The primary area of concern is the portion just past MP 1.7 (portion that has been treated). Although there is some evidence of previous surface treatment, heavy ditch line erosion near MP 1.8 is delivering significant quantities of sediment downgrade to a wetland bottom and stream crossing at MP 1.9. Diversion of surface runoff and ditch stabilization should be performed, followed by surface treatment.

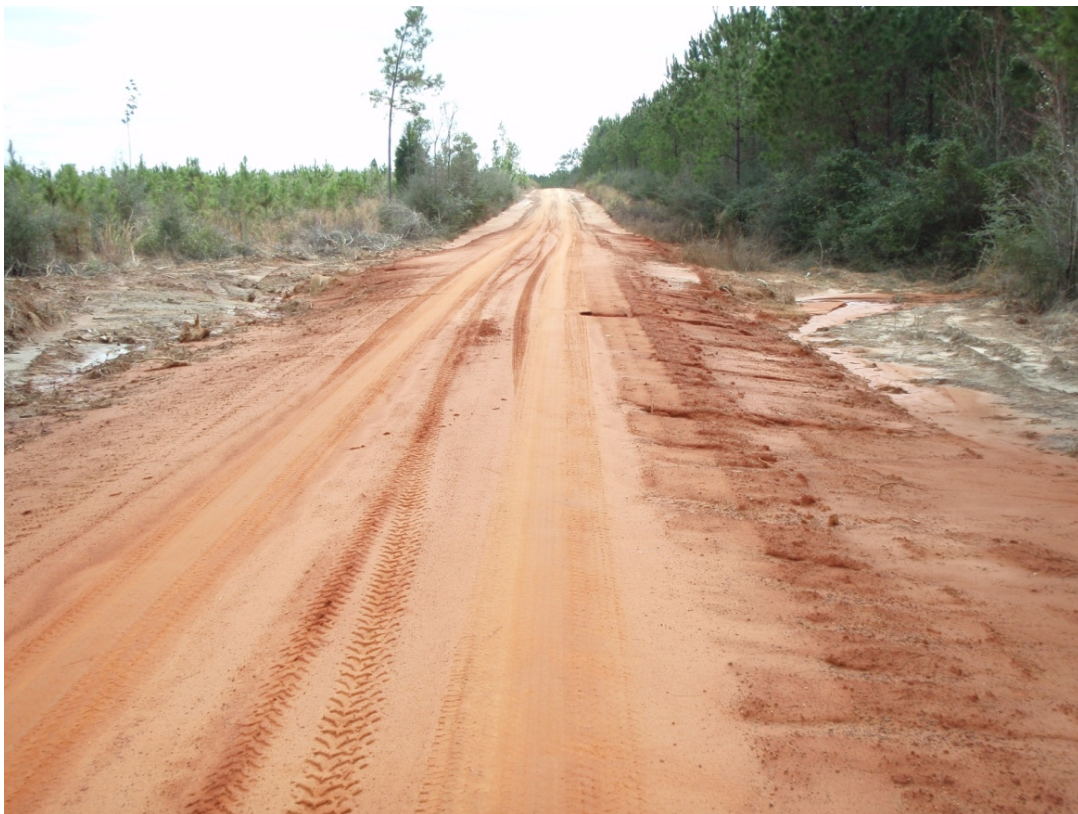
- MP 0.9 – Wetland crossing with sediment and turbid water in wetlands
- MP 1.5 – Wetland crossing with sediment in wetlands
- MP 1.7 – Wetland crossing with sediment in wetlands
- MP 2.0 – Turnouts to wetlands with sediment in wetlands
- MP 3.1 – Wetland crossing with sediment in wetlands and fresh clay covering

Peter Morris Road near MP 1.5 (6 February 2010).

As usual, the primary concerns are where the roadway crosses wetland areas. In several of these areas, repair and maintenance activities have included clearing a portion of the right-of-way and placement of fill without the benefit of best management practices (BMPs) to control erosion and sedimentation. Temporary BMPs should be employed in these critical areas until disturbed right-of-way is restabilized. Surface treatment should be considered to prevent the erosion of imported fill material. Peter Morris Road was not included in the earlier survey.

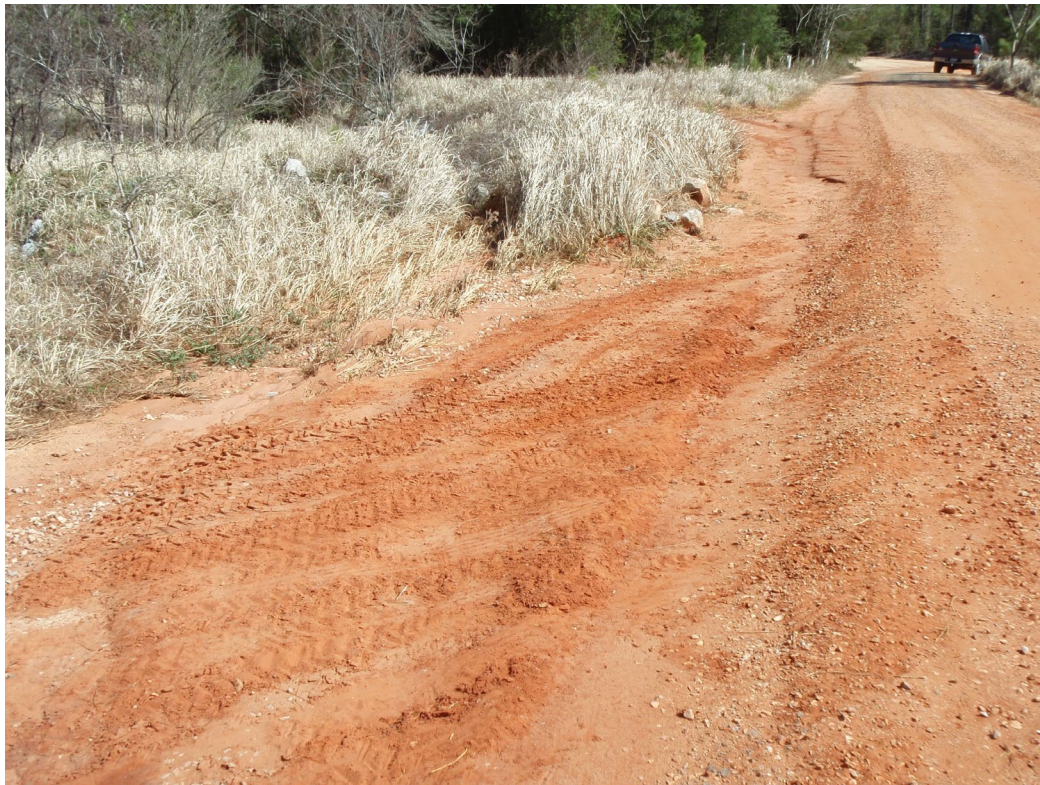
- MP 0.1 on east section – Dry Branch crossing with severe channel erosion and turnouts of sediment into stream

Goat Cooper Road near MP 0.1 (east) (15 March 2010).

The only portion of Goat Cooper Road that is of significant environmental concern is the discharge from the first 0.1 miles to Dry Branch. Historical discharges apparently enlarged the “turnout” into a gully which has been treated with rip-rap and is vegetated with cogon grass. A new turnout is now located just past the gully. The imported red fill material has caused vegetative staining, an indication that stormwater discharges are highly turbid. This discharge location also receives stormwater runoff from the last 0.1 miles of Goat Cooper Road North (where residences begin). Runoff from the north should be diverted into the wooded area along its western ROW. Alternative fill materials or treatments should be considered to reduce turbid discharges.

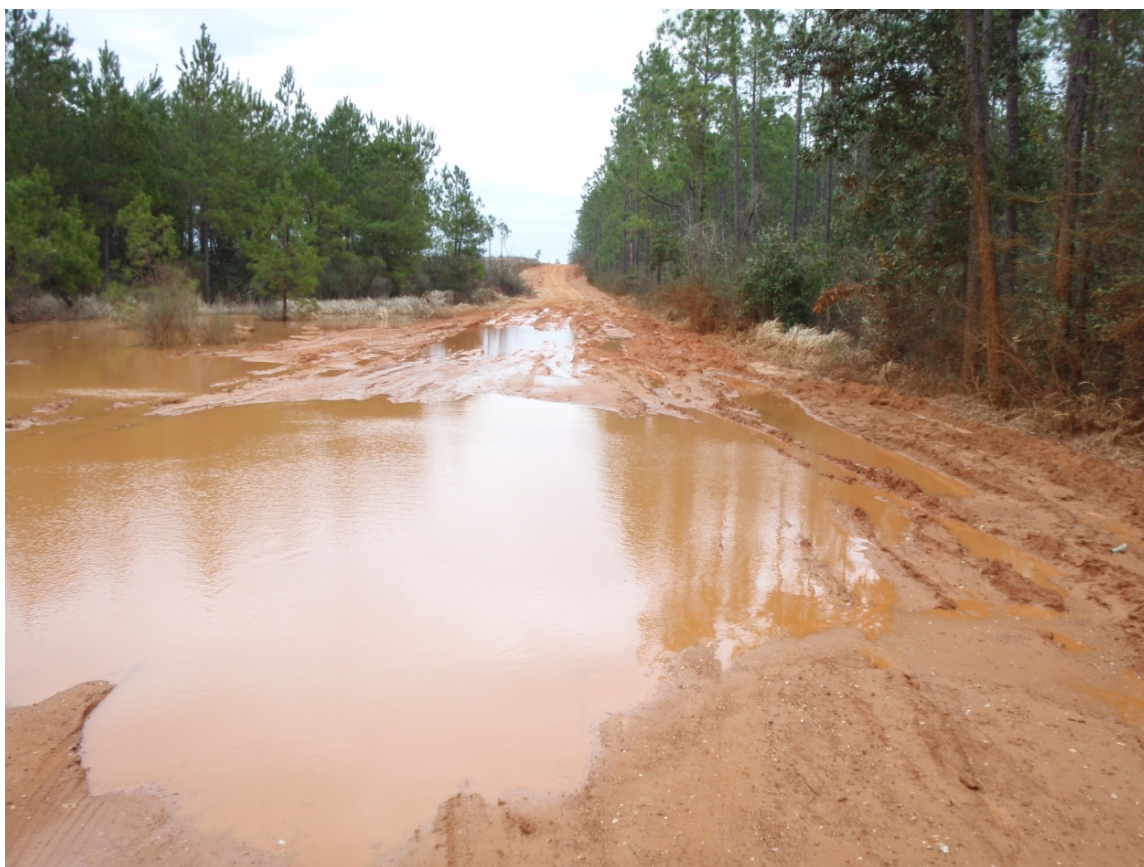
- MP 0.3 – Wetland crossing with sediment and turbid water in the wetland area
- MP 2.0 – Wetland crossing with sediment and turbid water in the wetland area
- MP 2.2 – Springs in road bed to wetland area
- MP 2.3-2.8 – gully erosion in ditches discharging to Perdido River

Barrineau Park Road wetland crossing MP 2.2 (6 February 2010).

Barrineau Park Road was included on the earlier survey (as Duck Road) with a ranking of 17, the primary concern being the direct discharge from the ditches to Perdido River at the bridge. During the field inspection of 6 February 2010 the road was impassable at the wetland crossing located near MP 2.2. Where possible water diversions (turn-outs) should be located such that they discharge away from wetlands and into upland areas. The portion of the road that crosses wetlands (MP 0.3 and 2.0-2.2) should be repaired and stabilized and the wetlands restored. The eastern ~0.5 miles drain directly to the Perdido River and significant gully erosion is occurring along both ditch lines. Routine maintenance past MP 2.2 was not evident. Repair and treatment for ditches leading to Perdido River (MP 2.3-2.8) is necessary to reduce sediment discharges.

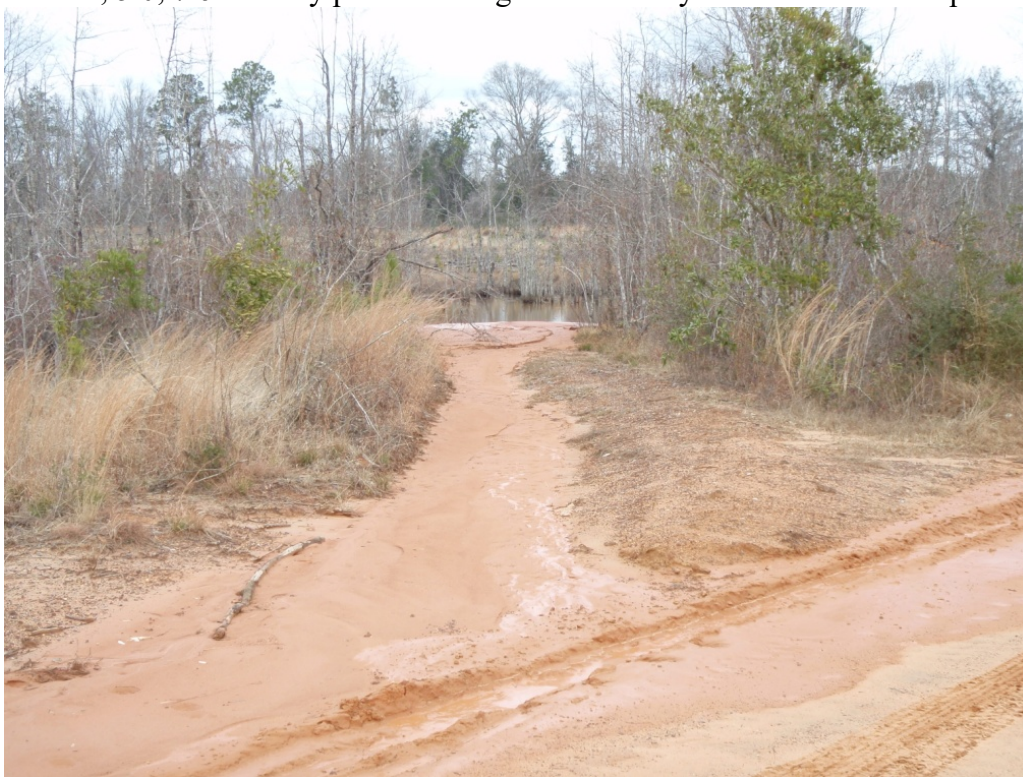
- MP 0; MP 0.2; MP 0.7; MP 1.0; MP 1.7; MP 1.9; MP 2.4; MP 3.5; MP 4.7; MP 5.6; MP 6.0; MP 6.6; MP 7.1; MP 7.3; MP 7.8; MP 8.1; MP 8.5; MP 8.8; MP 9.2; MP 9.4; MP 10.3; MP 10.6; MP 10.9 – Wetland cross drains with sediment impacts
- MP 4.1; 5.0; 7.6 – Grady pond crossing with turbidity and/or sediment impacts

Brady Road near MP 5.0, sediment from turnout impacting Grady pond (6 February 2010).

Although Brady Road follows the ridge top along much of its route, there are 23 cross drains at wetland areas within the first 11 miles of the second segment, each with sediment impacts noted. Significant impacts to Grady ponds, associated with sediment discharges from turnouts, were noted at three locations. Sediment should be removed from turnouts located close to wetlands; turnouts relocated such that they discharge to upland areas (where possible), and impacted wetlands restored. If the I-10 – I-65 connector follows this route, most of the problems can be eliminated or addressed.

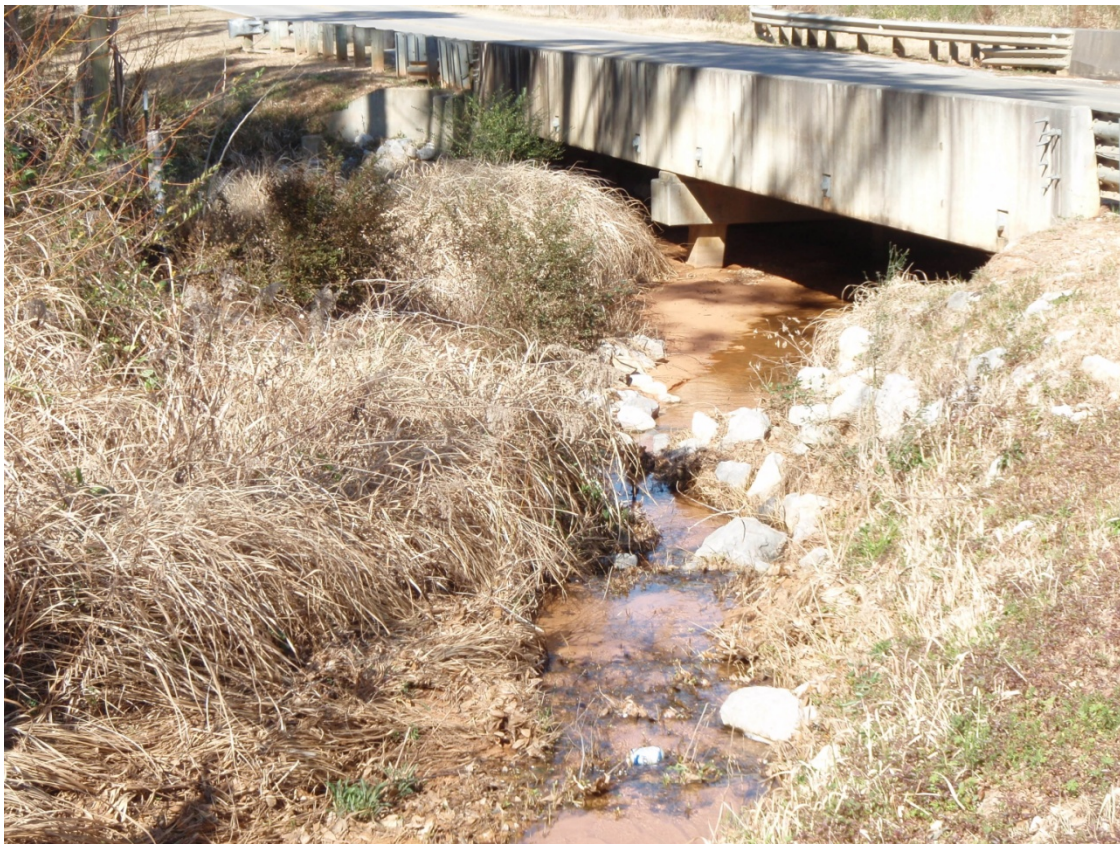
- Intersection of County Road 83 & Bretz Lane – Sediment plumes located in Miflin Creek from turnouts funneling sediment into creek
- MP 0.1 – Large ditches with slope funneling sediment to creek; Unnamed tributary flows within road side ditch to cross drain (~ 100 feet west of CR 83) into Miflin Creek
- MP 0.3 – Downhill approach to Miflin Creek

Bretz Lane discharge to Miflin Creek MP 0.0 (20 February 2010)

The ditches along this road channel stormwater runoff and sediment directly into Miflin Creek. There is evidence of sedimentation in Miflin Creek and adjacent wetlands. The incised ditches continue to erode sediment. There are rip rap lined ditches along the steepest slope and gravel treatment on portions of the road surface; however these BMPs are not adequate for the conditions of the road. Recommendations include filling the ditches, crowning the road and paving the length.

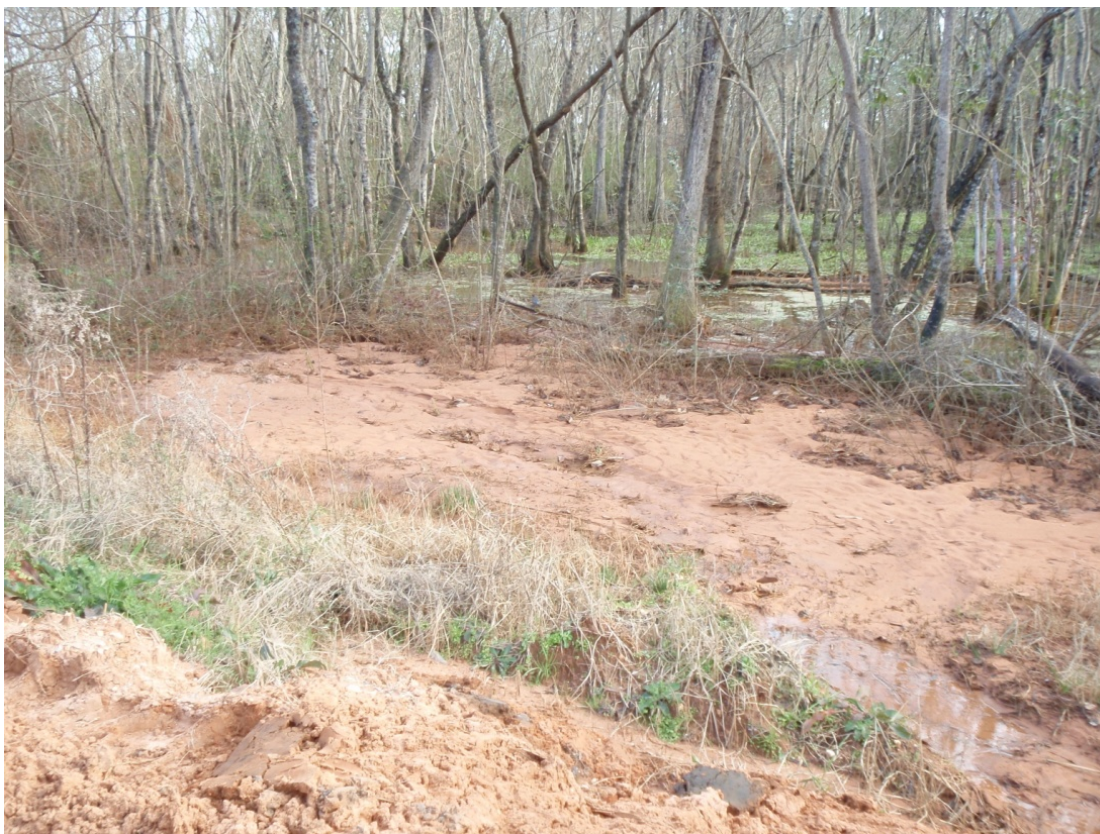
- MP 0.3 – UT Threemile Creek crossing with minor erosion and sediment in the stream
- MP 0.6 – UT Threemile Creek & wetland crossing with sediment impacts & turbid water; turnouts funneling sediment into wetland (aquatic vegetation noted in stream)
- MP 1.2 – Wetland crossing with extremely turbid water; Sediment deposited at cross drain and cross drain completely filled with sediment
- MP 1.4 – Wetland crossing with sediment plume and deep road side ditches
- MP 1.9 – UT Narrow Gap Creek crossing with sediment plumes and clay staining in wetlands

Malkoskie Road near MP 0.6 (20 February 2010)

Portions of the road are within Grady ponds and headwater wetlands. Each crossing has evidence of sedimentation and turbidity impacts. Cross drains are clogged with sediment and water flow has been impeded. Recommendations would include maintenance of cross drains and sediment removal from wetlands and streams. Wetland and stream crossings would benefit from gravel treatment.

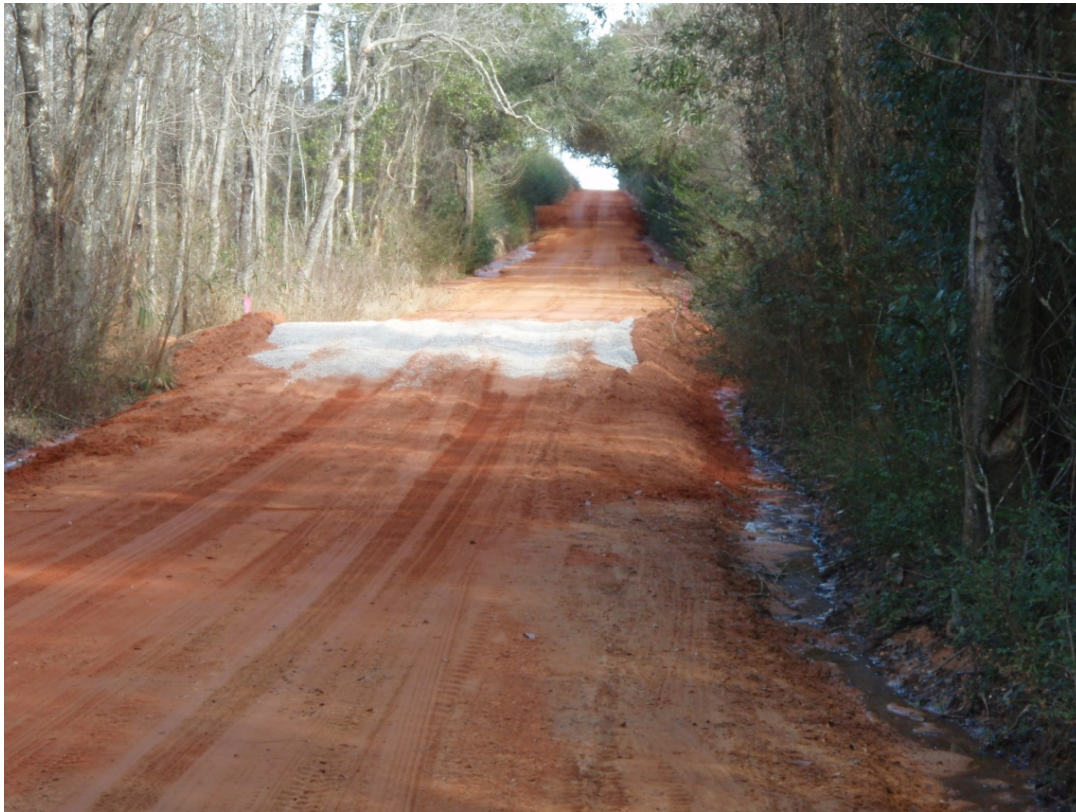
- MP 0.1 – UT Soldier Creek crossing with recently placed red clay and small area of gravel treatment of crossing; heavy sedimentation observed in stream; wetlands and stream have sedimentation and turbidity impacts

Hagendorfer Road near MP 0.1 (20 February 2010)

The western  $\frac{3}{4}$  mile of the road is the most environmentally damaging due to its drainage point at the stream and wetlands. The gravel treatment at the crossing may lessen the sediment loss; however the additional red clay application will likely erode into the stream. Recommendations for improvements would include paving the western  $\frac{3}{4}$  mile of the road and removing the sedimentation from the stream and wetlands. The ditches should be treated and the road crowned and treated.

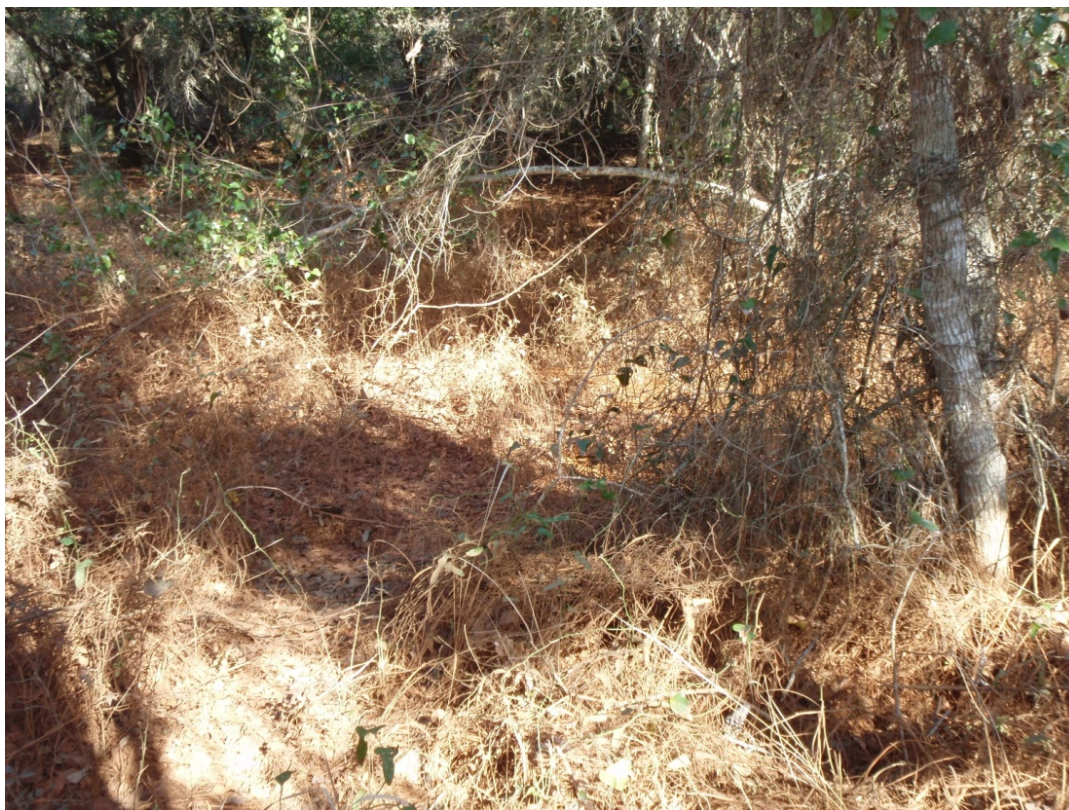
- MP 0 – Erosion evident at end of road with sediment in UT of Roberts Bayou
- MP 0.25 – Lack of cross drain for wetland area; Major sediment loss into wetland area; Red staining on vegetation up to 4 feet in height
- MP 0.5 – Lack of cross drain for UT Roberts Bayou with erosion of road and major sedimentation in UT Roberts Bayou and adjacent wetlands

Wolf Field Road near MP 0.25 (20 February 2010)

The lack of drainage from the wetland areas to the streams is causing considerable erosion. The sedimentation and turbid water impacts are evident on both sides of the road at the ½ mile mark. The south end of the road routinely erodes into Roberts Bayou and has recently eroded a channel from Josephine Road northern right-of-way to the stream. Recommendations include installation of cross drains at wetland and stream crossings as well as paving, or otherwise treating with non-staining materials, the length of the road.

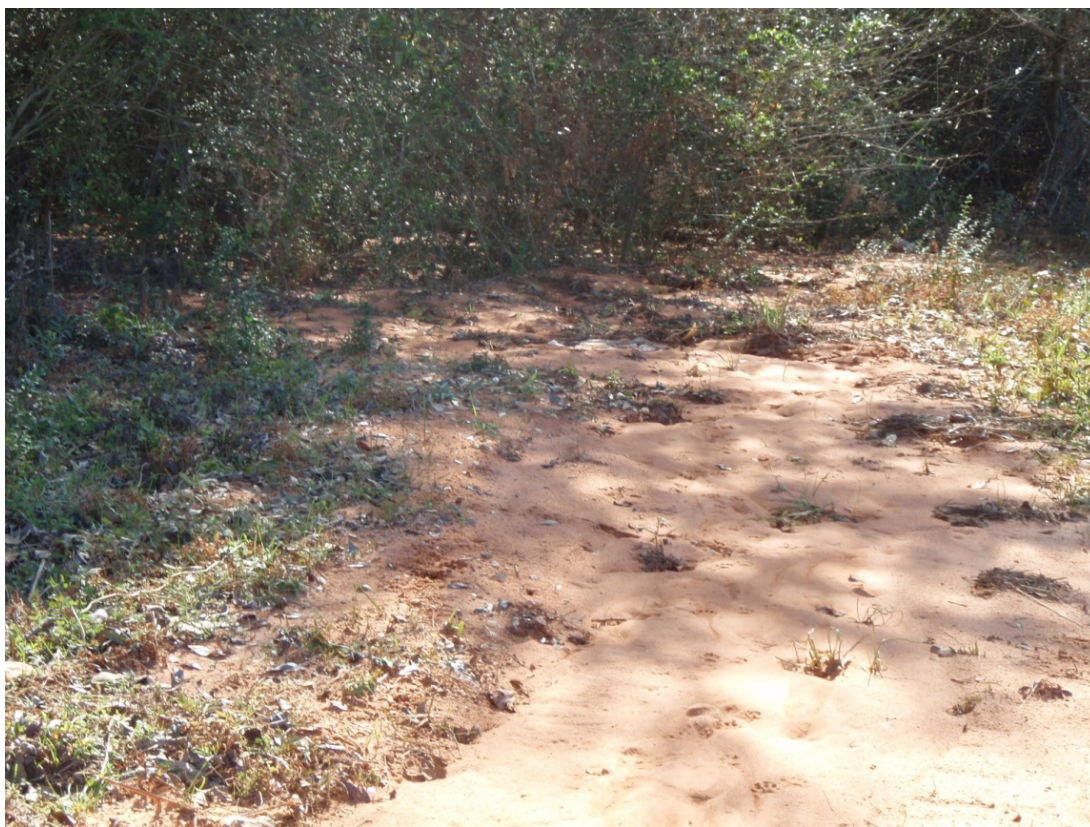
- MP 0 – Wetland cross drain at intersection with Breman Rd is submerged
- MP 0.1 – Wetland crossing with sedimentation impacts from turnouts
- MP 0.2 – Gravel surface treatment for ~0.3 miles
- MP 0.3 – Wetland crossing with minor sedimentation in wetland ; head cut at outlet
- MP 0.5 – Hammock Creek crossing with sediment in stream and wetlands
- MP 0.7 – Turnouts funneling sediment into wetlands

County Road 26 near MP 0.7 (20 February 2010)

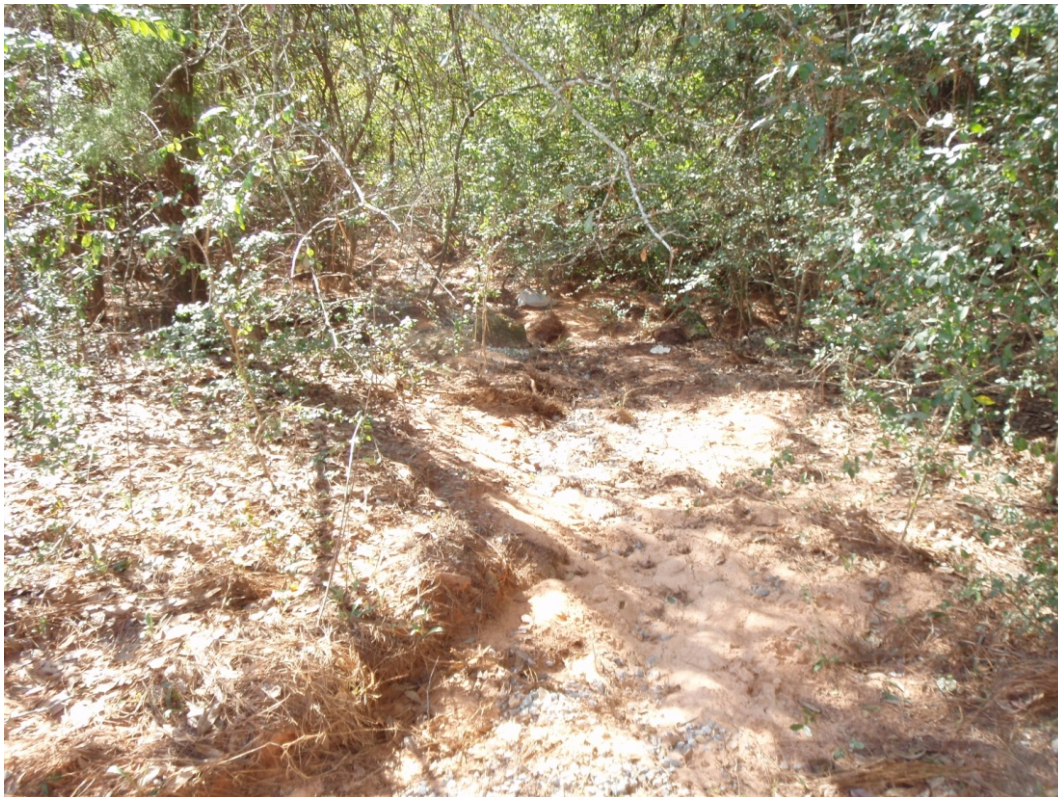
- MP 0.3 – erosion at culvert crossing discharging sediment
- MP 0.6 – erosion of road and ditches discharging from terminus

Spring Creek Drive near terminus (20 February 2010).

The terminus of the road is substantially scoured with gullies forming in the ditches and red clay staining and sediment is present off the ROW. Sediment accumulation was present in uplands and encroaching on the floodplain and wetlands adjacent to Baker Branch. Surface treatment and creative water diversions are suggested.

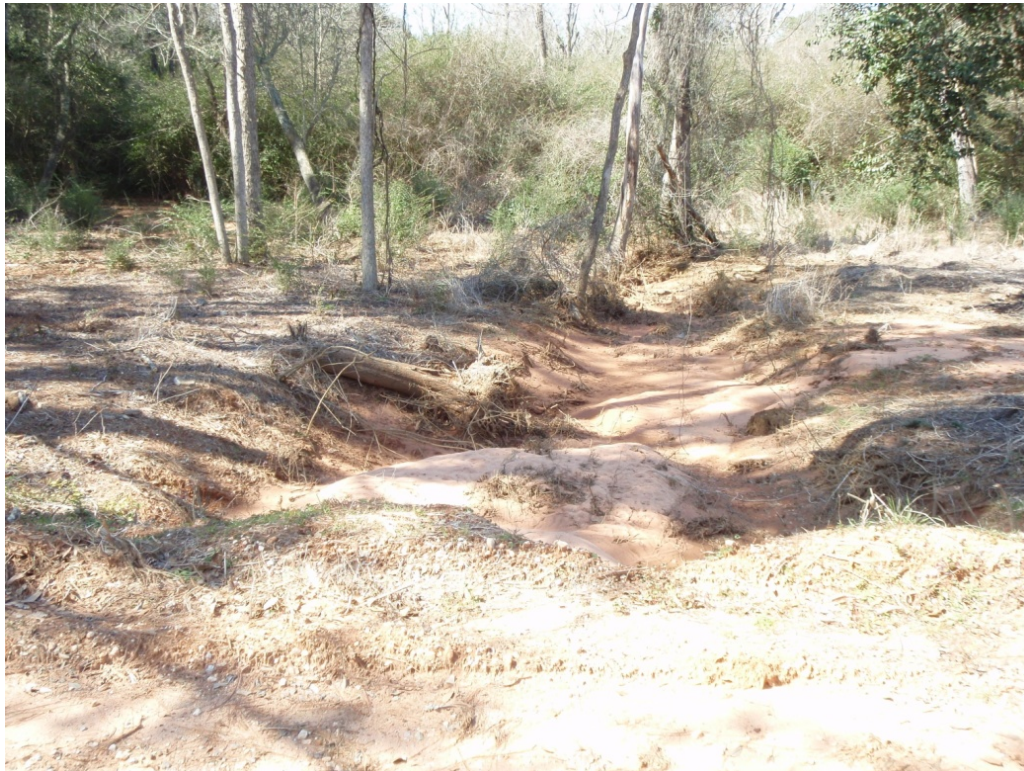
- MP 0.2 – wetland crossing with evidence of sediment impacts, turnouts directing sediment to wetlands

Lipscomb Road near MP 0.2 (20 February 2010).

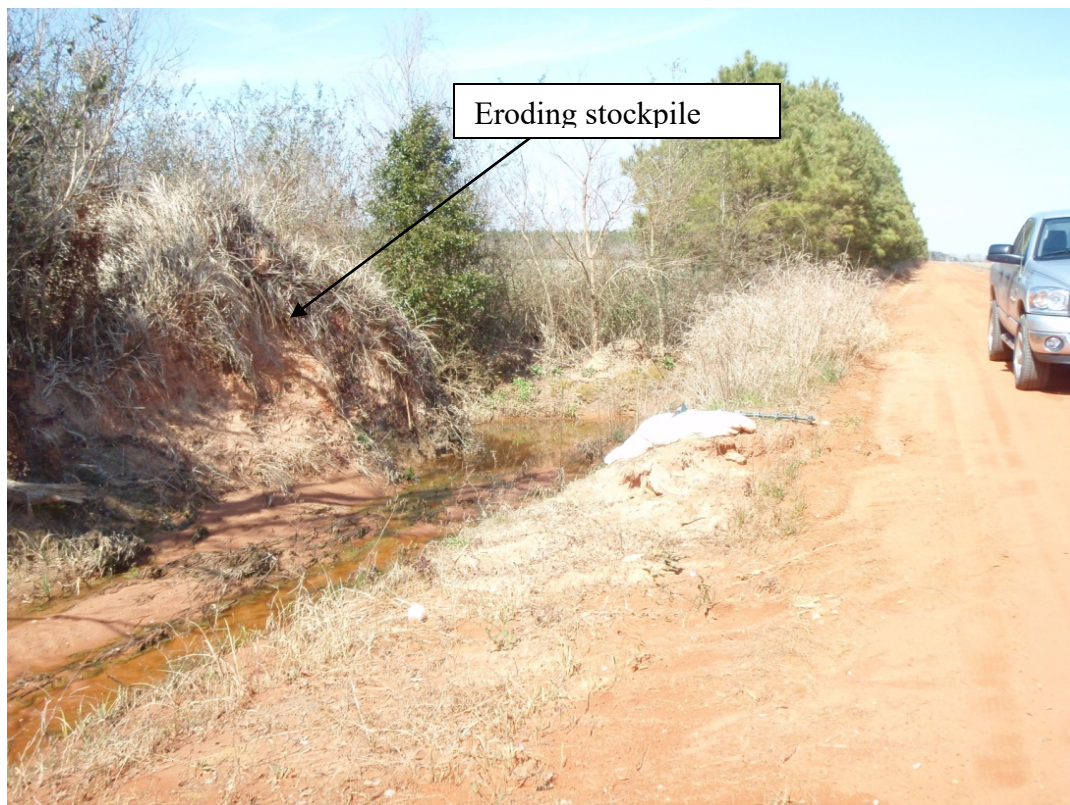
- MP 0.4 – stream crossing with sediment impacts evident
- MP 0.8 – stream crossing with sediment impacts and erosion of side-cast stockpile
- MP 0.9 – watercourse crossing at power line sediment impacts and staining evident
- MP 1.0 – stream crossing with sediment impacts and inadequate culvert protection

Side-cast stockpile at stream crossing on Norris Lane near MP 0.8 (20 February 2010).

New red clay fill was evident in some areas where culverts had previously blown out. Significant amounts of sediment were present in all three stream crossings and impacts were observed in Weeks Creek as far downstream as Sherman Road. Some effort to protect the culvert outlet were evident at MP 1.0, however scour erosion was still evident. Staining of vegetation along stream banks and ditch lines, due to the red color of the fill material, was evident. A large pile of reddish sandy-clay, apparently from side-casting during ditch maintenance, was noted along the ditch line near MP 0.8. This road segment appears to require constant maintenance to the roadway and ditches resulting in continued impacts to the streams.
