# ***The 25 Most Environmentally Damaging Dirt Roads of Baldwin County, Alabama***

A Report by the Baldwin County  
Environmental Advisory Board

**March 2010**

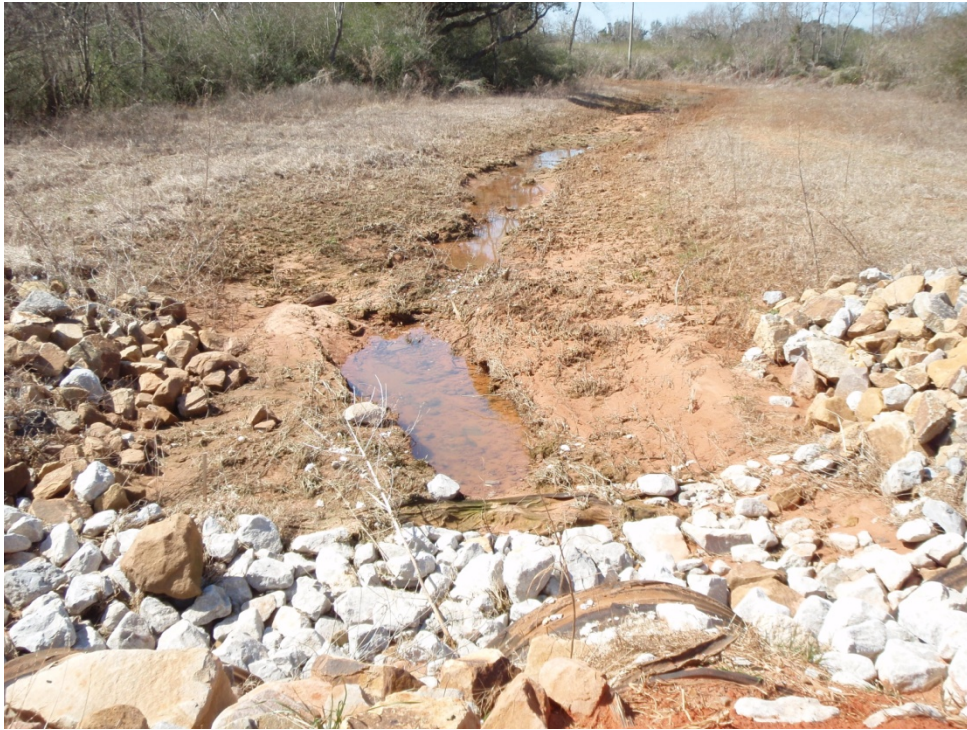
Culvert outlet scour Norris Lane near MP 0.9 (20 February 2010).

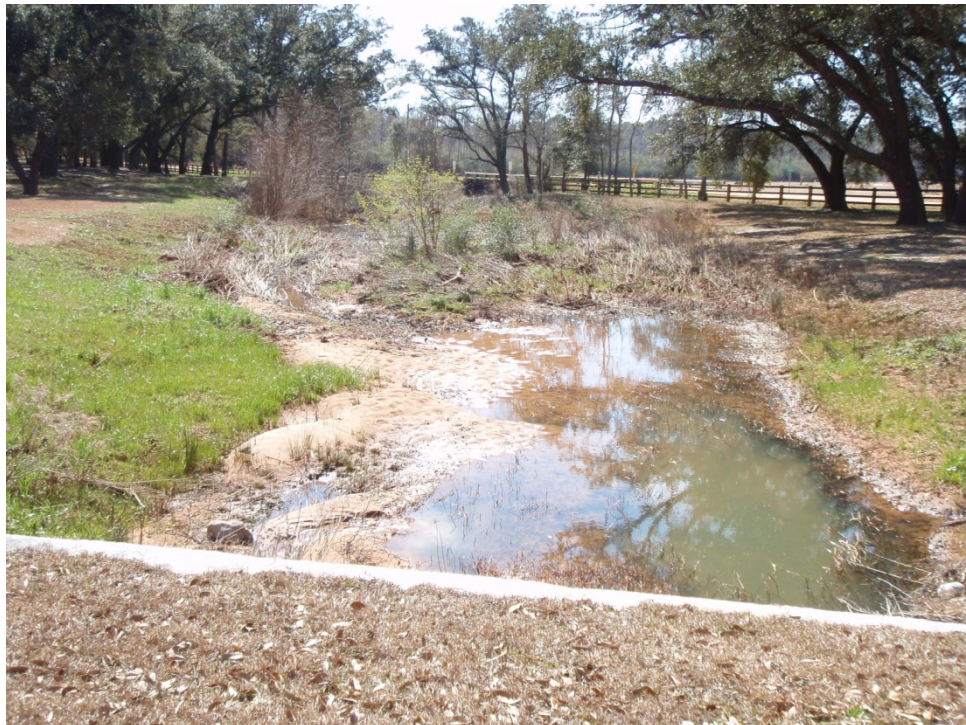
Sediment impacts to Weeks Creek downstream of Norris Lane  
(photo taken upstream of Sherman Rd) (20 February 2010).

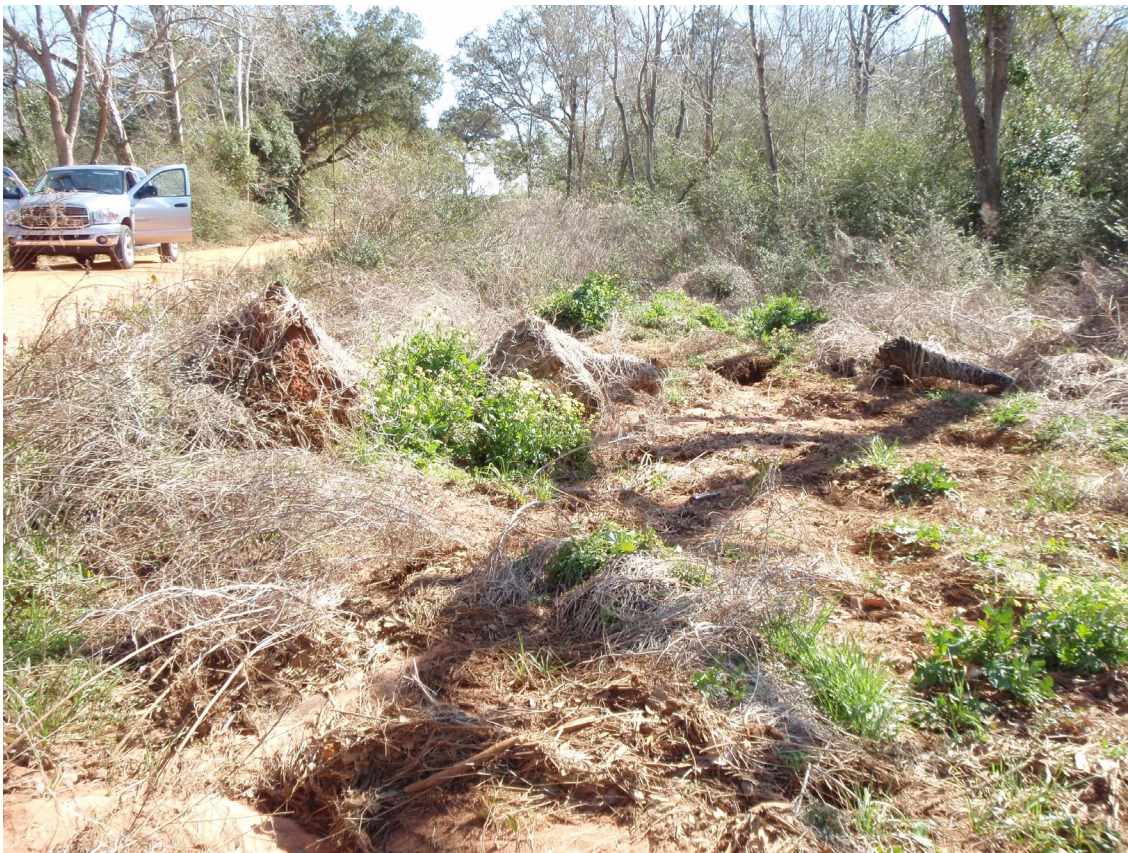
- MP 0.3 – Spring Branch Crossing, sediment in wetlands and channel

Mannich Lane (S2) near MP 0.3 (20 February 2010).

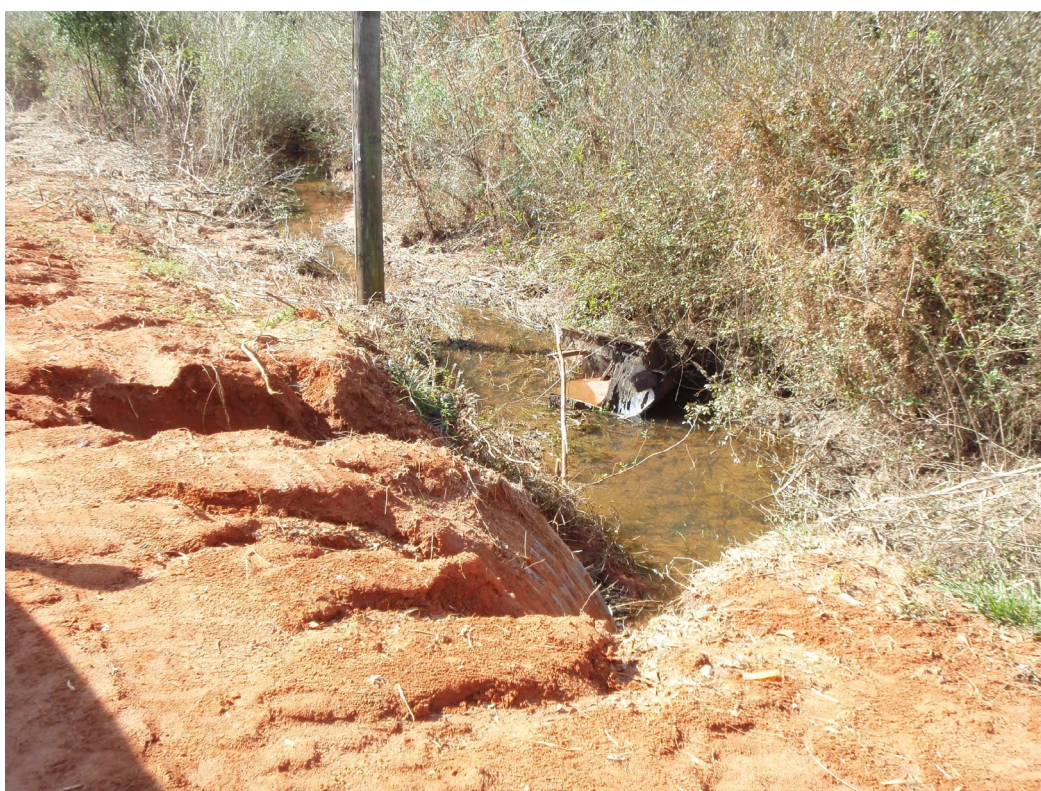
- MP 0.1 – stream crossing with erosion around culvert and sediment in stream
- MP 0.3 – stream crossing with minor amount of sediment noted in stream

Paul Cleverdon Road sediment impacts at stream crossing (20 February 2010).

The first stream crossing occurs at MP 0.1 where major erosion was present at the culvert crossing and sediment plumes were observed downstream. At MP 0.3 the second stream crossing occurs with minor traces of sediment present. No significant impacts to wetlands were identified. Protection around stream culverts and surface treatment near stream crossings would reduce erosion and sediment delivery to the streams.

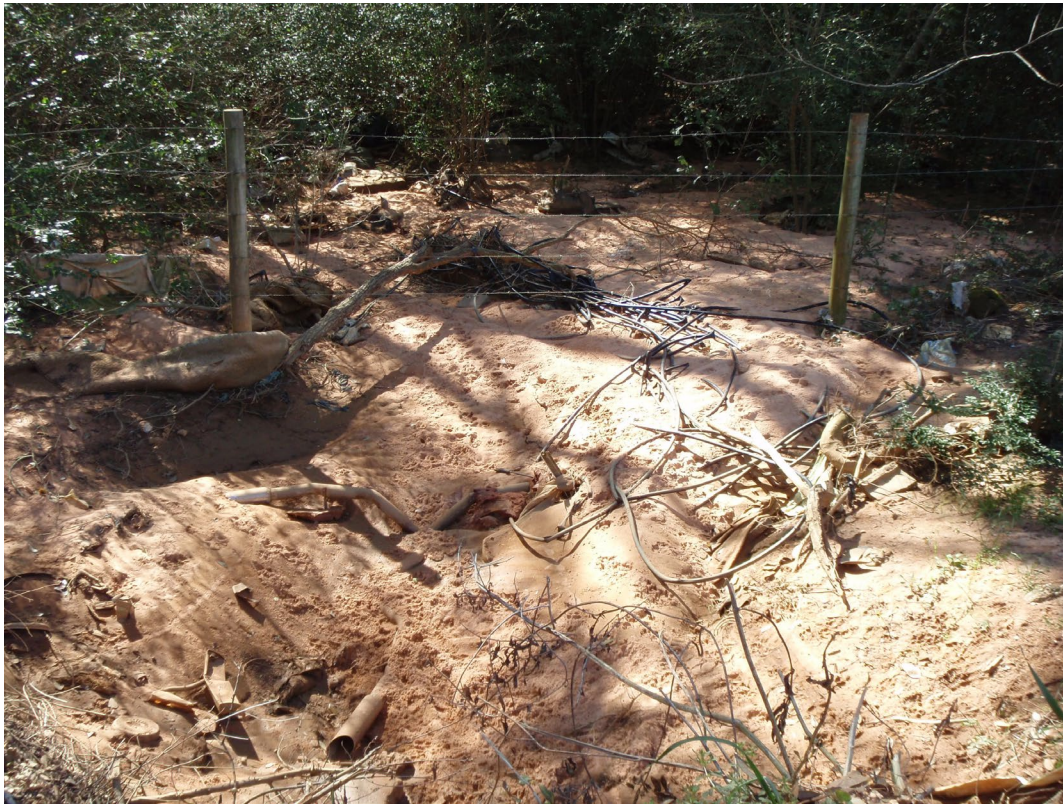
- MP 0.5 – culvert crossing with sediment plume
- MP 0.9 – culvert crossing with sediment plume

Mannich Lane (S4) near MP 0.9 (20 February 2010)

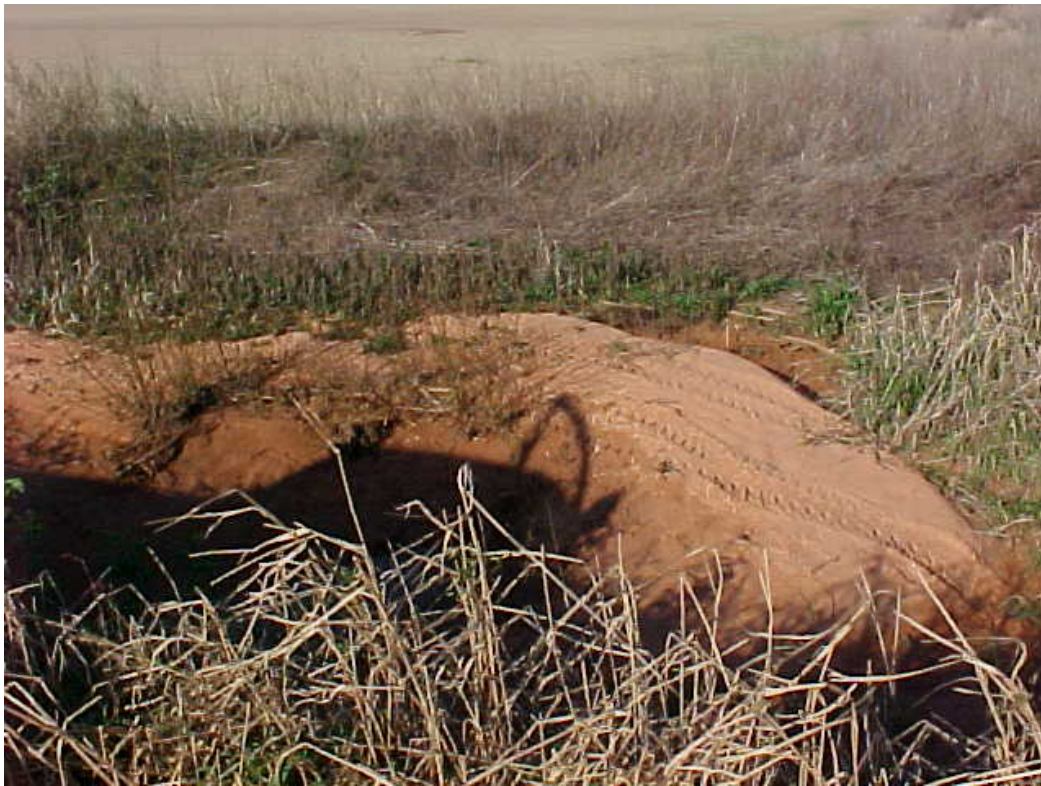
- MP 0.4 – cross drain with significant sediment discharging off ROW

Sherman Road near MP 0.4 (16 March 2010).

Red staining is present on the vegetation in ditches and in adjacent sod fields where stormwater backs up from the road. The stormwater eventually drains to Weeks Creek. Sediment plumes were evident downstream of cross drains.

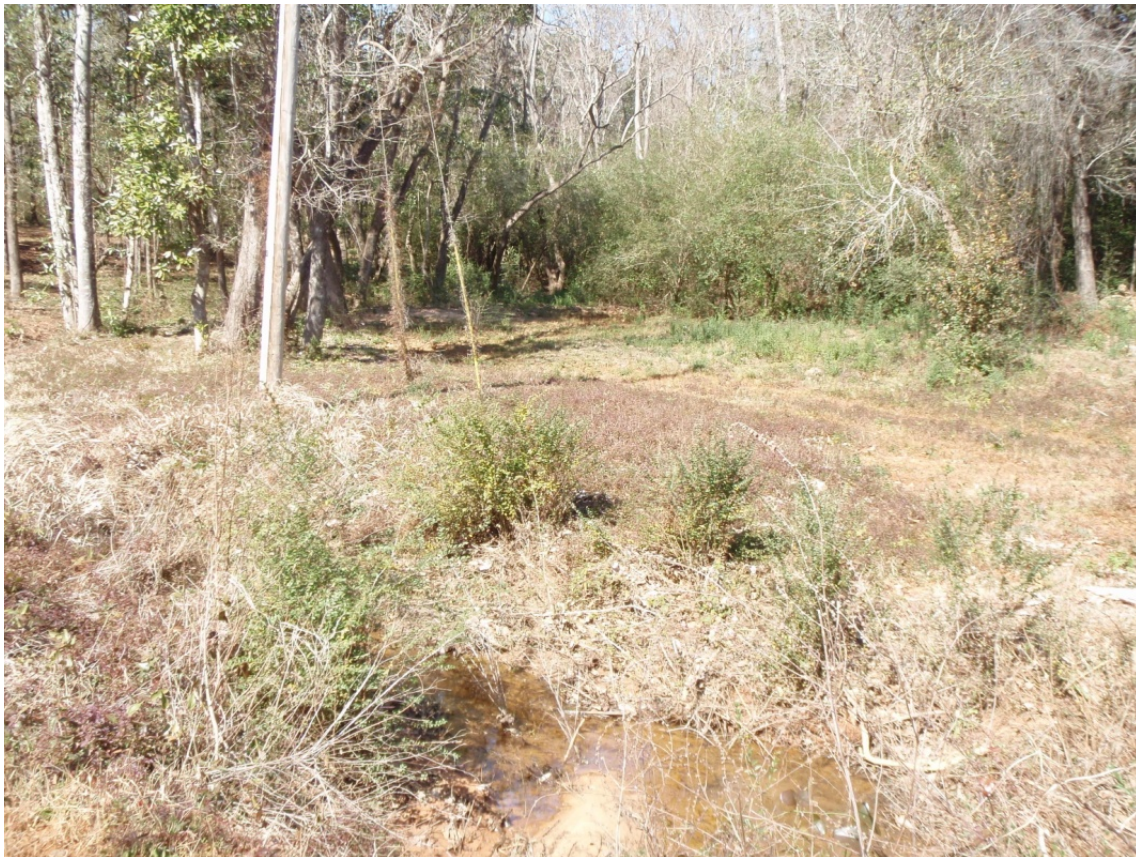
- MP 0.2 – stream crossing with sediment impacts evident
- MP 0.3 – erosion gullies perpendicular to road

Nolte Creek Drive near MP 0.2 (20 February 2010).

At the MP 0.2 stream crossing red staining of vegetation was observed and diversion swales are cut to direct sediment laden runoff to the flood plain and tributary. There was also strong evidence that this portion of the road is frequently inundated by stormwater and erosion gullies were observed perpendicular to the roadway near MP 0.3.

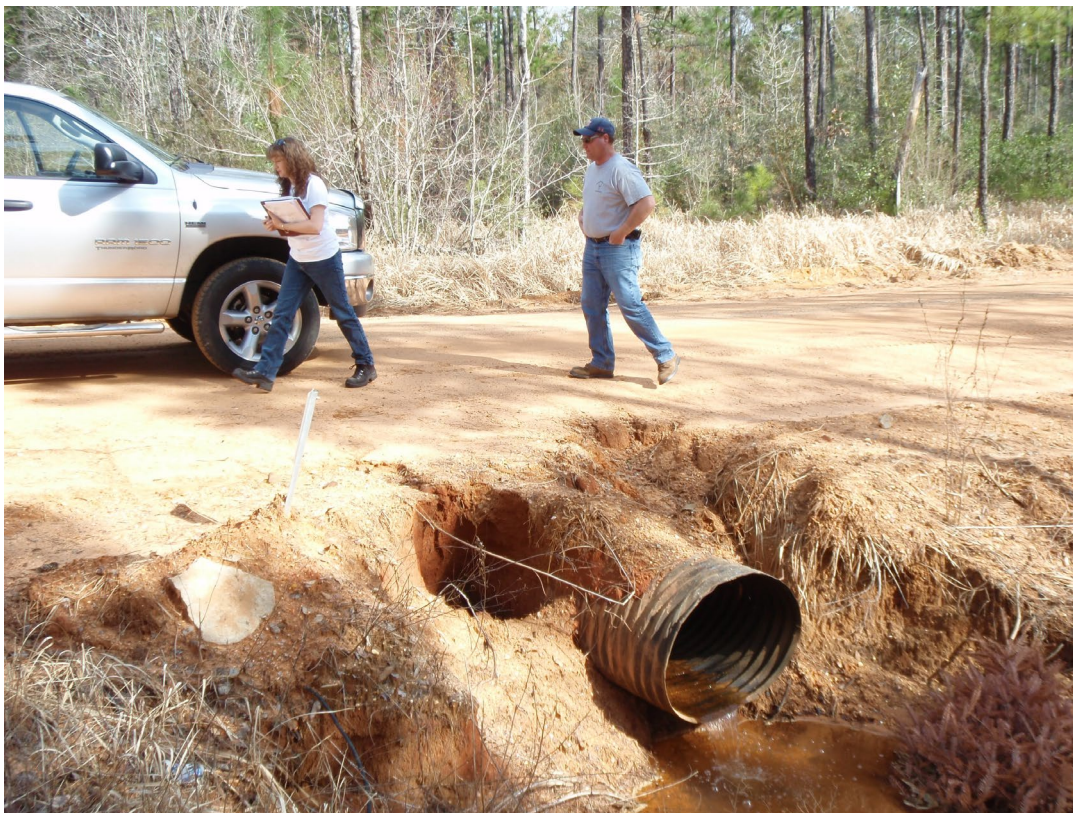
- MP 0 – Road discharges south at Hwy 225 to wetland area with turbidity impacts
- MP 1.1 – Red clay surface with high shoulders, steep slope and incised ditches
- MP 1.5 – Past gravel treatment observed
- MP 1.8 – UT Martin Branch crossing with sediment impacts; head cutting at culvert due to no outlet protection; turnouts funneling sediment into stream
- MP 2.0 – Past gravel treatment and old asphalt treatment
- MP 2.3 – UT Martin Branch crossing with sediment impacts; culvert  $\frac{3}{4}$  full of sediment; north side of road has beaver pond; sediment observed downstream causing channel to be braided
- MP 2.4 – Turnouts funneling sediment into wetlands

Kilcrease Road near MP 1.8 (12 March 2010).

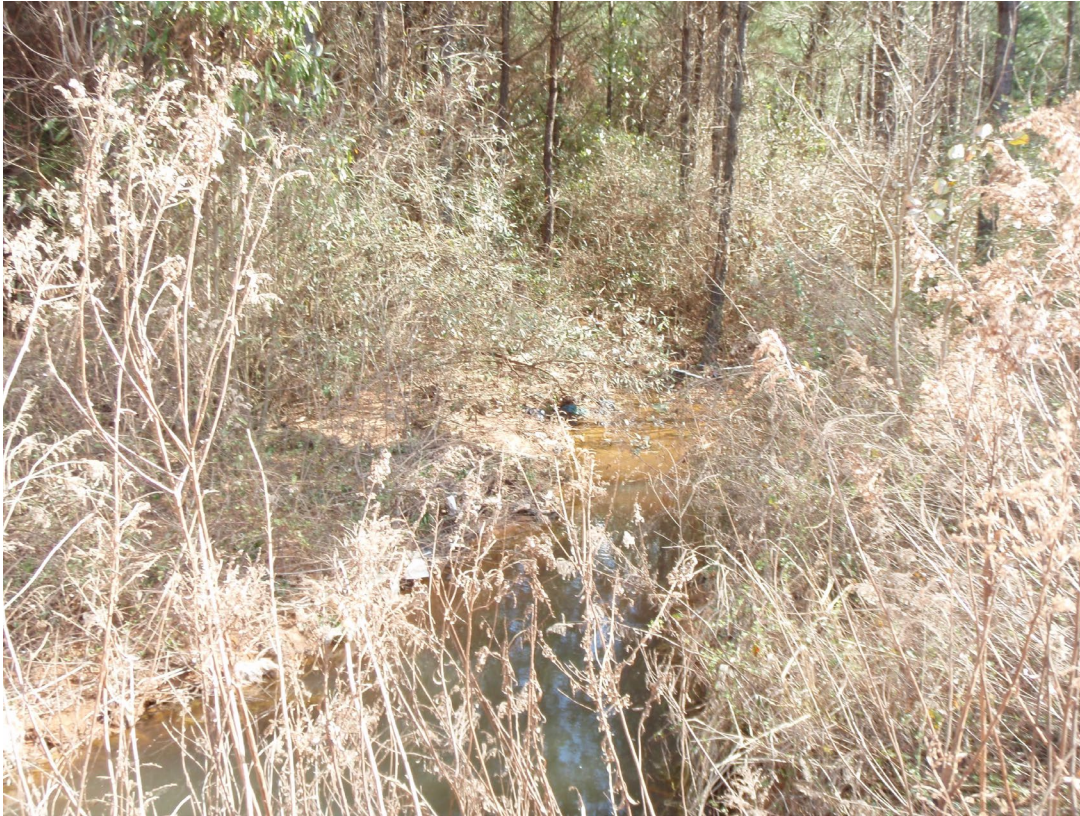
- MP 0.2 – Hurricane Creek crossing with sediment impacts; sediment impacts from road upstream at Grady pond; turnouts funneling sediment into stream and wetlands

Ewing Farm Road near MP 0.2 (12 March 2010).

Ewing Farm Road has the entire length draining into Hurricane Creek. The recommendation would be asphalt treatment. Sediment removal from Hurricane Creek and floodplain wetlands should be considered.

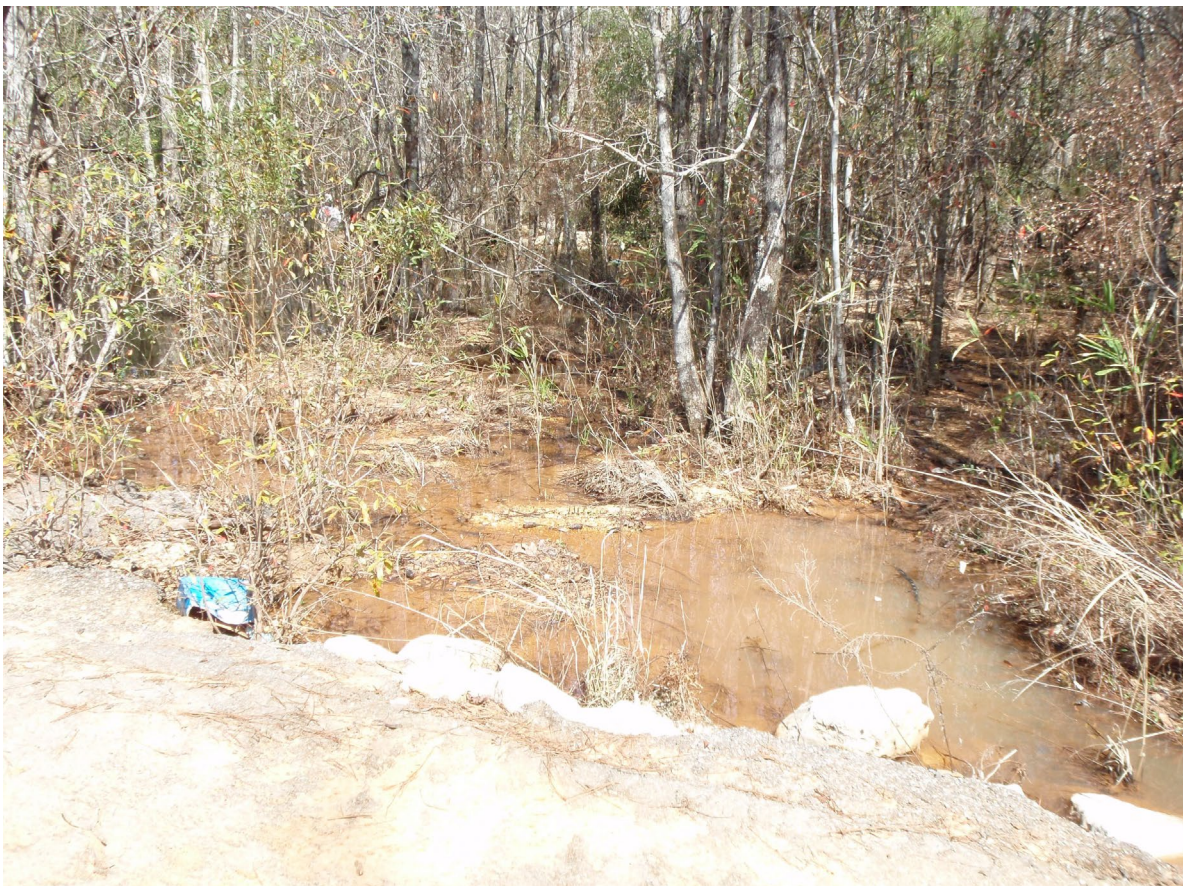
- MP 1.0 turnouts discharging sediment to stream
- MP 1.9 – Holly Creek crossing; rip rap headwall with asphalt overlay on road; turnouts funneling sediment and gravel into stream
- MP 2.0 – Holly Creek crossing – ditch erosion; garbage and sediment in stream
- MP 2.4 – Cross drain – no impacts
- MP 3.2 – UT Holly Creek crossing – scour on downstream side of culvert
- MP 3.4 and MP 3.7 – Wetland crossing – no impacts
- MP 4.7 – UT Holly Creek crossing – turnouts from slope to stream - minimal sediment

Holly Creek Road sediment impacts to stream and wetland (12 March 2010).

At the time of field investigation, there were minimal impacts noted at most of the stream crossings (i.e. MP 0.5, 1.3, 1.5, 2.9, 3.0, 3.9, 4.4). Holly Creek Road has great potential for environmental impacts due to the numerous stream crossings. The road has become a major dumping ground near MP 0.9. Turnouts require maintenance when filled with sediment and culverts in some areas need outlet protection to minimize erosion. It is recommended that a surface treatment be applied to the road surface particularly on sections at or near stream crossings and the BCHD work with the County Solid Waste Department to address illegal dumping.

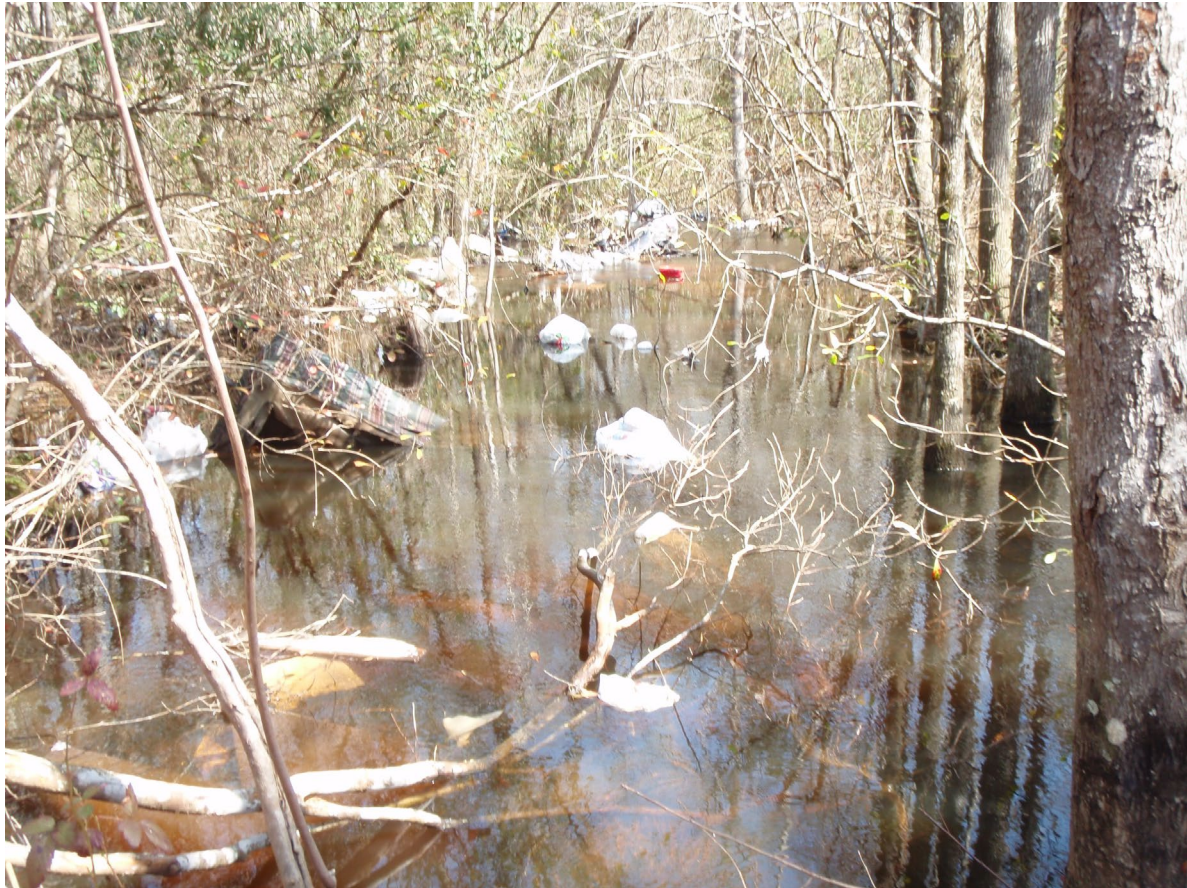
Holly Creek Road near MP 0.9 depicting garbage in stream (12 March 2010).
