Baldwin County Planning District 26 Wetlands Evaluation and Recommendations

February 2022

**PREPARED BY
GENA TODIA**

Baldwin County Meadows Property

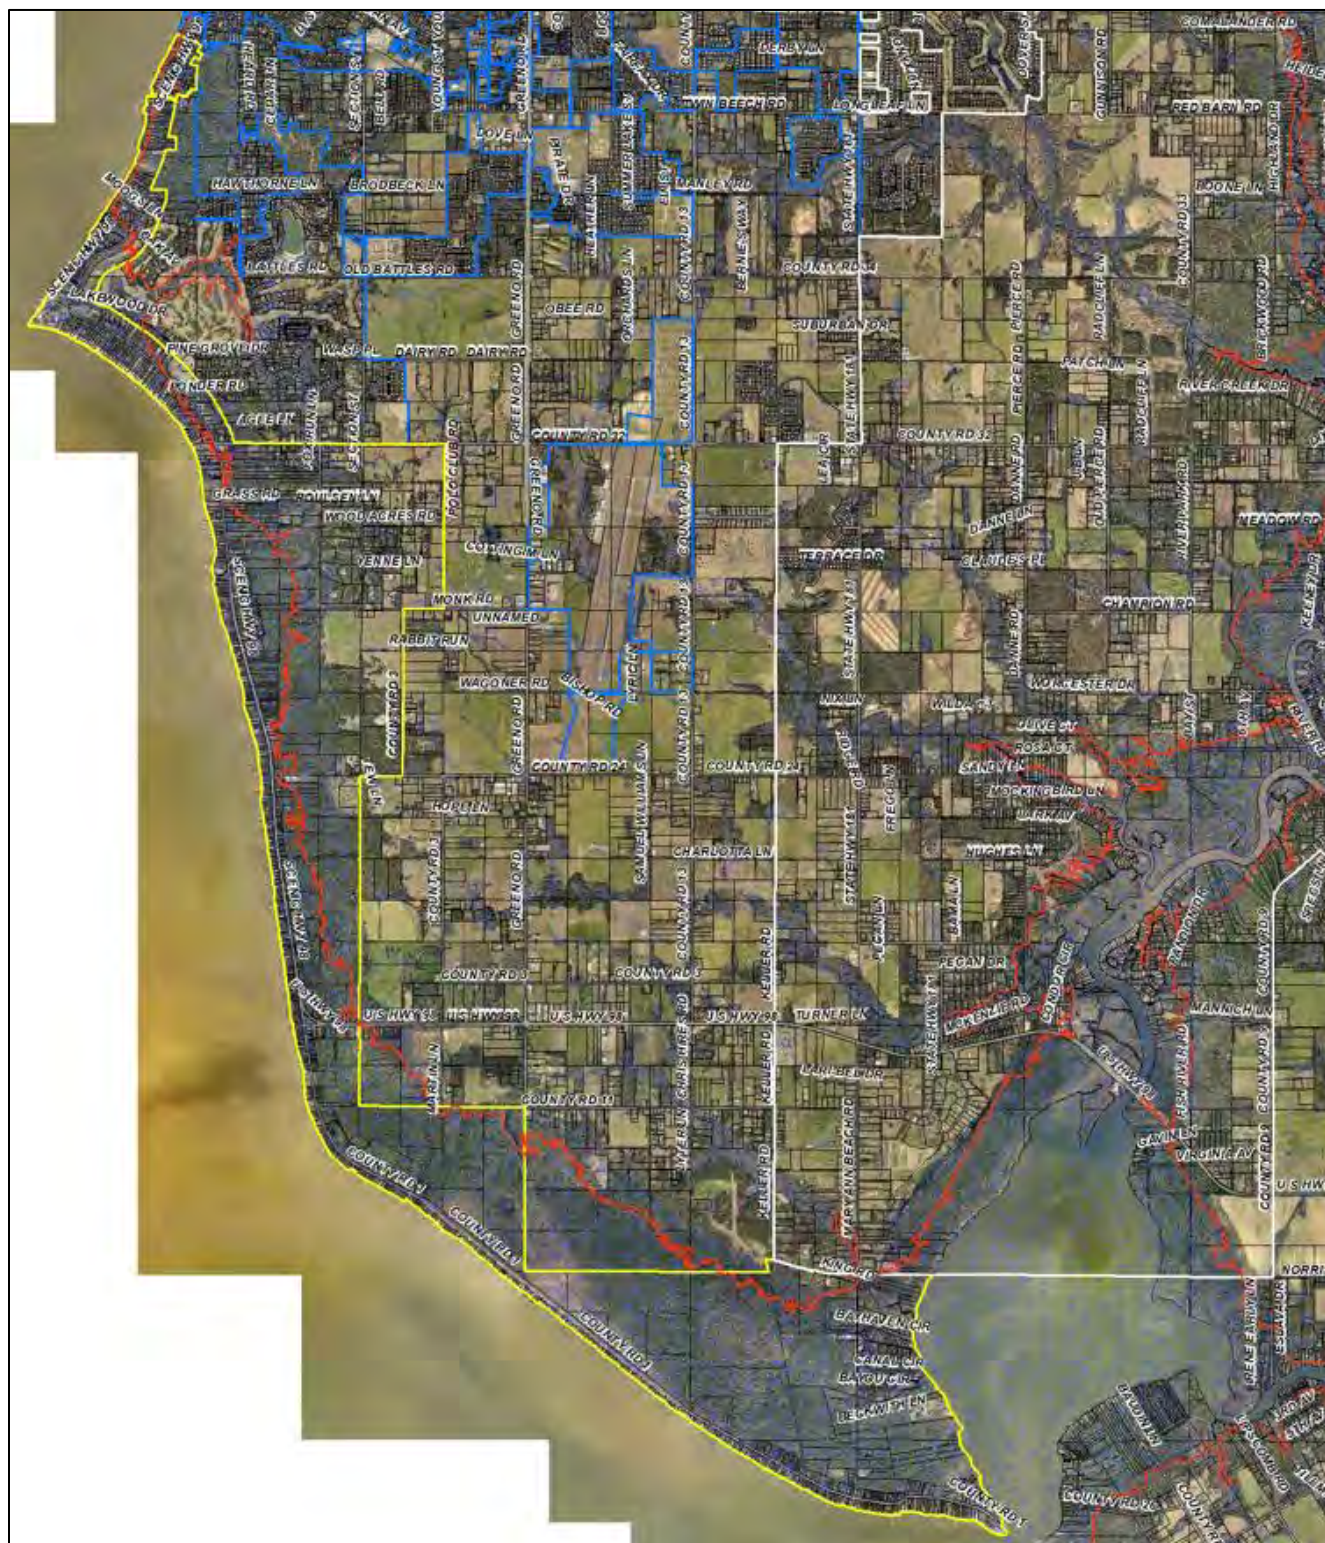
Figure 1. Planning District 26 (outlined in yellow)

Figure 1 depicts Planning District 26, outlined in yellow, which lies along the eastern shore of Mobile Bay south of downtown Fairhope. The red line on the map is the state-designated coastal zone, defined by ADEM as land lying waterward of the continuous 10-ft. contour line. A large percentage of Planning District 26 falls within the state's coastal zone.

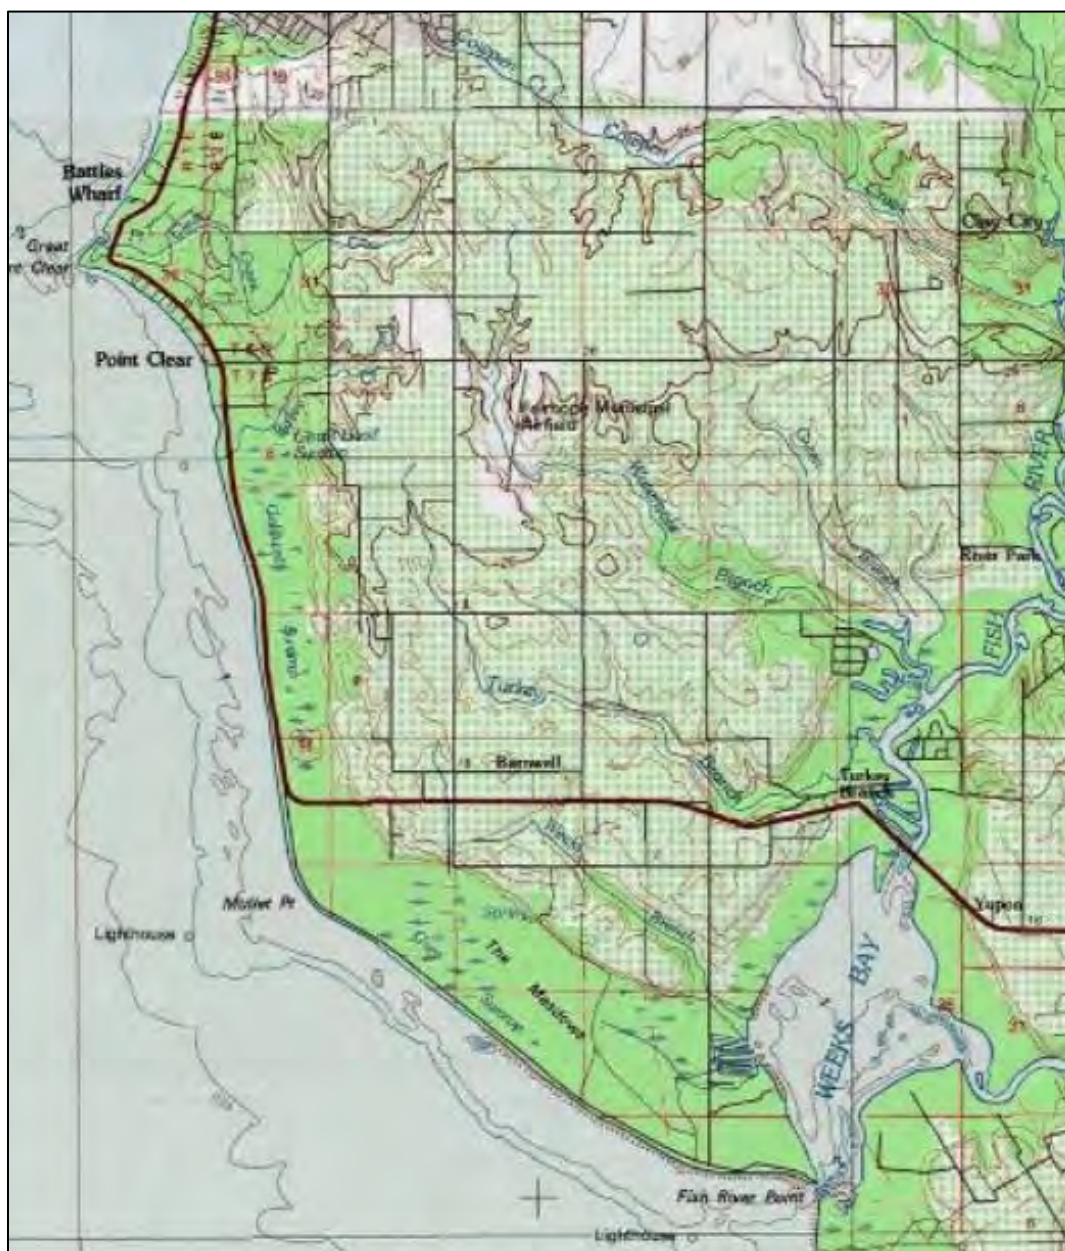
Figure 2. USGS Topographic Map of Planning District 26 (outlined in yellow)

US Geological Survey topographic mapping indicates the locations of most wetlands and streams in the district (Figure 2).

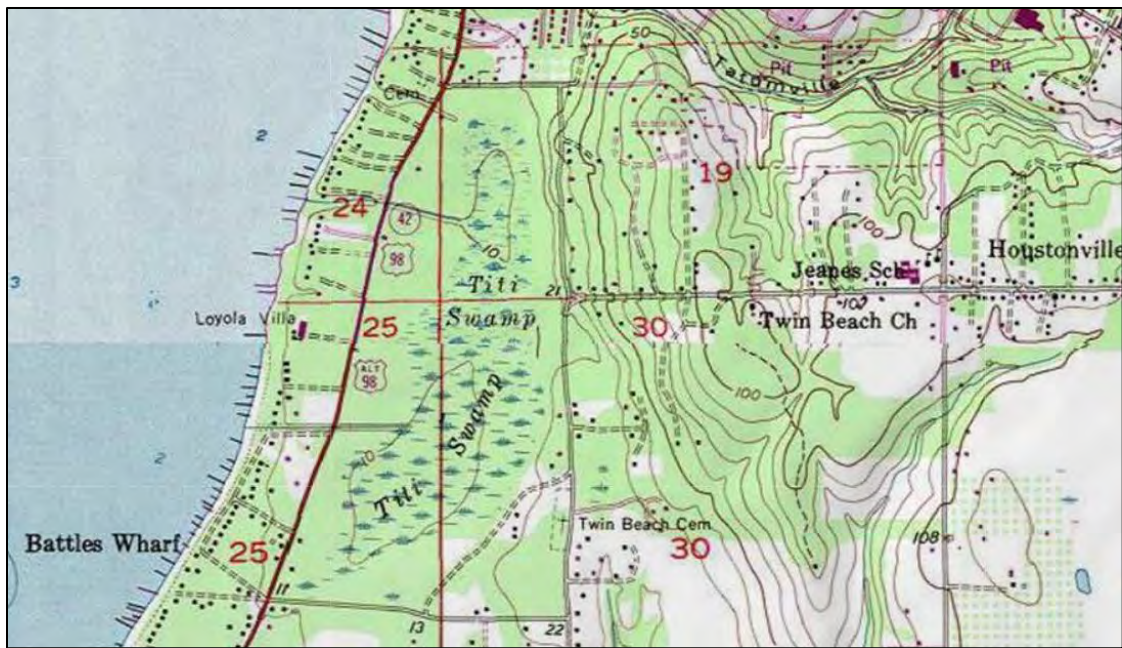
Figure 3. USGS Topographic Map of Titi Swamp

The sources of water flowing through Sweetwater Branch come from rainfall and runoff from higher elevations that enter Titi Swamp where it is filtered by leaf litter, decomposing organic matter, and soil. Water is released slowly and continuously into Sweetwater Branch, which discharges clear, clean water into Mobile Bay. The stream and surrounding wetlands provide habitat for wildlife and support the food chain. Titi Swamp acts as a sponge that captures, holds, and slowly releases stormwater, thereby attenuating flooding of surrounding developed land.

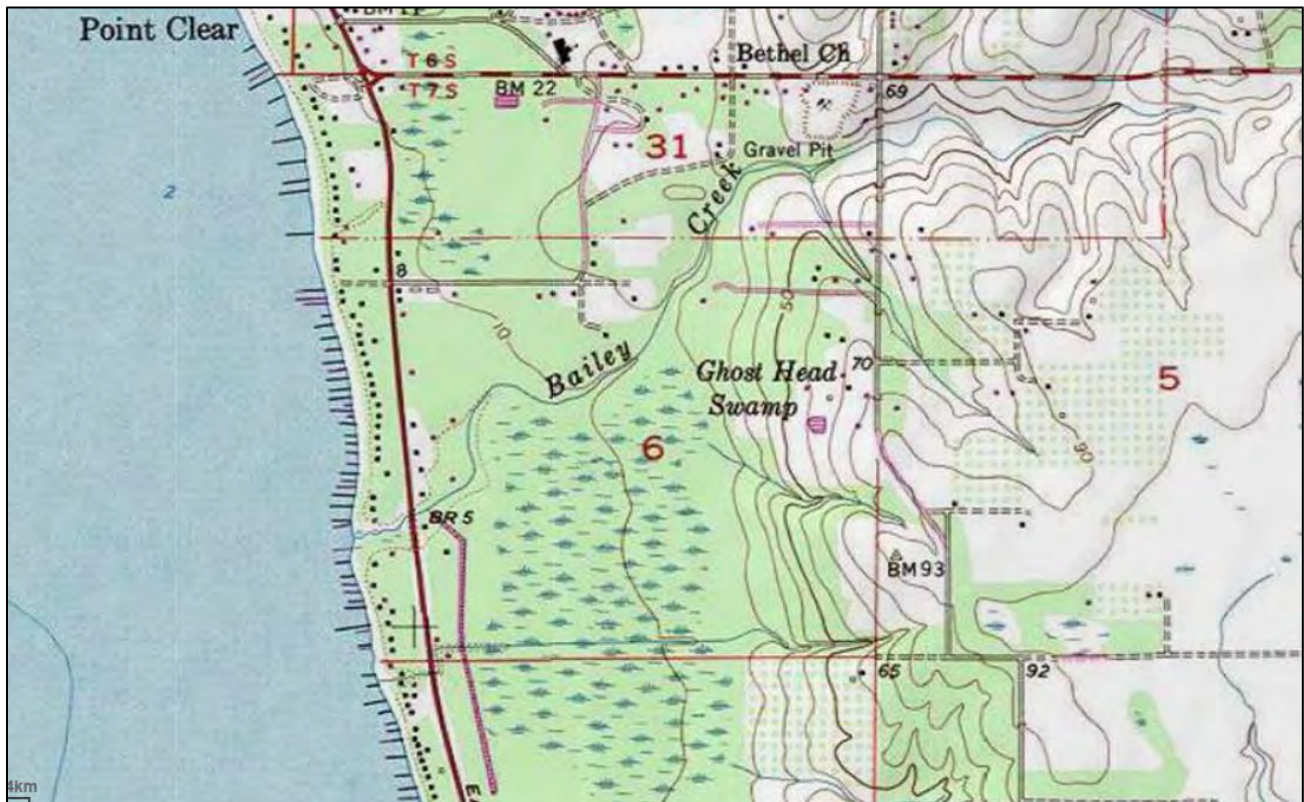
Figure 5. USGS Topographic Map of Ghost Head Swamp

The swamp is primarily composed of wet slash pine-dominated flatwoods that have not experienced fire for many years. Mixed hardwoods and shrubs are present, but the understory is mostly open. Although there has been some hydrologic modification in the form of ditching, it remains ecologically and functionally intact. Ditches are quite old and have not been maintained. Invasive exotic plant species in most areas are minimal or absent. As with Titi Swamp, water enters the system as rainfall and runoff where it is absorbed, held, filtered, and slowly released ultimately to Mobile Bay.

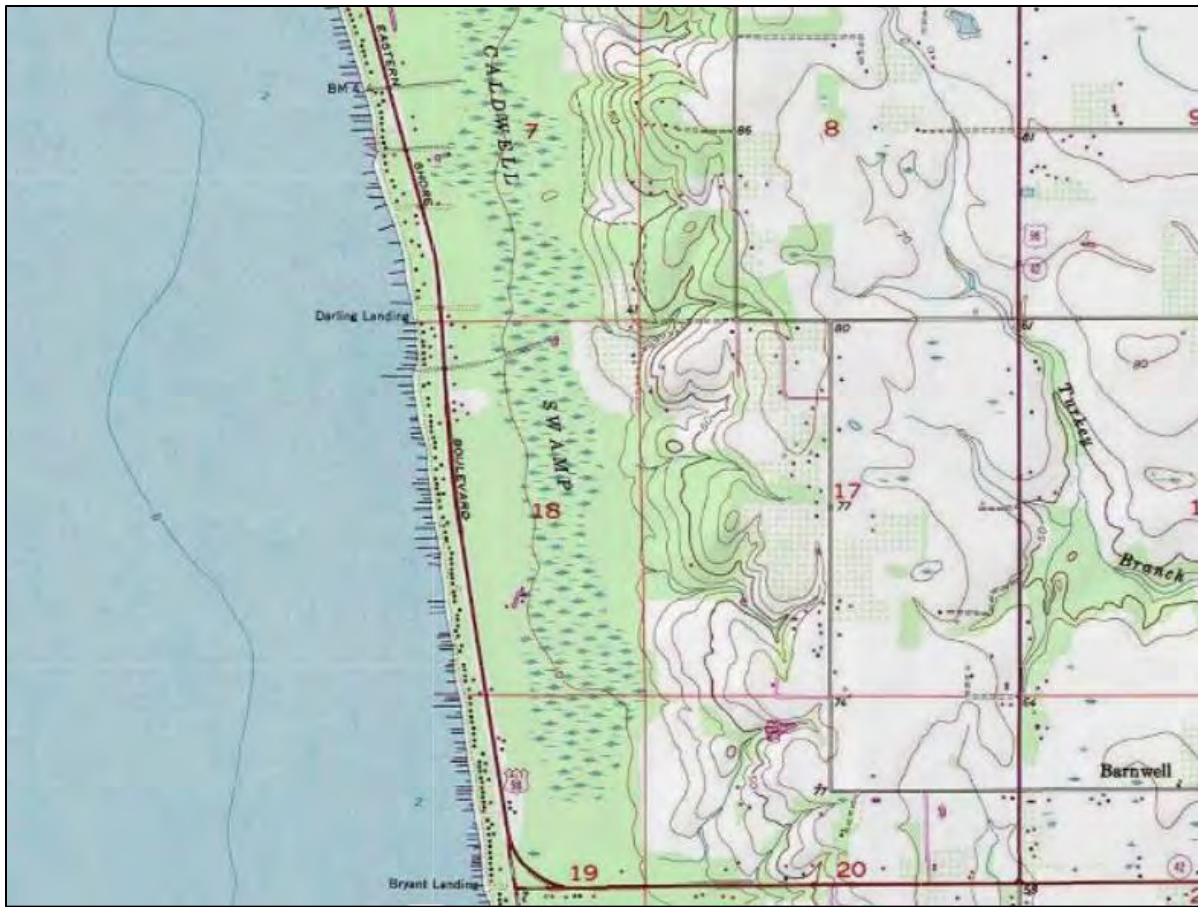
Figure 7. USGS Topographic Map of Caldwell Swamp

Aside from development of some of the lots that line the east side of Scenic Highway 98, a one-lane dirt road within the Live Oak Avenue right-of-way, and a road constructed on property with Parcel ID Number 26931, this wetland system is primarily in a natural, albeit fire-suppressed, condition. For the most part, the forest is dominated by slash pine except in the wettest areas where tupelo gum and sweetbay magnolia are more prevalent. Some invasive exotic plant species are present along disturbed edges in some areas, but within the interior they are almost nonexistent.

Water enters Caldwell Swamp as rainfall and runoff where it is absorbed, held, filtered, and slowly released ultimately to Mobile Bay. There are several artificial channels or ditches that flow out of the swamp through culverts under the highway and drain into the bay.

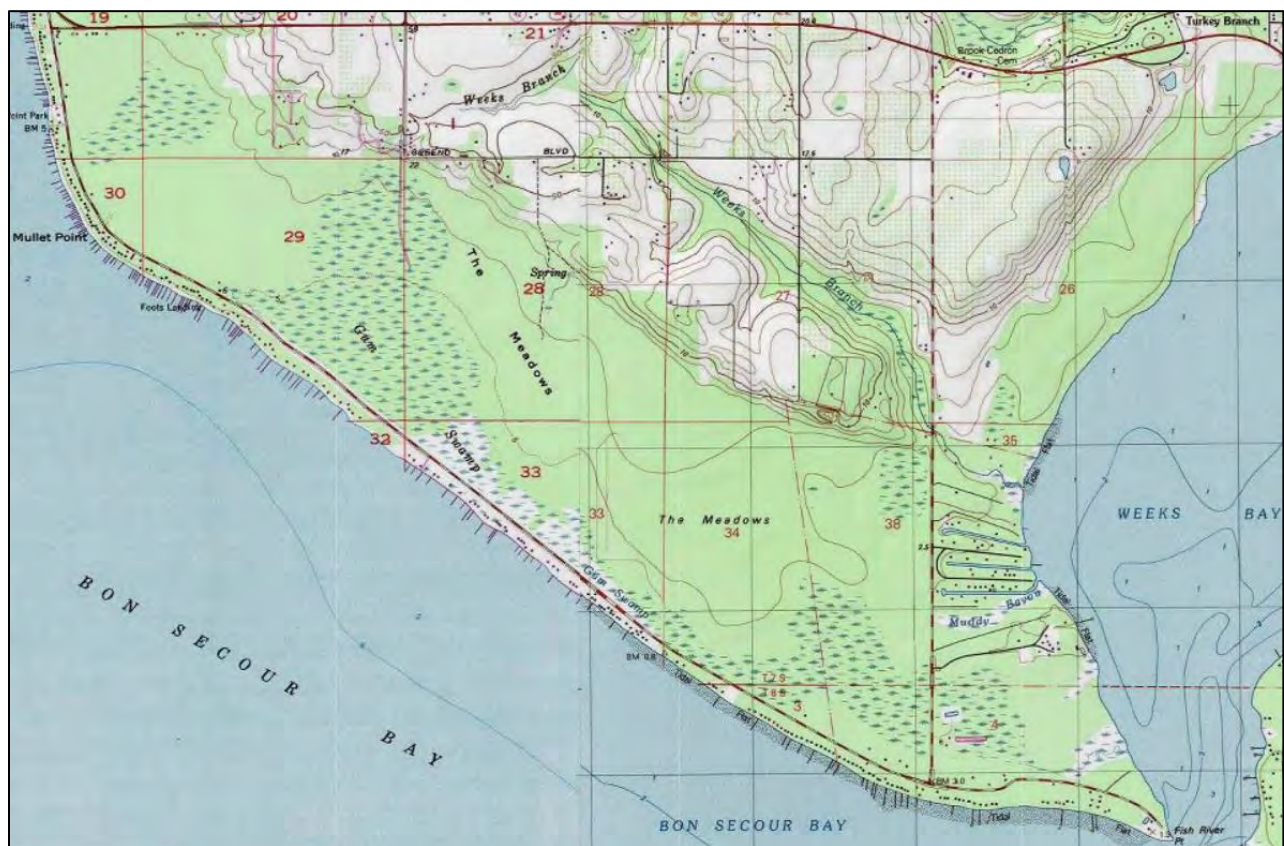
Figure 9. USGS Topographic Map of Gum Swamp, the Meadows, and Weeks Bay Wetlands

Muddy Bayou, Weeks Branch, and at least two unnamed tidal creeks flow through wetlands and into Weeks Bay, which is a National Estuarine Research Reserve.

Several of the parcels within this wetland system have conservation easements on them that are held by SALT or are owned by the state of Alabama or Baldwin County.

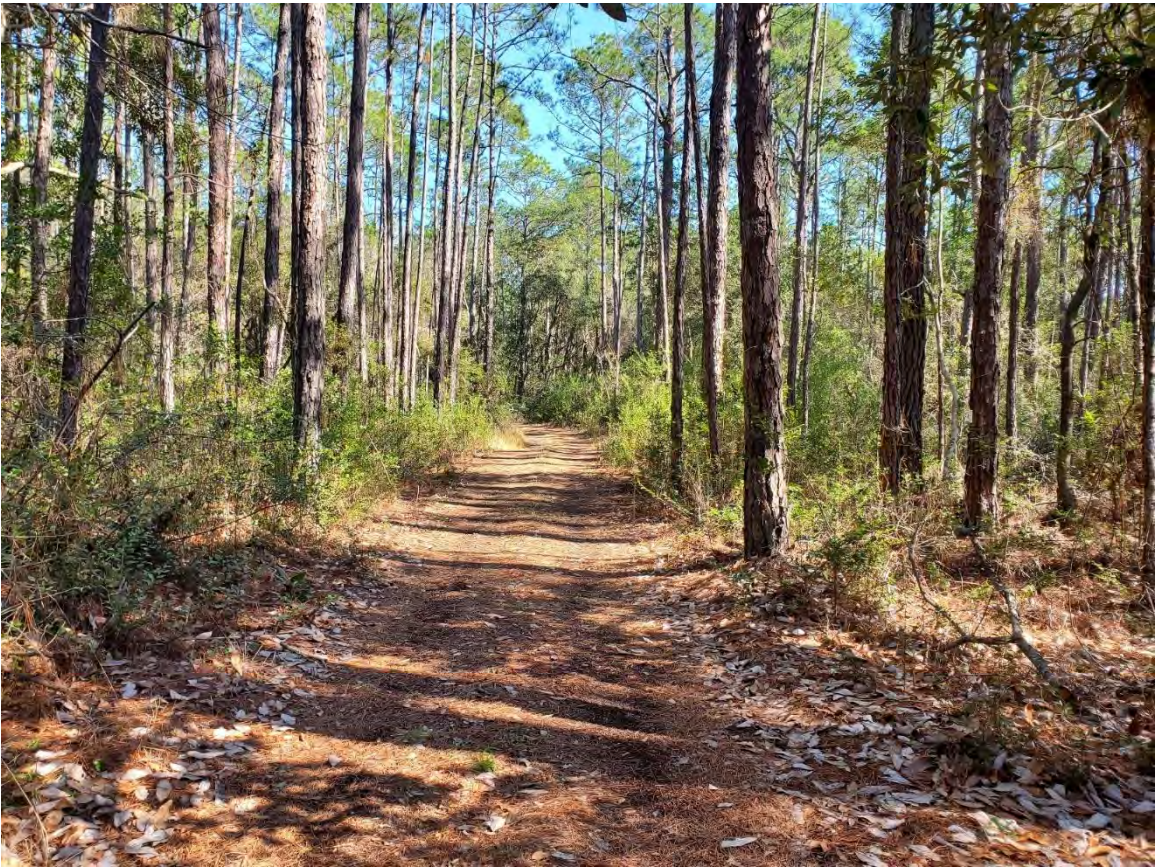
One-lane dirt road in Live Oak Avenue right of way, which is in Caldwell Swamp.

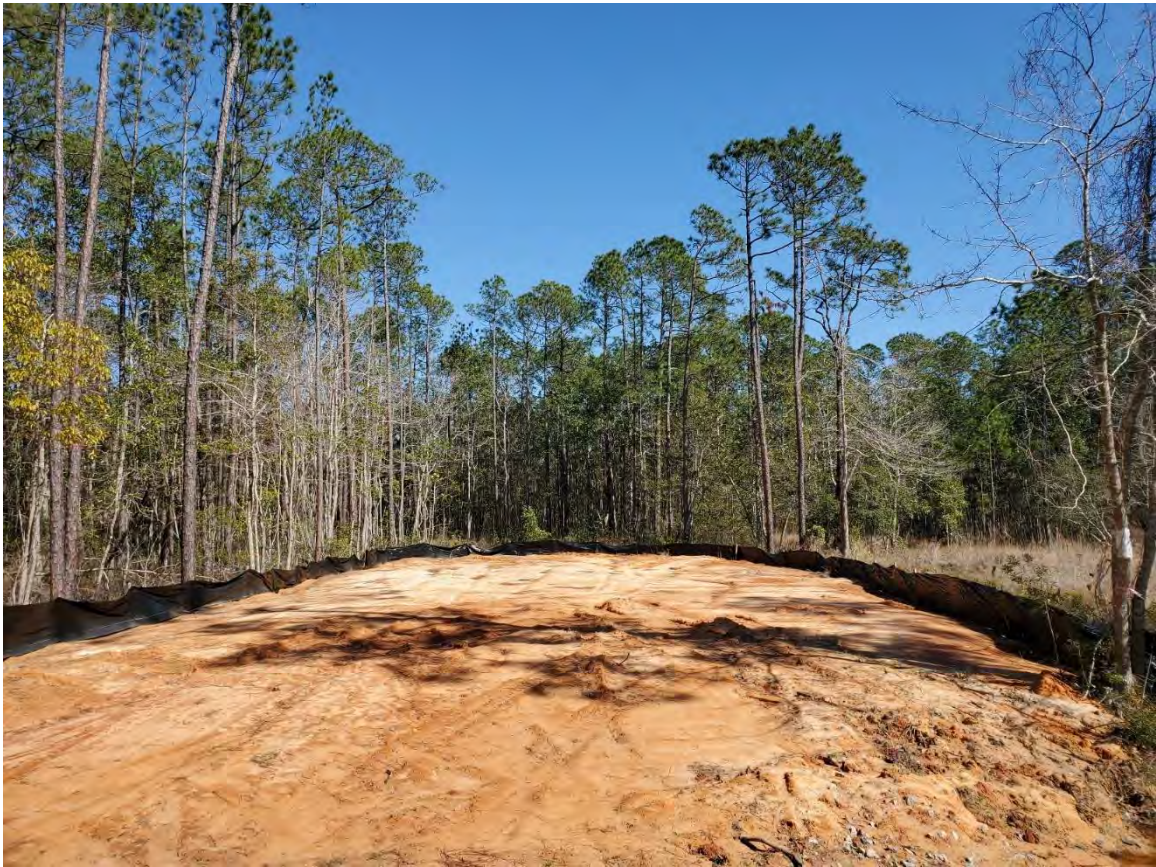
New fill in wetlands on a lot along the east side of CR 1.

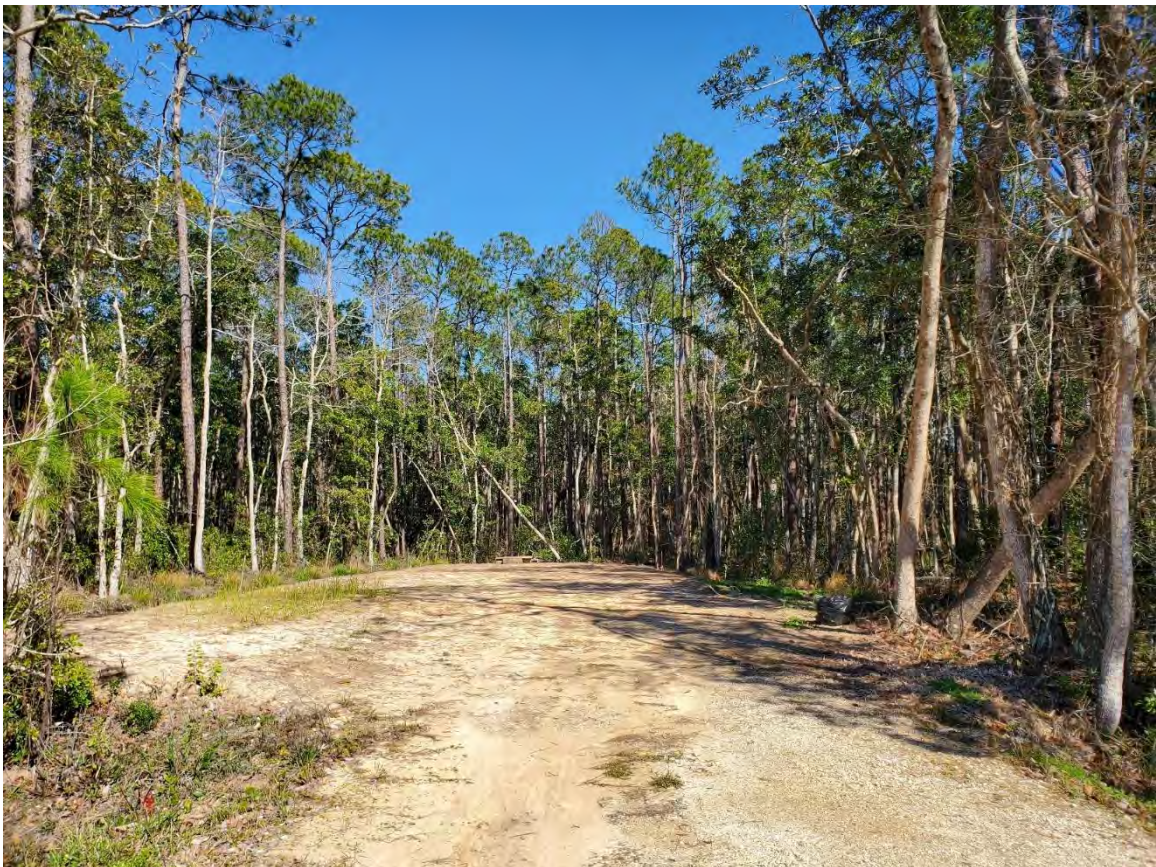
Fill in wetlands on a lot along the east side of CR 1.

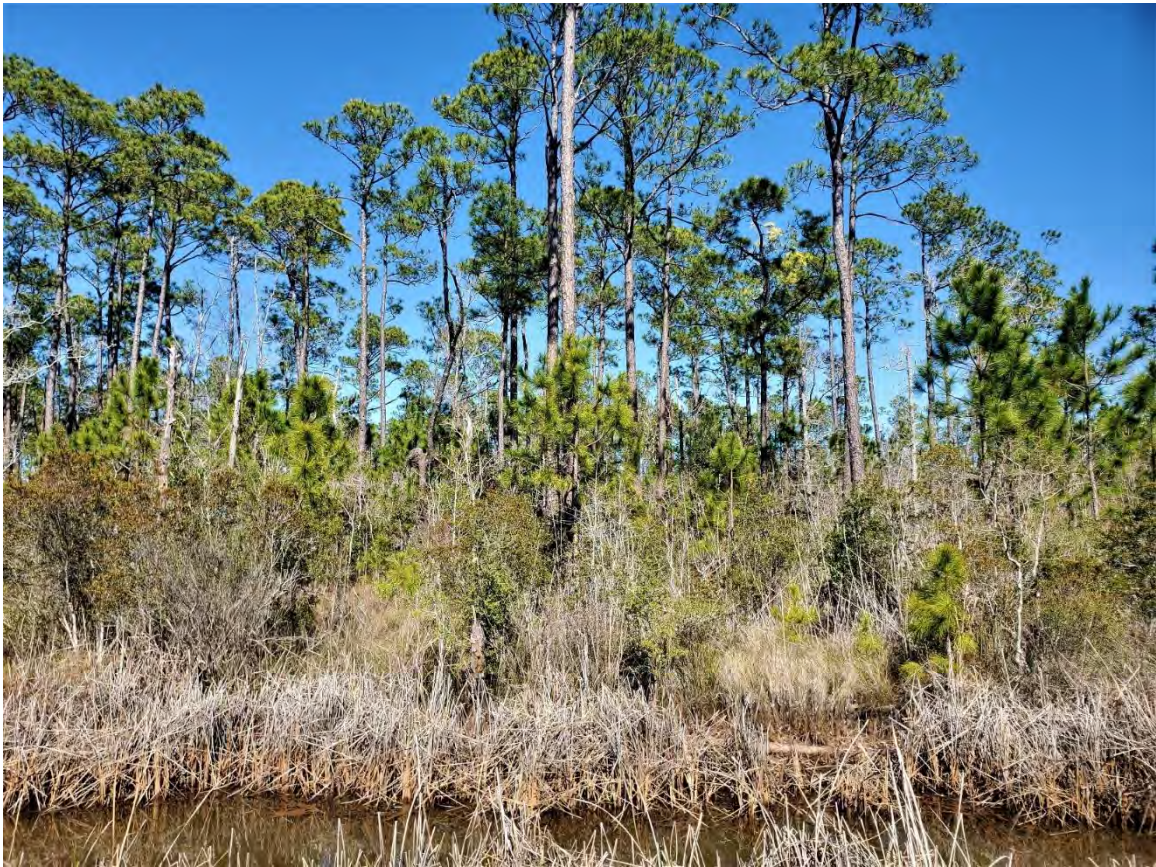
Fire-suppressed pine savanna, edge of the Meadows.

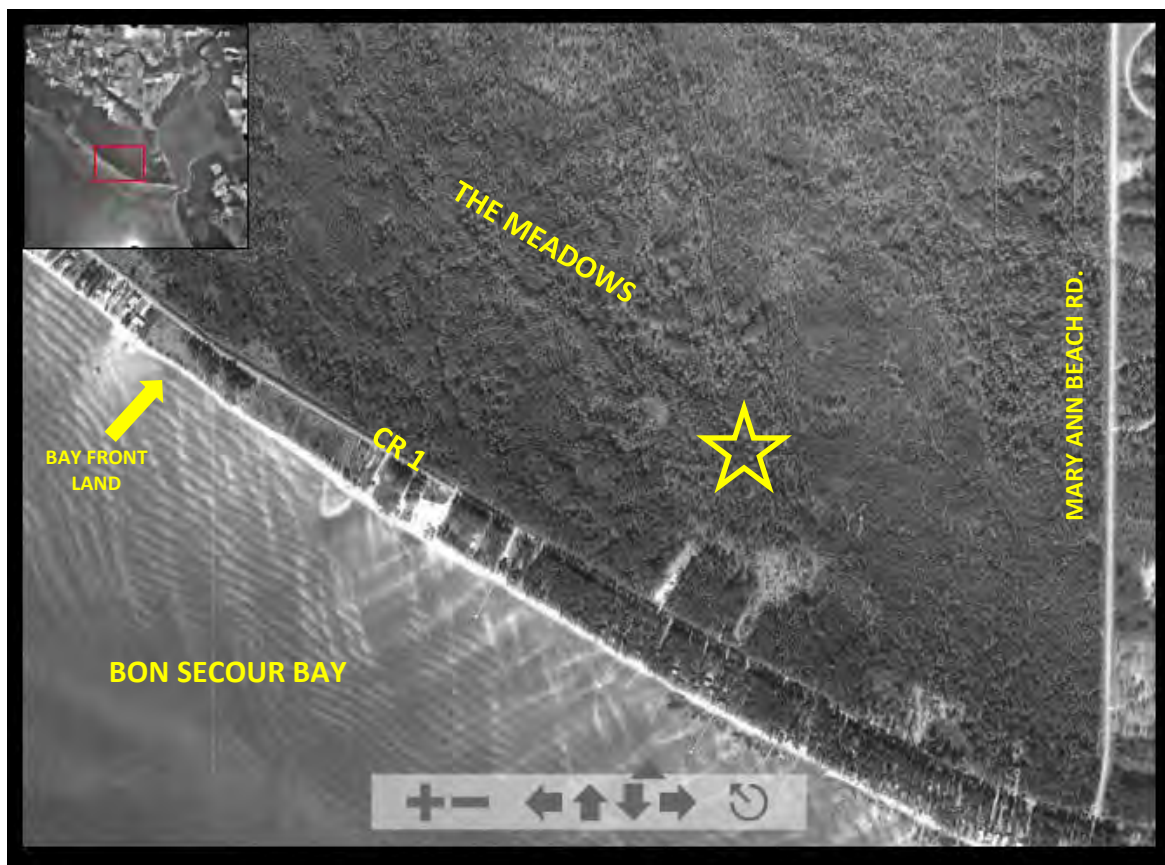
1974 Aerial Photo

By 1974, many of the bay front lots have been developed and some have piers into Bon Secour Bay. While only a narrow strip of the land east of Mary Ann Beach Rd. is visible in the photo below, signs of additional development can be seen there as well. The biggest change to the Meadows is that it no longer appears open, but has been overtaken by an overstory of trees, probably primarily slash pine (*Pinus elliottii*) and longleaf pine (*P. palustris*). If fire has been excluded leading up to this time period, then it is likely that a dense understory of shrubs and hardwood trees were also invading. The internal roads are barely visible or not visible at all. The bay front land appears to be in a natural condition with the sand plume still visible on the northwest end of the property at the mouth of the tidal creek.

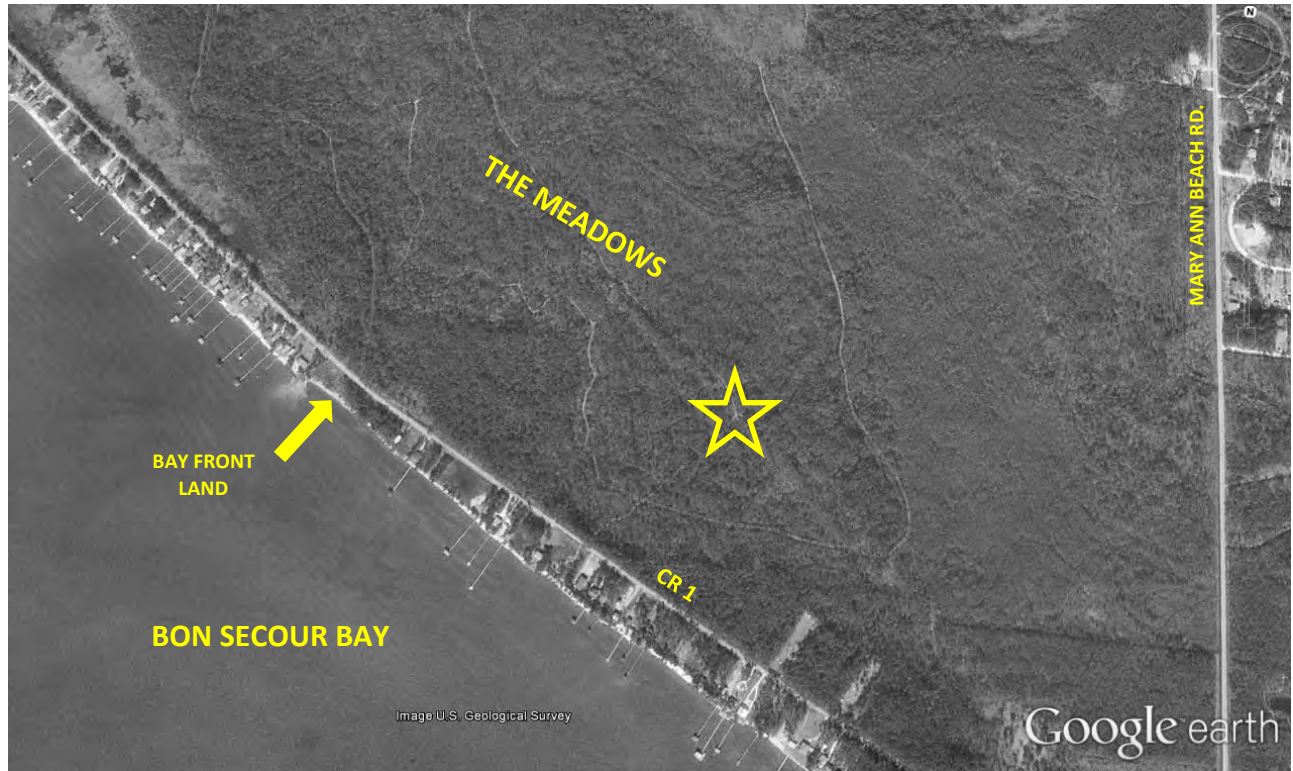
1997 Aerial Photo (Google Earth; US Geological Survey Image)

In the 1997 aerial photo below, roads through the Meadows are again visible, possibly indicating timber harvesting activity, which would have necessitated opening up and improving the roads. The bay front land appears unchanged with the possible exception of a slightly receded shoreline.

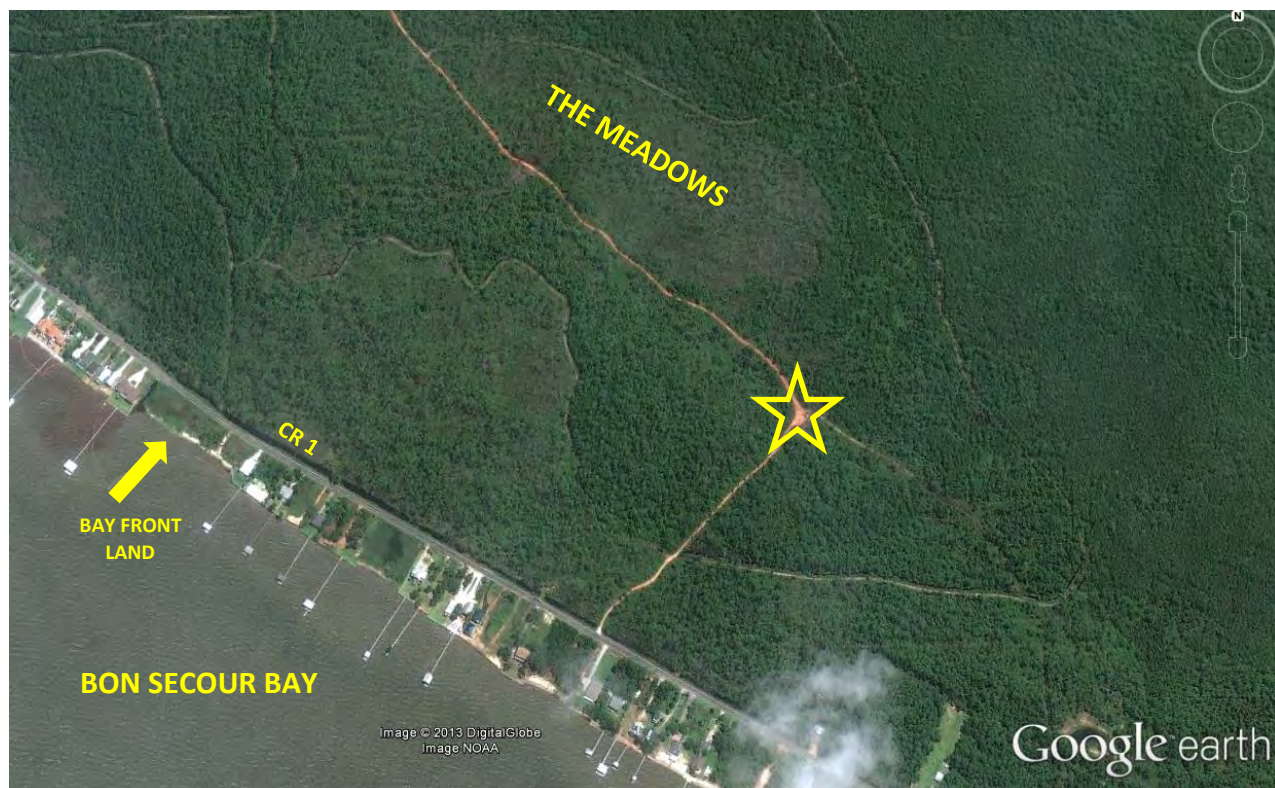
June 2010 Aerial Photo (Google Earth; NOAA Image)

The June 2010 aerial photo was taken following the April 2010 BP Deepwater Horizon oil spill in the Gulf of Mexico. Floating boom can be seen in the water in front of the bay front land. The tree canopy in some areas of the Meadows property appears less dense, indicating that timber harvesting has occurred.

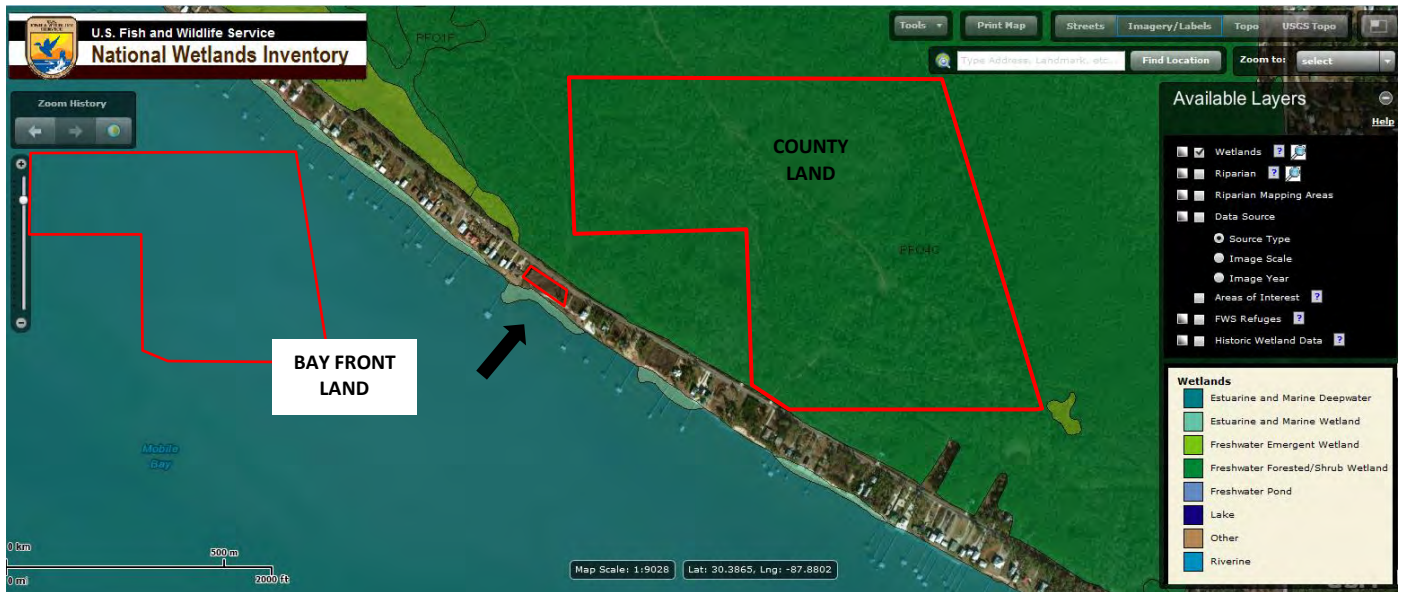
National Wetland Inventory Map, US Fish and Wildlife Service

E1UBL – Estuarine and Marine Wetland (**BL** = **Saturated, Subtidal**)

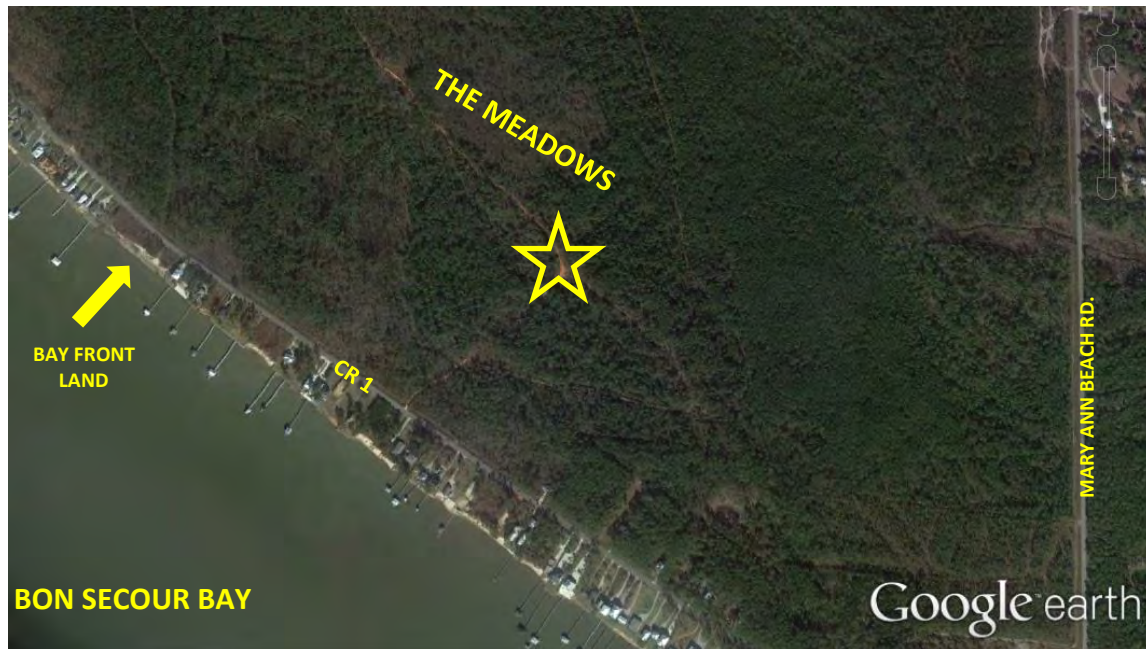
2012 Aerial Photo (Google Earth)

In this 2012 aerial photo, the Meadows and bay front land look essentially unchanged from 2009 - 2010.

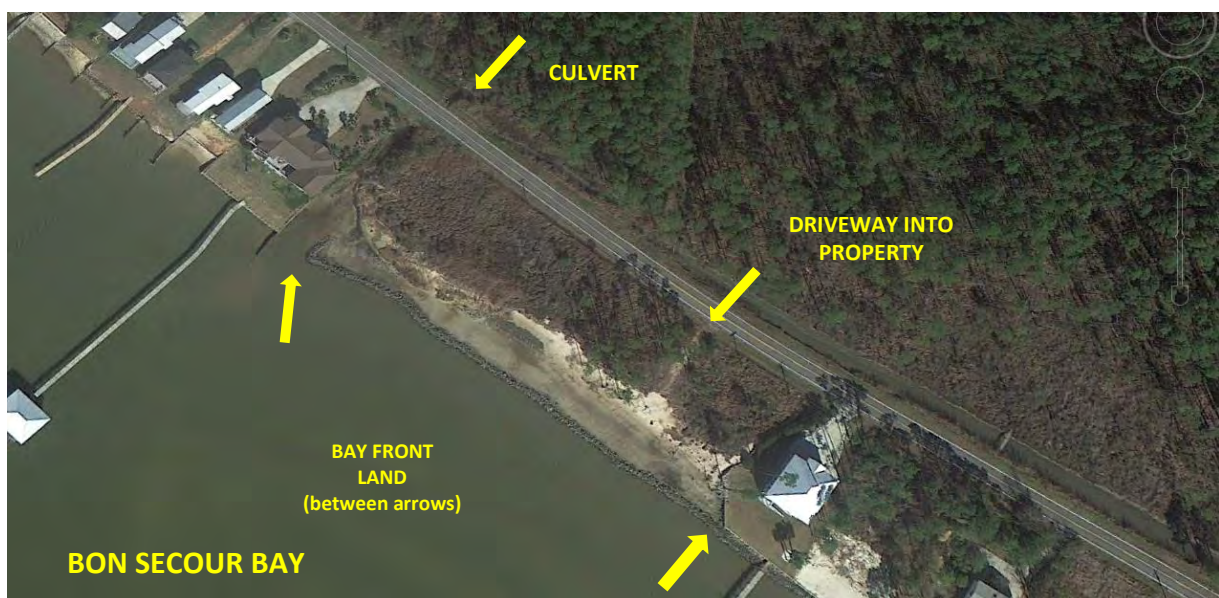
2012 Aerial Photo (Google Earth)

The following aerial photo is a closeup view of the bay front land. The tidal creek is clearly visible. It drains water from the Meadows and Gum Swamp on the northeast side of CR 1. The majority of this land is emergent marsh. There is a small stand of slash pines just northwest of the driveway into the property and a few scattered shrubs throughout. A natural beach and sand berm run along the shoreline. The back side of the berm adjoins the emergent marsh. A significant wrack line is present along the shoreward slope of the berm, on top of it, and in some areas, spilling over into the marsh. There is an intertidal area between the line of rip-rap and the shoreline. It appears that the rip-rap, which absorbs wave energy, has been effective in preventing additional loss of land through erosion.

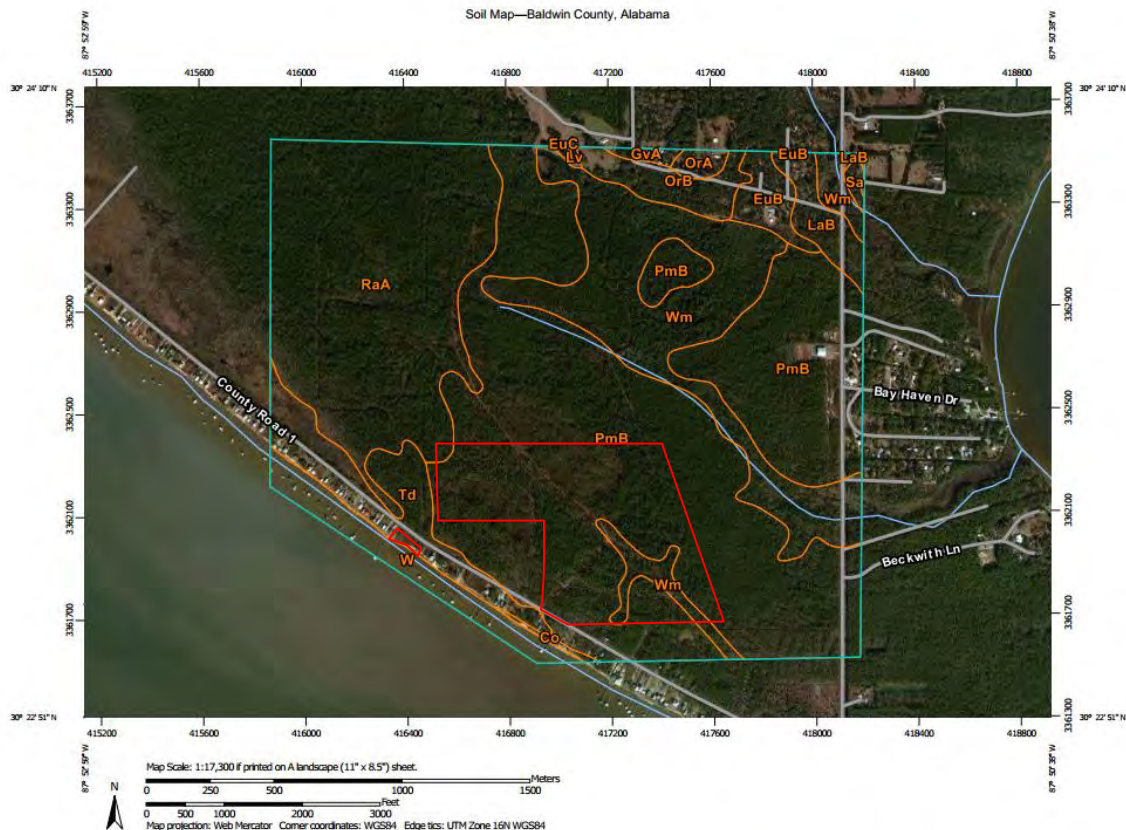
USDA Natural Resources Conservation Service Soil Map (www.websoilsurvey.sc.egov)

The USDA Natural Resources Conservation Service soil mapping is shown below. The soils report, which was generated using Web Soil Survey, for the site can be found at **Appendix B**. Four soil map units are included within the boundaries of the county-owned land, all of which are considered **hydric**. Hydric soils are those that formed under conditions of saturation, flooding, or ponding long enough during the growing season to develop anaerobic conditions in the upper part (USDA Soil Conservation Service, 1994).

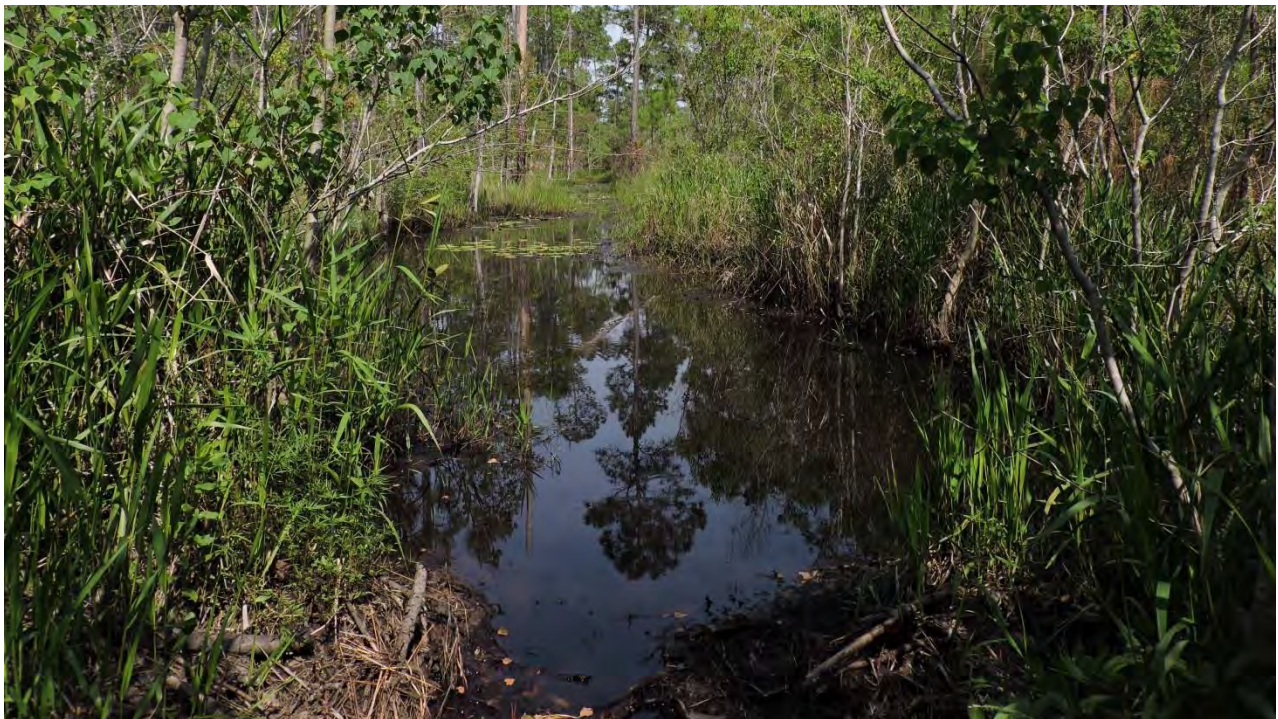
This tract contains a network of roads typically constructed for timber harvesting operations. These roads appear to have been constructed by borrowing materials from adjacent areas along the road alignments, creating roadside ditches. Along the main road leading into the property from CR 1, those borrowed soils are capped with reddish sandy-clay fill material. The former logging deck (marked by the yellow star in aerial photos) is also capped with the same type of fill material. Because of the naturally high groundwater table, the ditches contain water during most seasons of the year. When water flows through these ditches during and/or following a significant rainfall event, the flow velocity is very low, therefore soil erosion and deposition does not appear to be an issue. The road surface varies in elevation relative to the adjacent land. At some locations the road surface elevation approximates that of the adjacent land or is just slightly higher. At other locations the road surface elevation is a foot or higher than the adjacent land. At no location did the internal road network appear to act as a significant damming feature. Ultimately, it appears that the native plant communities have adapted to any alteration of the natural hydrology caused by road and ditch construction.

View of one of the larger ditches excavated for the purpose of road-building.

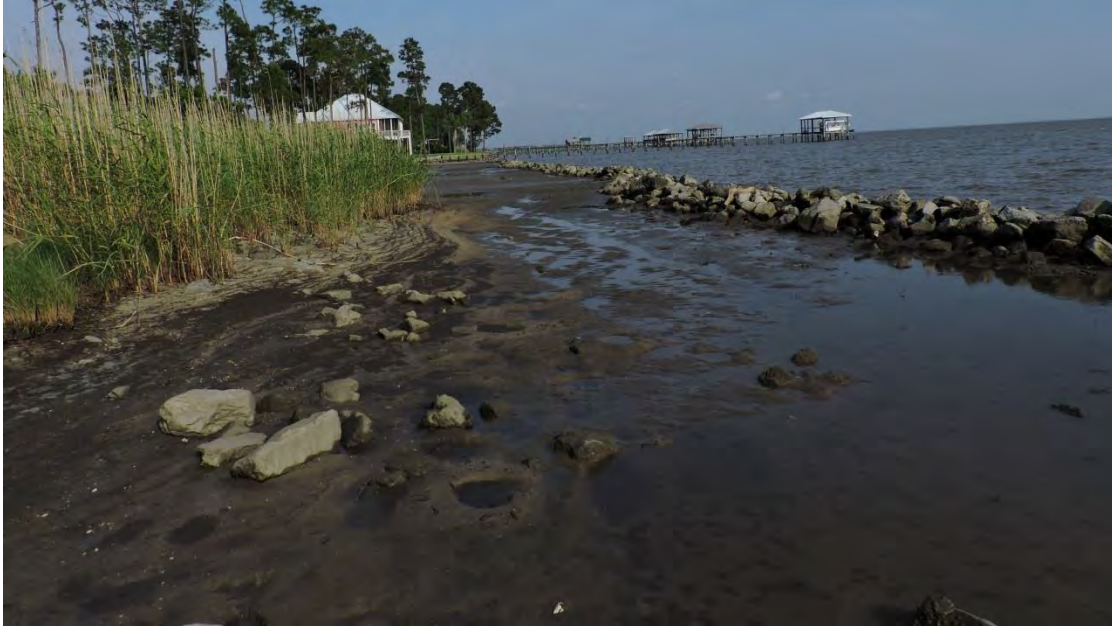
Bay Front Land. The shoreline fronting the bay is subject to the ebb and flow of the tide, as well as high-energy wave events such as during hurricanes and other storms. Adjacent shorelines to the northwest and southeast have been bulkheaded or otherwise armored, which may have contributed to shoreline erosion on this property. A previous landowner constructed a rip-rap energy dispersion berm waterward of the shoreline in an apparent attempt to stop erosion and accrete lost land. The open-water area between the rip-rap berm and the mean high tide line does appear to be accreting. This area is shallow and the shoreline now appears to be stable.

View of the intertidal area between the rip-rap and shoreline, looking south.

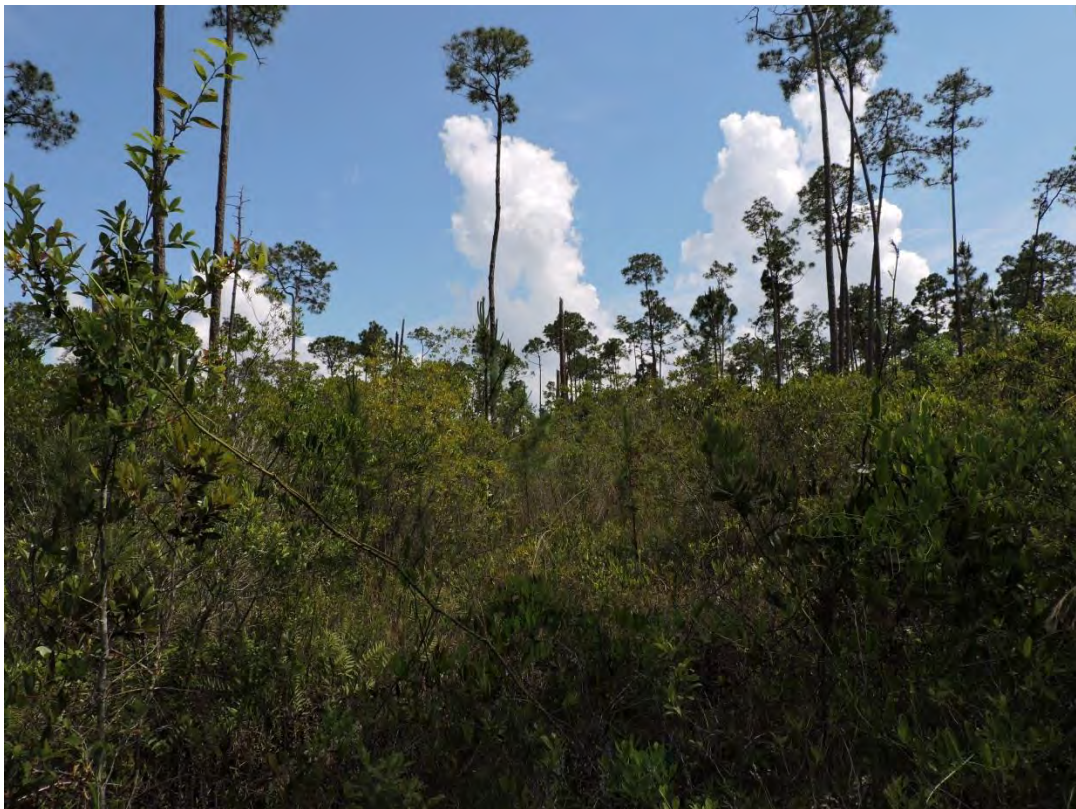
When fire is excluded from these areas, an understory of hardwood trees and shrubs will quickly become established, which is detrimental to the ecosystem as a whole. The plant community is transformed from an incredibly diverse herbaceous-dominated system to one with little to no groundcover and a dense thicket made up of relatively few plants, many of which are of limited value to most wildlife species. Many species of wildlife that depend on the savannah-like plant community are soon crowded out by the dense undergrowth and must move to more suitable habitat or perish. Oftentimes, there is no suitable habitat nearby due to development or other conversion.

Fire-suppressed Pine Savannah
