Baldwin County Planning District 26 Wetlands Evaluation and Recommendations

February 2022

**PREPARED BY
GENA TODIA**

Baldwin County Meadows Property

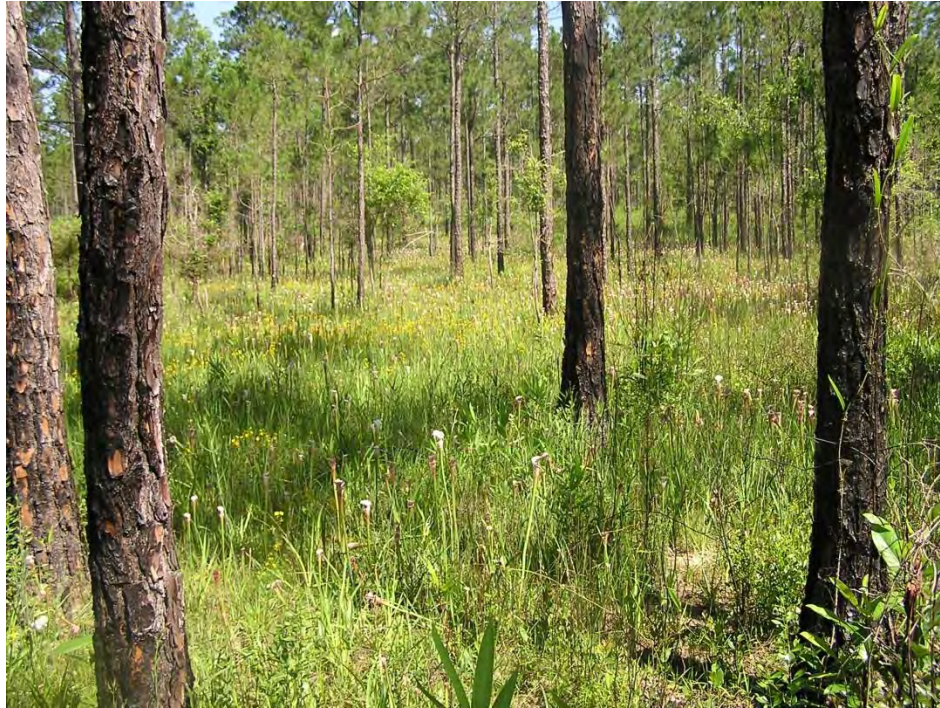
Historically, natural fire in this type of system in coastal Alabama is estimated to have occurred at 1 – 3 yr. return intervals (Frost, C. 2006. *History and future of the longleaf pine ecosystem*. In: Jose, S., Jokela, E.J., Miller, D.L. (Eds.), *The Longleaf Pine Ecosystem: Ecology, Silviculture, and Restoration*. Springer, New York, pp. 9-42). In order to dramatically reduce and control the woody understory and restore more open, meadow-like conditions, it will be necessary to burn frequently and under conditions that produce hot fires.

Fire-managed Pine Savannah

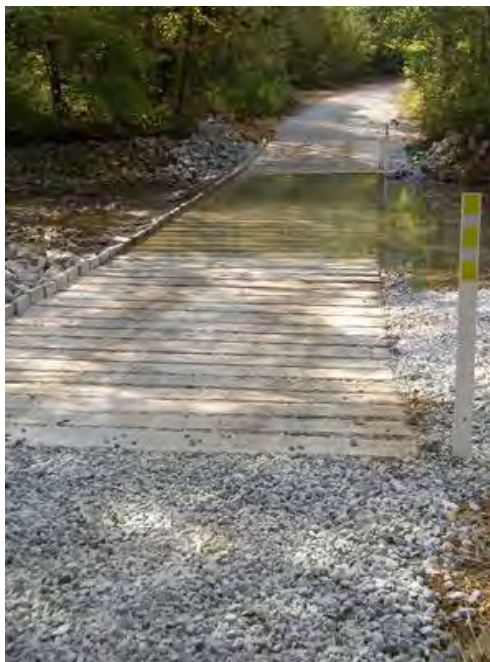
Example of a Low-Water Crossing

In areas where a road segment is obviously higher than the adjacent natural ground elevation, low-water crossings, or fords, can be constructed. The overflow section should have the surface armored with coarse gravel and/or riprap or concrete to prevent erosion and allow vehicular traffic to pass during overflow events. If low-water crossings are installed, elevated boardwalks should be constructed along one edge of the crossing to allow for pedestrian access.

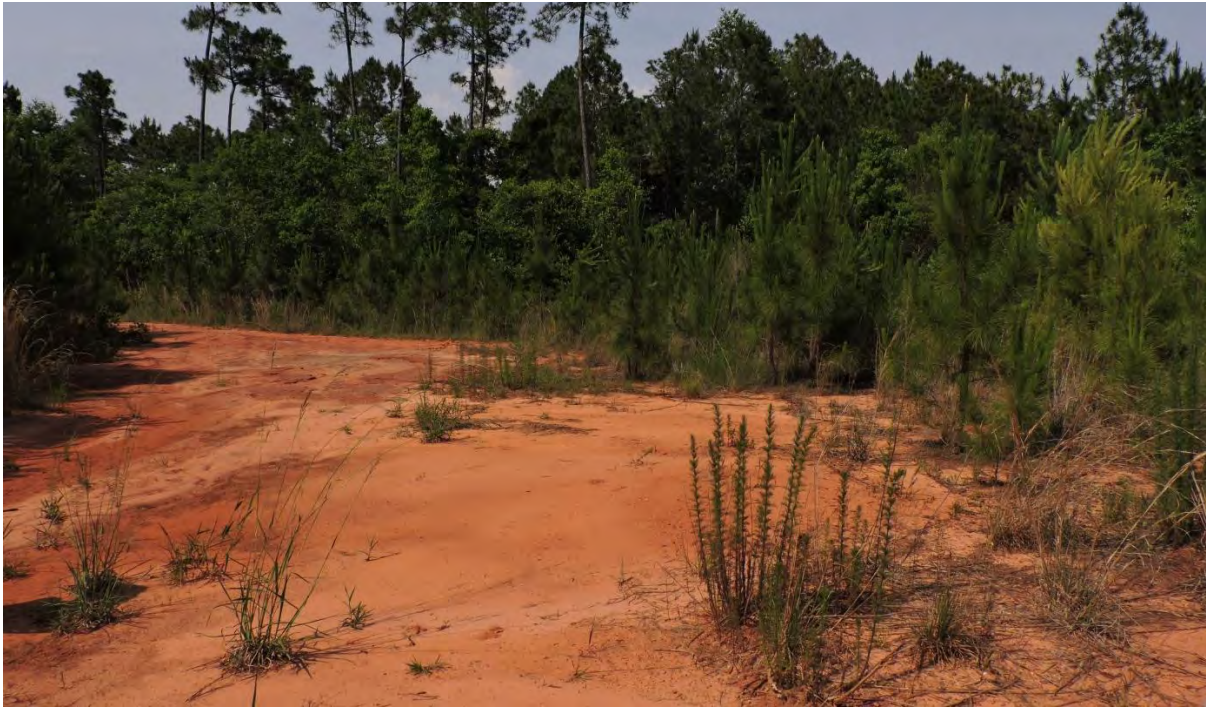
Potential Parking Area

If the former logging deck is to be used for parking, then it will be necessary to improve the road segment between CR 1 and the former logging deck. This road corridor is currently somewhat overgrown, so there is a need to clear vegetation from a narrow swath along the road edges. To accommodate regular passenger cars, the road surface may need some improvement, such as grading, filling in mud holes, and perhaps adding an aggregate material such as limestone or gravel.

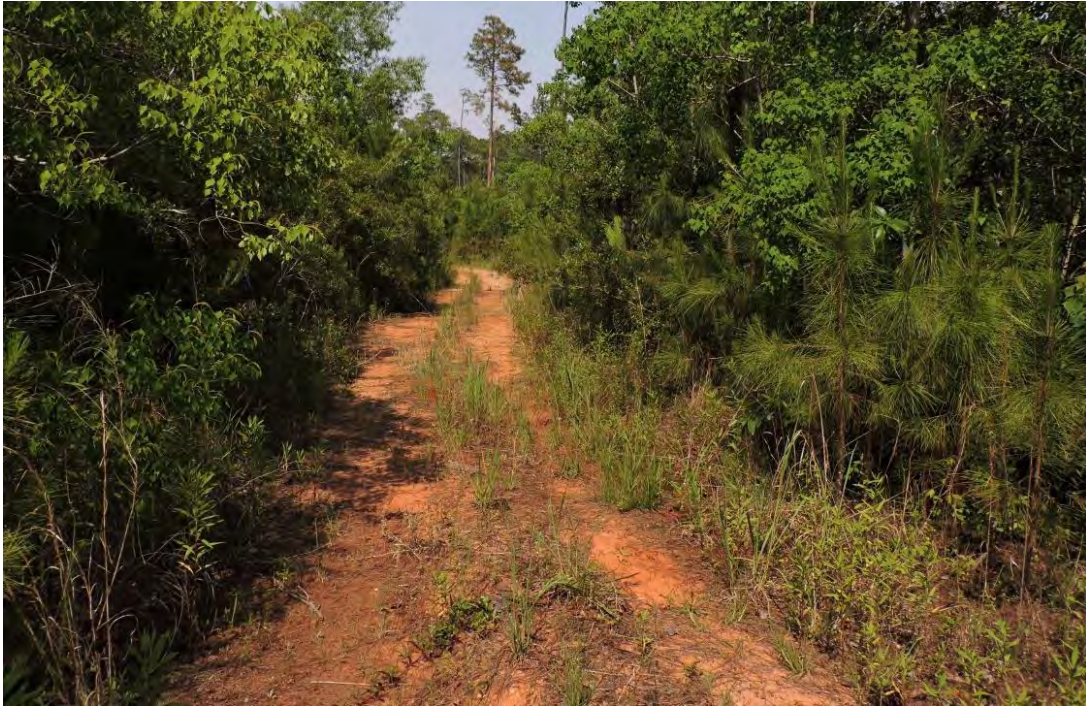
Road / Trail Leading into the Property from CR 1

The existing former logging roads and other paths provide an essentially ready-made trail system throughout the property. Relatively minimal effort will be required to make these trails user-friendly in

most areas; however, some segments will require boardwalks. Initially, trails should be bush-hogged / mowed and vegetation encroaching from the adjacent natural areas trimmed to open up an adequate path where necessary.

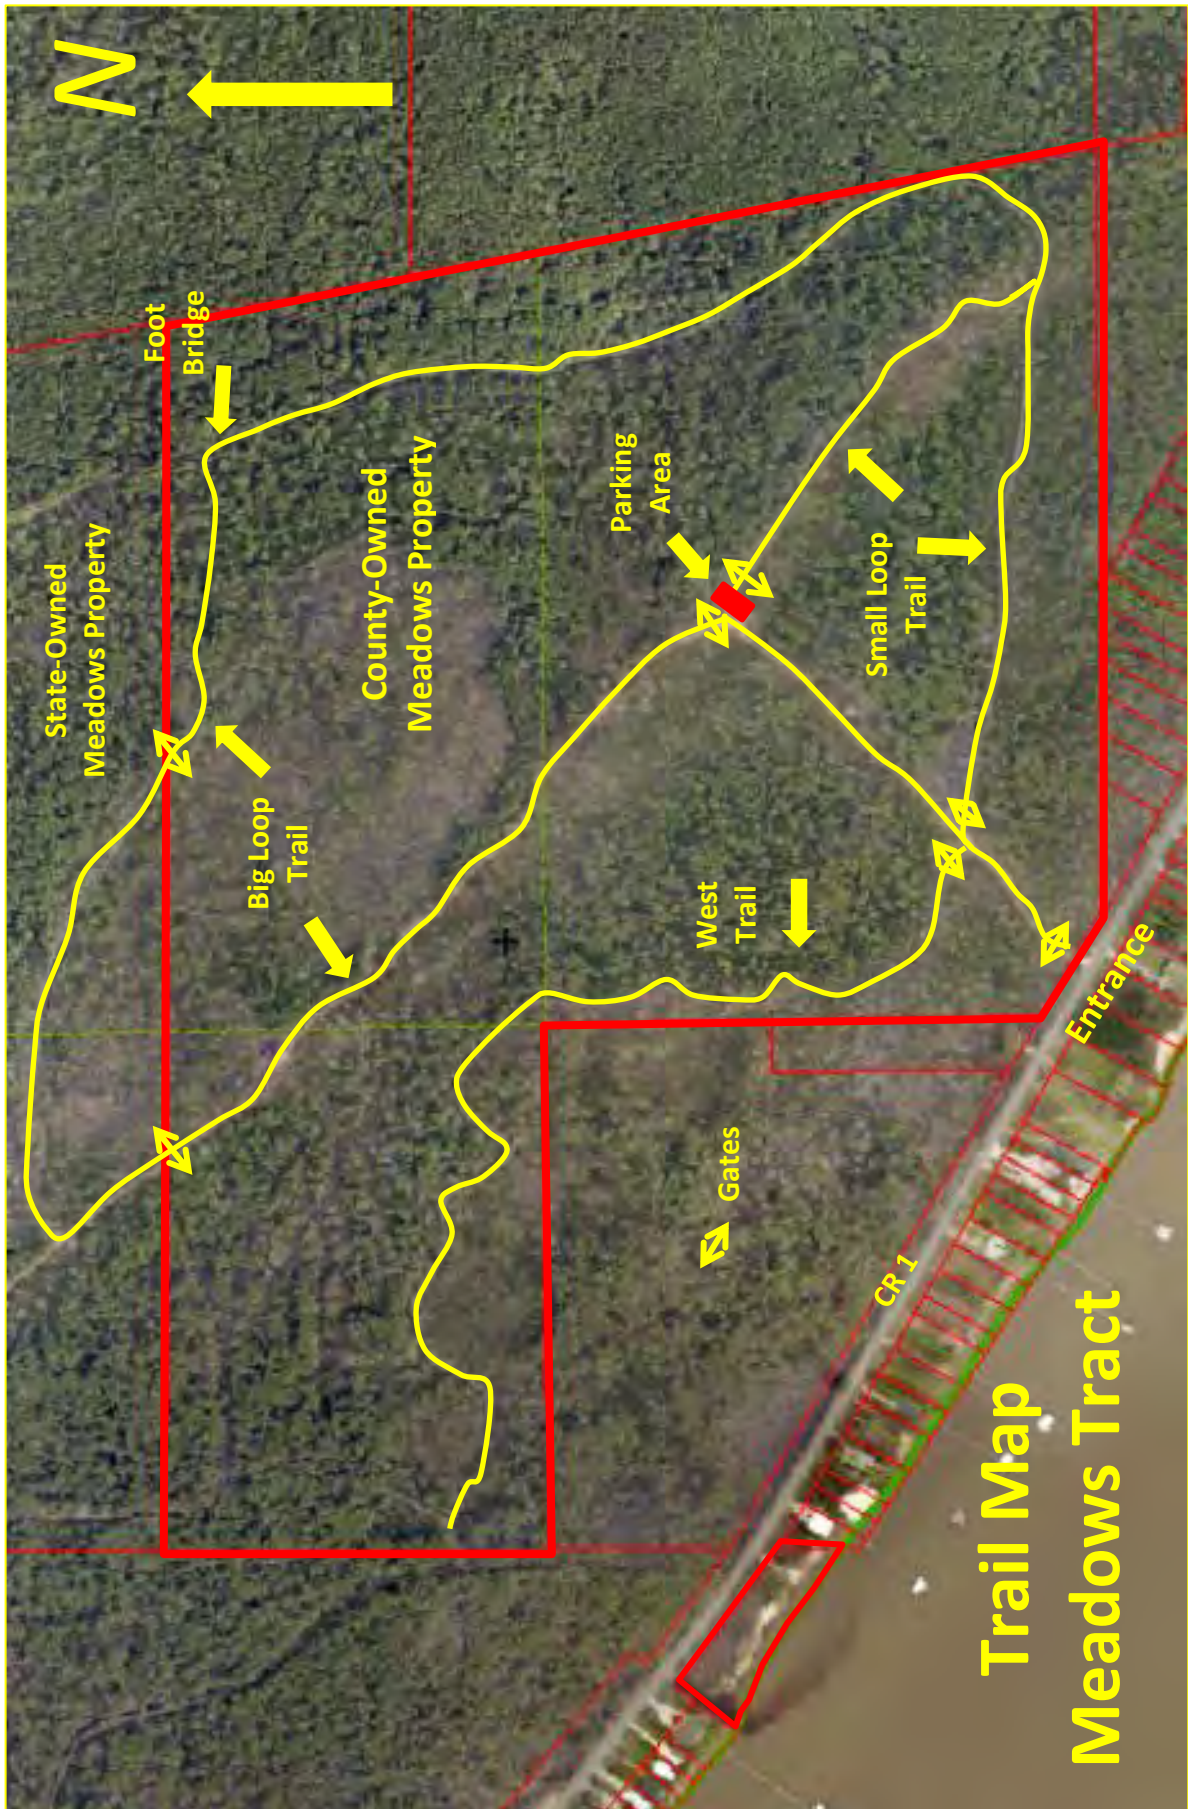
Proposed Signage The Meadows Tract

Informational and interpretive signage can be placed along the trail system at appropriate locations. Pages 53-60 lists suggested verbiage and other information to be posted. For now, these three main trails are called West Trail, Big Loop Trail, and Small Loop Trail. The County Commission may want to name these trails something more interesting when the time comes to produce signage.

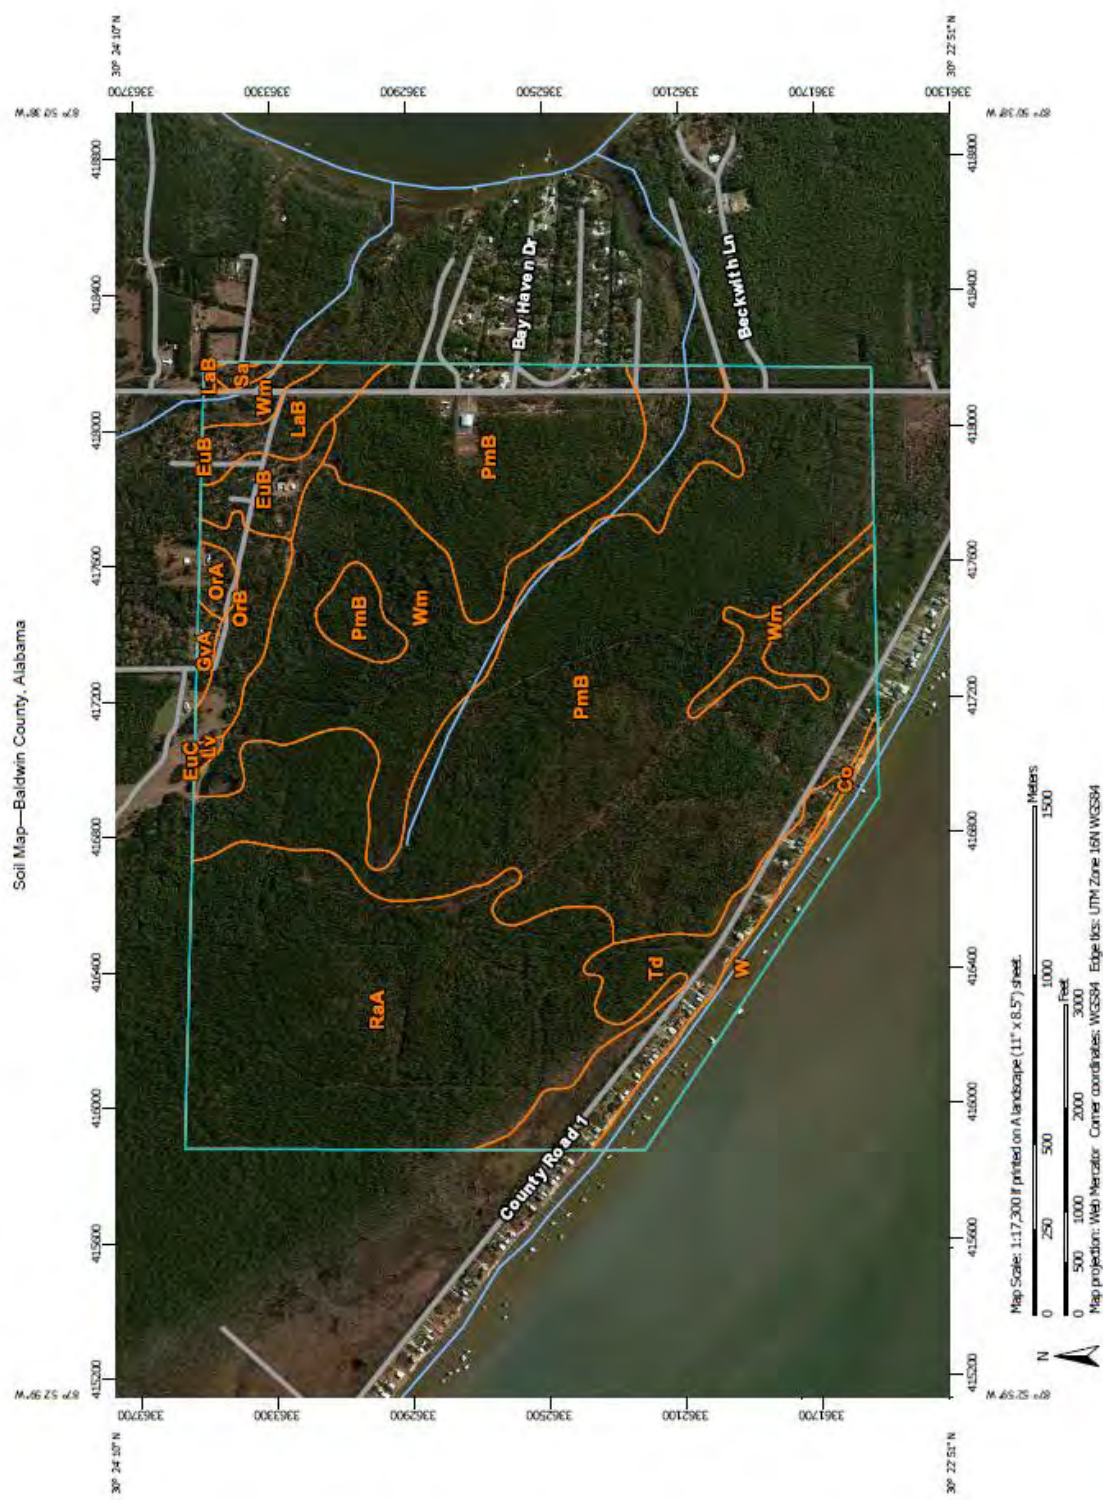
Soil Map—Baldwin County, Alabama

The soil surveys that comprise your AOI were mapped at 1:20,000. Please rely on the bar scale on each map sheet for map measurements.
