# The 25 Most Environmentally Damaging Dirt Roads 3rd Publication

# 2022 Baldwin County Environmental Advisory Committee

# **Executive Summary**

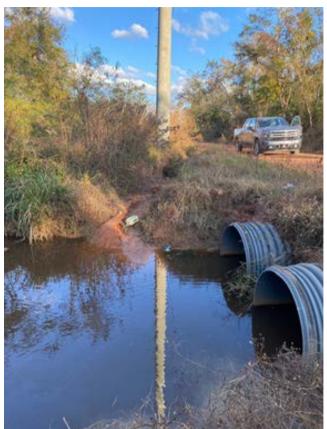
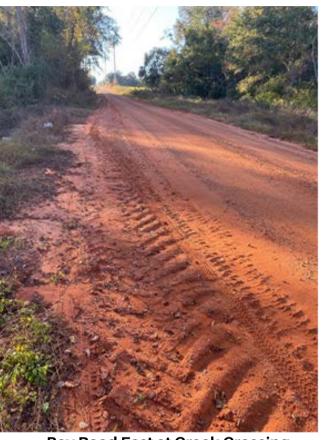
**Bay Road East at Creek Crossing**

<u>Observation:</u> The road is relatively flat but does discharge to Nolte and Weeks Creeks and its wetlands and tributaries. Sediment impacts were noted in the creek. During the evaluation, it was noted that new red clay was recently placed along the road near the creek. It was also noted that there were minimal vegetated buffers between the farm fields and the road right-of-way.

- 1. Contact the NRCS regarding recommendations or incentives for the farmers to allow for additional vegetated buffers along the right-of-way especially near creeks and wetlands.
- 2. Due to its location and the multi road connectivity, the road be paved.

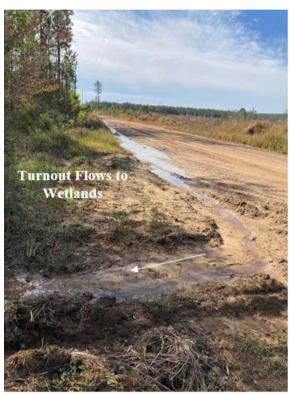
Stormwater Turnout Directed to Wetland

**Observation:** Since, the 2010 Report, the BCHD has graveled large portions of Brady Road which has helped minimize sediment impacts along the wetlands and stream crossing. Impacts were noted to several wetlands, associated with sediment discharges from turnouts.

- 1. Contact the Alabama Forestry Commission regarding recommendations or incentives for the foresters to allow for additional vegetated buffers along the right-of-way especially near creeks and wetlands.
- 2. Turnouts be relocated such that they discharge to upland areas where possible.
- 3. Stabilize the entire right-of-way including the roadway and ditches, with appropriately sized rock. If not feasible, stabilize the rights-of-way on each side of the stream and wetland crossings for a distance to be determined by engineering analysis. Possible solutions to be considered to minimize stream and wetland impacts may include, but are not limited to, sediment traps, additional upland turn outs, etc.

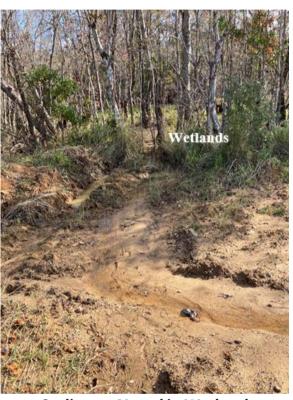
**Sediment Noted in Wetland**

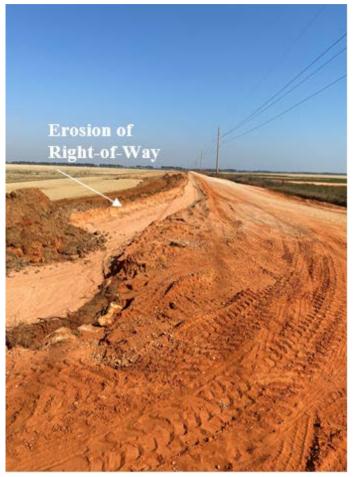
**Erosion noted along Right-of-Way**

- 1. Contact the NRCS regarding recommendations or incentives for the farmers to allow for additional vegetated buffers along the right-of-way especially near creeks and wetlands.
- 2. Turnouts relocated such that they discharge to upland areas where possible.
- 3. Stabilize the entire right-of-way including the roadway and ditches, with appropriately sized rock. If not feasible, stabilize the rights-of-way on each side of the stream and wetland crossings for a distance to be determined by engineering analysis. Possible solutions to be considered to minimize stream and wetland impacts may include, but are not limited, to sediment traps, additional upland turn outs, etc.

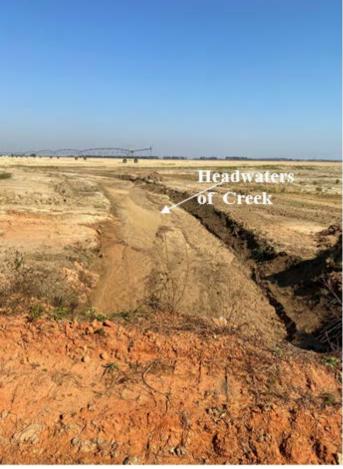
**Sediment in Weeks Creek**

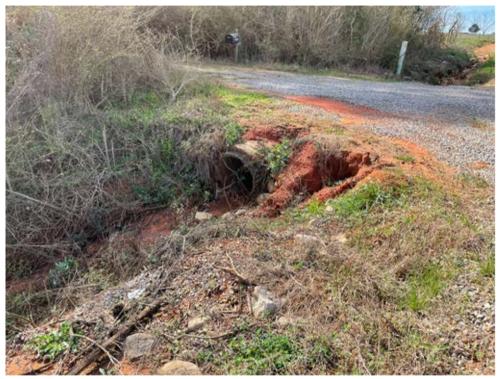
**Erosion Near Road Culvert Flows to Wetlands and Stream**

**Observation:** Erosion was noted at each culvert and sediment was noted in the Un-named Tributary to Blackwater River.

- 1. Contact the NRCS regarding recommendations or incentives for the farmers to allow for additional vegetated buffers along the right-of-way especially near creeks and wetlands.
- 2. Stabilize the entire right-of-way including the roadway and ditches, with appropriately sized rock. If not feasible, stabilize the rights-of-way on each side of the stream and wetland crossings for a distance to be determined by engineering analysis. Possible solutions to be considered to minimize stream and wetland impacts may include, but are not limited to, sediment traps, additional upland turn outs, etc.

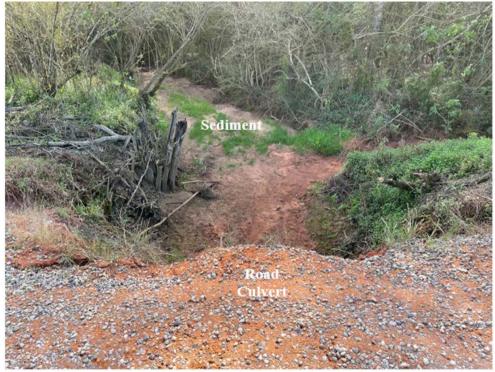
**Road Culvert Discharges to Down Stream Wetlands and Stream**

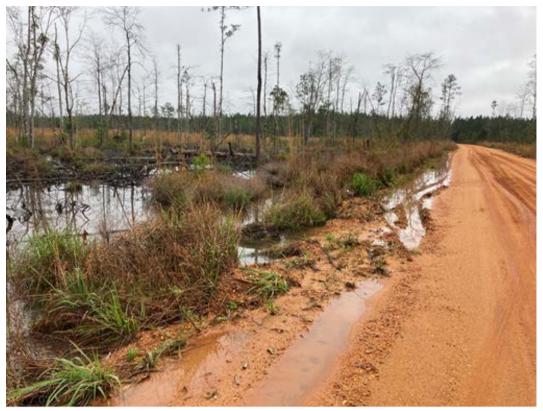
**Sediment Impacts to Wetlands**

**Observation:** The road is a major dumping ground. Erosion was noted along the length of the road leading to wetland impacts, especially at turnouts and near culvert outfalls.

- 1. Contact the Alabama Forestry Commission regarding recommendations or incentives for the foresters to allow for additional vegetated buffers along the right-of-way especially near creeks and wetlands.
- 2. Turnouts relocated such that they discharge to upland areas where possible.
- 3. Stabilize the entire right-of-way including the roadway and ditches, with appropriately sized rock. If not feasible, stabilize the rights-of-way on each side of the stream and wetland crossings for a distance to be determined by engineering analysis. Possible solutions to be considered to minimize stream and wetland impacts may include, but are not limited to, sediment traps, additional upland turn outs, etc.

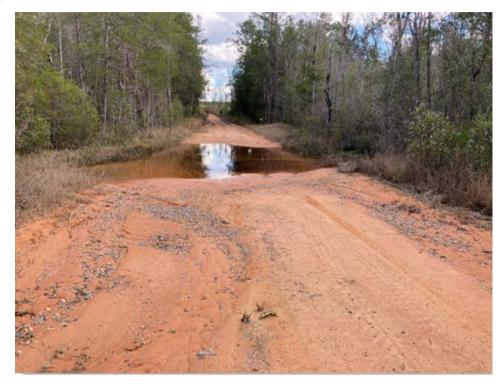
**Observation:** Portions of the road have been graveled. The road is impacting numerous wetlands and two stream. The USDA NRCS has conservation easements along the road.

- 1. Contact the Alabama Forestry Commission regarding recommendations or incentives for the foresters to allow for additional vegetated buffers along the right-of-way especially near creeks and wetlands.
- 2. Turnouts relocated such that they discharge to upland areas where possible.
- 3. Stabilize the entire right-of-way including the roadway and ditches, with appropriately sized rock. If not feasible, stabilize the rights-of-way on each side of the stream and wetland crossings for a distance to be determined by engineering analysis. Possible solutions to be considered to minimize stream and wetland impacts may include, but are not limited to, sediment traps, additional upland turn outs, etc.
- 4. The USDA NRCS and The Nature Conservancy (TNC) be contacted regarding a partnership to reduce the environmental impact from the road.

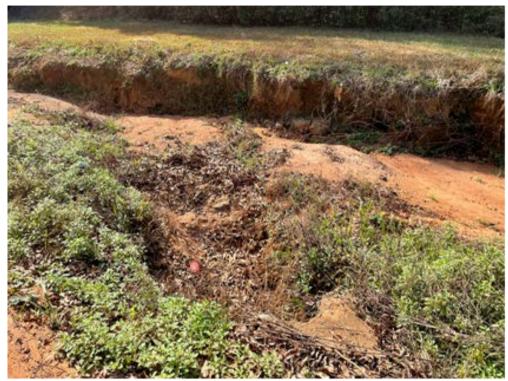
Roadside Right-of-Way Erosion-Flows to Channel

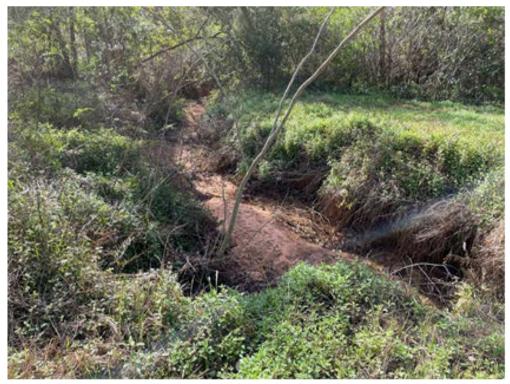
Sediment Noted in Wetland Ditch That Flows to Rock Creek

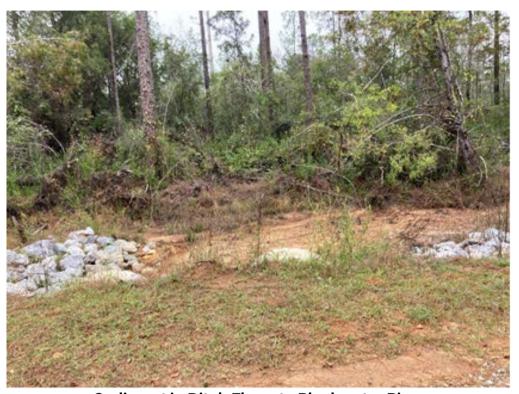
**Sediment in Ditch Flows to Blackwater River**

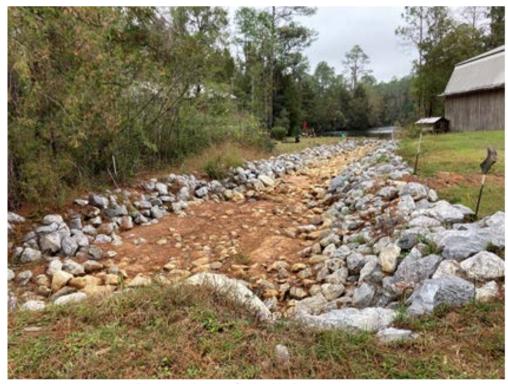
**Sediment Noted in Ditch Outfall Discharges to Blackwater River**

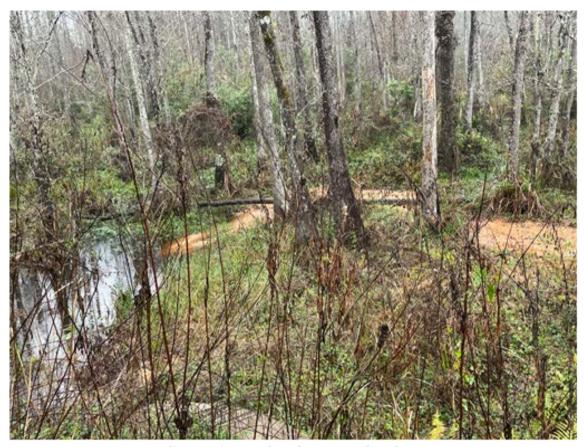
Sediment in Wetlands at Road Culvert

**Observation:** The road crosses Miflin Creek which is a headwater of Wolf Bay Watershed. Substantial sediment was noted in the wetland adjacent to the stream.

- 1. Contact the NRCS regarding recommendations or incentives for the farmers to allow for additional vegetated buffers along the right-of-way especially near creeks and wetlands.
- 2. Turnouts relocated such that they discharge to upland areas where possible.
- 3. Stabilize the entire right-of-way including the roadway and ditches, with appropriately sized rock. If not feasible, stabilize the rights-of-way on each side of the stream and wetland crossings for a distance to be determined by engineering analysis. Possible solutions to be considered to minimize stream and wetland impacts may include, but are not limited to, sediment traps, additional upland turn outs, etc.

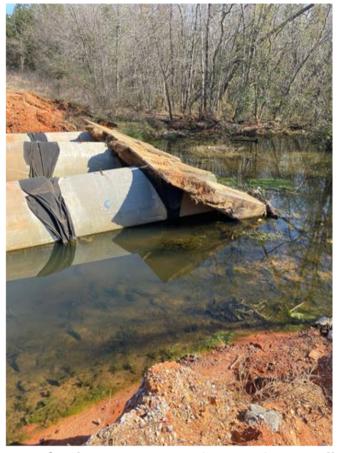
**Damage of Culvert System During Hurricane Sally**

**Observation:** Lehman Road crosses over an un-named Tributary to Negro Creek. The County recently repaired the culvert wash out and covered the road at the culverts with gravel for a distance to the east and west.

- 1. Contact the NRCS regarding recommendations or incentives for the farmers to allow for additional vegetated buffers along the right-of-way especially near creeks and wetlands.
- 2. Stabilize the entire right-of-way including the roadway and ditches, with appropriately sized rock. If not feasible, stabilize the rights-of-way on each side of the stream and wetland crossings for a distance to be determined by engineering analysis. Possible solutions to be considered to minimize stream and wetland impacts may include, but are not limited to, sediment traps, additional upland turn outs, etc.

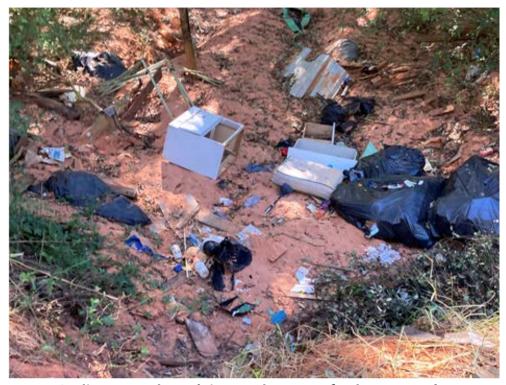
Sediment and Trash in Headwaters of Eslava Branch

**Observation:** The surface is primarily red sandy material with some gravel surface treatment. The road is a major dumping ground. Erosion was noted along the length of the road leading to impacts to Eslava Branch and its wetlands.

- 1. Due to its location and road connectivity, pave the road.
- 2. If not feasible, stabilize the entire right-of-way including the roadway and ditches, with appropriately sized rock. If not feasible, stabilize the rights-of-way on each side of the stream and wetland crossings for a distance to be determined by engineering analysis. Possible solutions to be considered to minimize stream and wetland impacts may include, but are not limited to, sediment traps, additional upland turn outs, etc.
- 3. It is recommended that the BCEAC & BCHD work with the County Solid Waste Department to address illegal dumping.

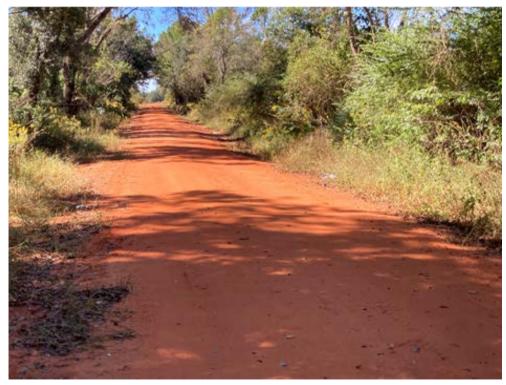
**Red Clay Base Road**

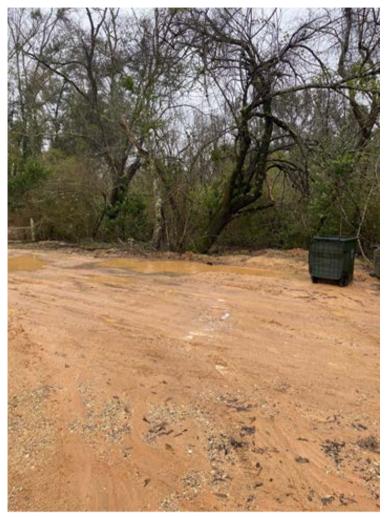
Sediment Impacts to Wetlands Adjacent to Baker Branch

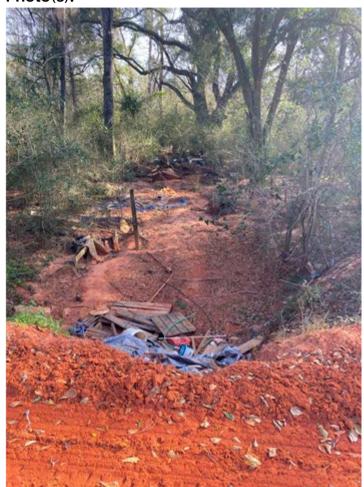
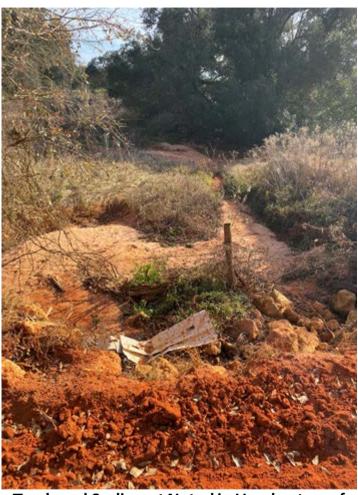
Trash and Sediment Noted in Headwaters of Weeks Creek

**Observation:** Significant amounts of sediment were present in the stream crossings including Weeks Creek. This road segment appears to require constant maintenance to the roadway and ditches, resulting in continued impacts to the streams. Sediment and trash were noted in the stream channel and wetlands.

- 1. Turnouts relocated such that they discharge to upland areas where possible.
- 2. Stabilize the entire right-of-way including the roadway and ditches, with appropriately sized rock. If not feasible, stabilize the rights-of-way on each side of the stream and wetland crossings for a distance to be determined by engineering analysis. Possible solutions to be considered to minimize stream and wetland impacts may include, but are not limited to, sediment traps, additional upland turn outs, etc.
- 3. It is recommended that the BCHD work with the County Solid Waste Department to address illegal dumping

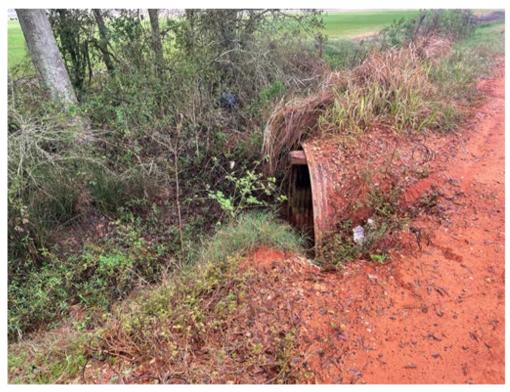
**Observation:** This segment has two stream crossings (tributaries to Baker Branch) and one large wetland crossing. Erosion was present at the culvert crossing and sediment plumes were observed downstream. No significant impacts to wetlands were identified.

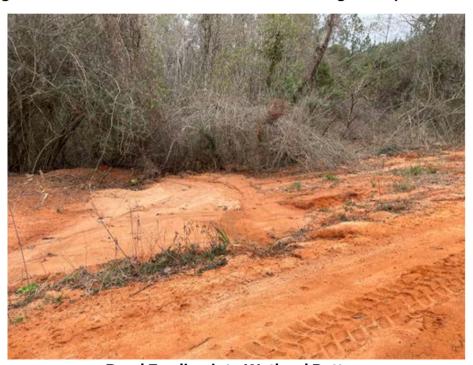
**Road Eroding into Wetland Bottom**

**Observation:** Erosion was noted along the length of the road leading to wetland impacts, especially at turnouts and near culvert outfalls.

- 1. Contact the Alabama Forestry Commission regarding recommendations or incentives for the foresters to allow for additional vegetated buffers along the right-of-way especially near creeks and wetlands.
- 2. Turnouts relocated such that they discharge to upland areas where possible.
- 3. Stabilize the entire right-of-way including the roadway and ditches, with appropriately sized rock. If not feasible, stabilize the rights-of-way on each side of the stream and wetland crossings for a distance to be determined by engineering analysis. Possible solutions to be considered to minimize stream and wetland impacts may include, but are not limited to, sediment traps, additional upland turn outs, etc.

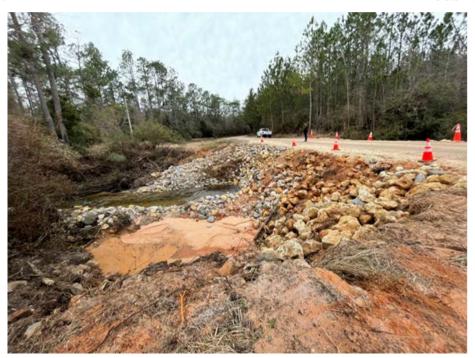
**Erosion Noted at Reedy Creek Culvert**

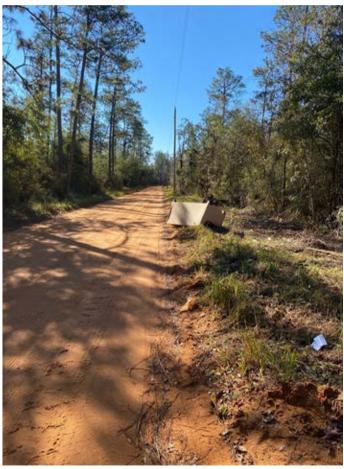
**Trash Noted on River Road North**

Observation: Sediment was noted in the wetland adjacent to River Road North which discharges to a tributary of Bon Secour River.

- 1. Due to its location and road connectivity, the road be paved.
- 2. If not feasible, stabilize the entire right-of-way including the roadway and ditches, with appropriately sized rock. If not feasible, stabilize the rights-of-way on each side of the stream and wetland crossings for a distance to be determined by engineering analysis. Possible solutions to be considered to minimize stream and wetland impacts may include, but are not limited to, sediment traps, additional upland turn outs, etc.
- 3. It is recommended that the BC EAC & BCHD work with the County Solid Waste Department to address illegal dumping.

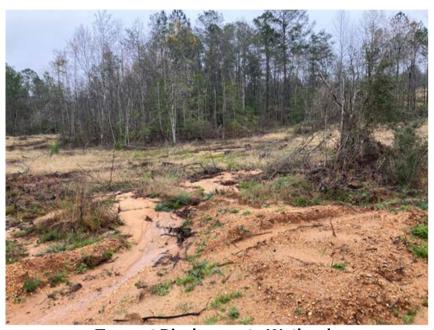
**Turnout Discharges to Wetlands**

**Observation:** Erosion was noted along the road leading to wetland impacts, especially at turnouts and near culvert outfalls.

- 1. Contact the Alabama Forestry Commission regarding recommendations or incentives for the foresters to allow for additional vegetated buffers along the right-of-way especially near creeks and wetlands.
- 2. Turnouts relocated such that they discharge to upland areas where possible.
- 3. Stabilize the entire right-of-way including the roadway and ditches, with appropriately sized rock. If not feasible, stabilize the rights-of-way on each side of the stream and wetland crossings for a distance to be determined by engineering analysis. Possible solutions to be considered to minimize stream and wetland impacts, may include but are not limited to, sediment traps, additional upland turn outs, etc.
- 4. It is recommended that the BCHD work with the County Solid Waste Department to address illegal dumping

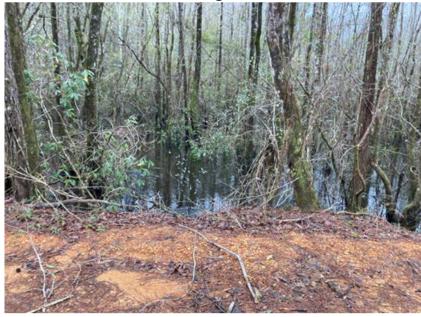
**Road Adjacent to Wetlands**

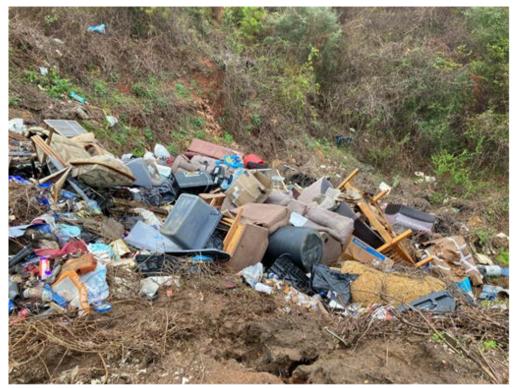
Illegal Dump on Road

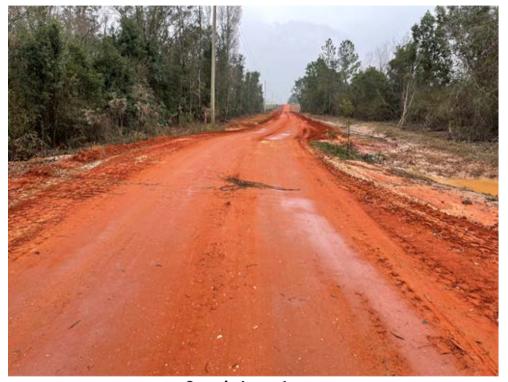
Sonnie Lynn Lane

**Observation:** The road crosses three wetlands. Sediment was noted in wetlands.

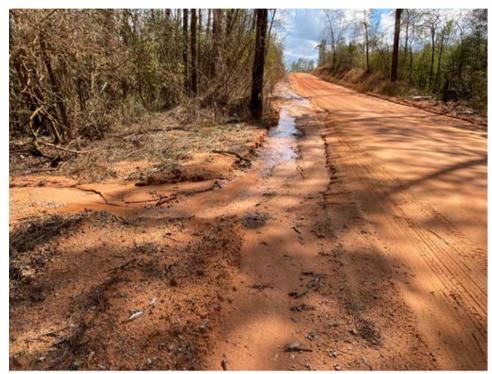
Road Turn Out Directed to Wetlands Adjacent to Hollinger Creek

**Observation:** The section of road near County Road 112 is steep resulting in erosion issues. Erosion was noted along the roadside ditches. The turnouts were directed to the wetlands. The wetlands along Hollinger Creek are heavily impacted by sediment.

- 1. Contact the Alabama Forestry Commission regarding recommendations or incentives for the foresters to allow for additional vegetated buffers along the right-of-way especially near creeks and wetlands.
- 2. Turnouts relocated such that they discharge to upland areas where possible.
- 3. Stabilize the entire right-of-way including the roadway and ditches, with appropriately sized rock. If not feasible, stabilize the rights-of-way on each side of the stream and wetland crossings for a distance to be determined by engineering analysis. Possible solutions to be considered to minimize stream and wetland impacts, may include but are not limited to, sediment traps, additional upland turn outs, etc.

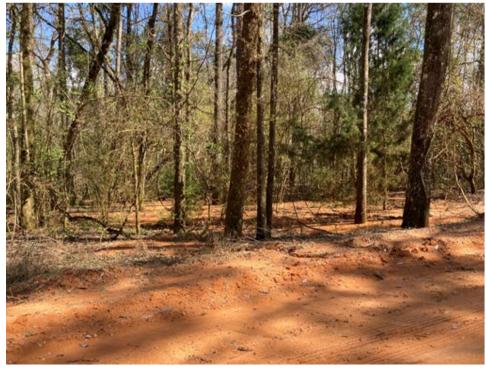
**Sediment in Wetlands Adjacent to Hollingers Creek**

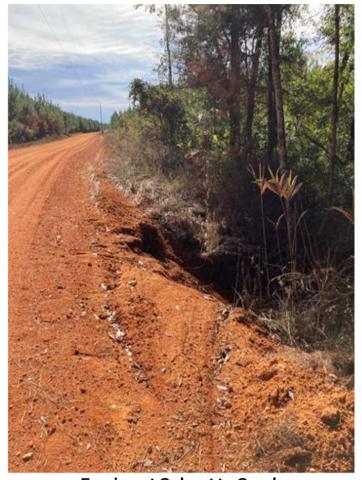
**Erosion at Culvert to Creek**

- 1. Contact the Alabama Forestry Commission regarding recommendations or incentives for the foresters to allow for additional vegetated buffers along the right-of-way especially near creeks and wetlands.
- 2. Turnouts relocated such that they discharge to upland areas where possible.
- 3. Stabilize the entire right-of-way including the roadway and ditches, with appropriately sized rock. If not feasible, stabilize the rights-of-way on each side of the stream and wetland crossings for a distance to be determined by engineering analysis. Possible solutions to be considered to minimize stream and wetland impacts may include, but are not limited to, sediment traps, additional upland turn outs, etc.

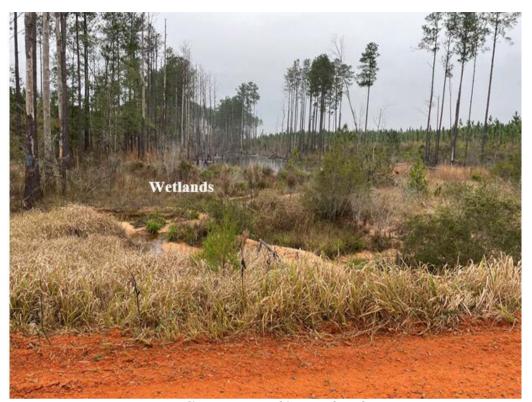
**Sediment Noted in Wetlands**

**Observation:** The Truck Route (Trail) 17 covering is a sandy-red clay material. Erosion was noted along the road and ditches. Impacts were noted in the creek and wetlands.

- 1. Contact the Alabama Forestry Commission regarding recommendations or incentives for the foresters to allow for additional vegetated buffers along the right-of-way especially near creeks and wetlands.
- 2. Turnouts relocated such that they discharge to upland areas where possible.
- 3. Stabilize the entire right-of-way including roadway and ditch with appropriately sized rock. If not feasible, stabilize the rights-of-way on each side of the stream and wetland crossings five hundred feet or a distance to be determined by engineering analysis. Possible solutions to be considered to minimize stream and wetland impacts may include, but are not limited to, sediment traps, additional upland turn outs, etc.

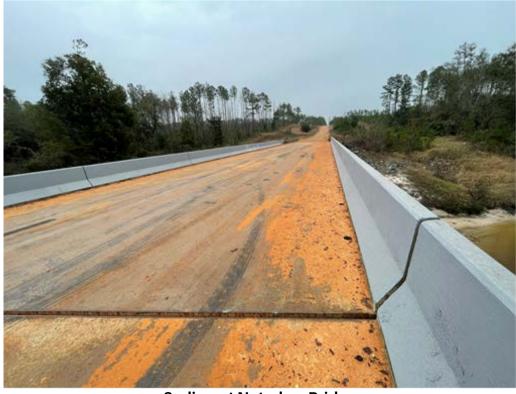
**Sediment Noted on Bridge**

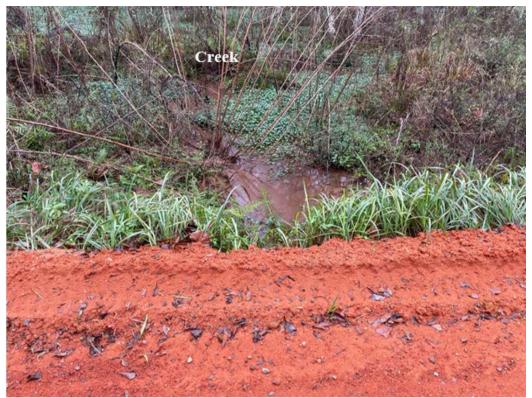
**Sediment Noted in Creek**

**Observation:** Woerner Road has been graveled at the intersections of CR 87 & 83. This helps prevent tracking onto the paved roads. However, the creek and wetland crossing have a clay surface. Erosion was noted along the ditches, and sediment was noted in wetlands and the creek.

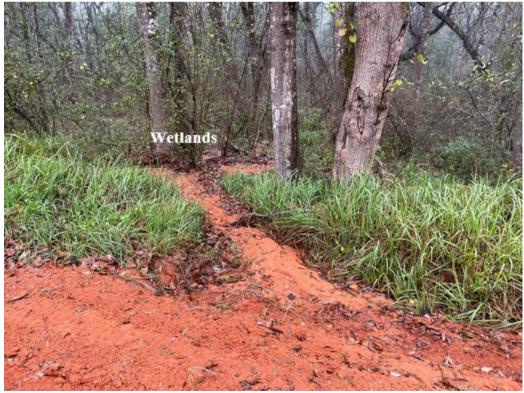
**Sediment in Wetlands**

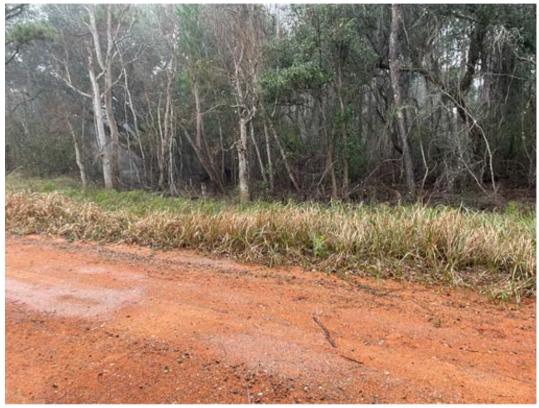
**Coastal Wetlands Adjacent to Road**
